Stream and Wetland Restoration Performance Assessment Project

Technical Report

Chagrin River Watershed Partners, Inc.
July 2018

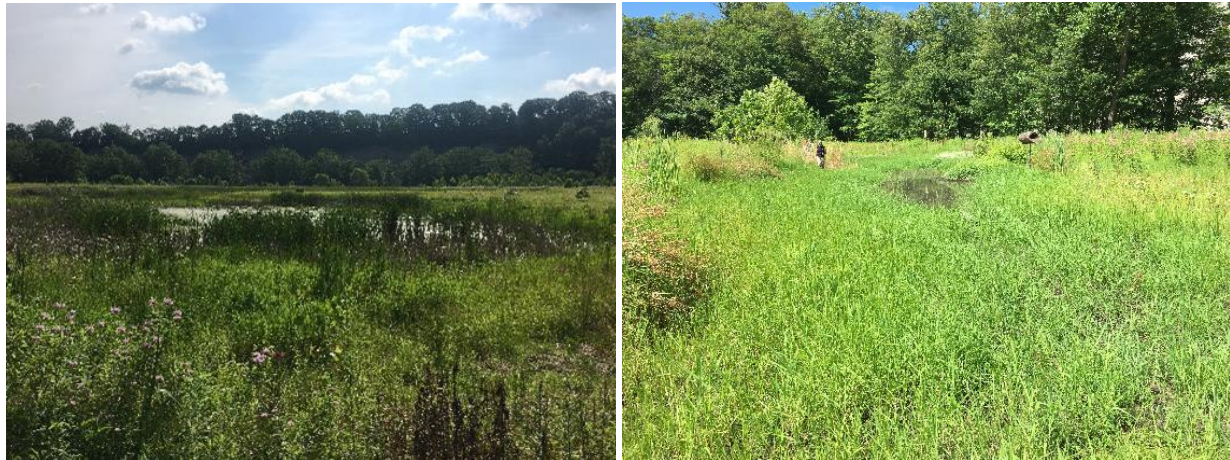
CRWP’s 2017 assessment results indicated a habitat assessment QHEI score of 80.5 (“excellent” narrative rating) adjacent to the restoration reach, which was slightly improved from Ohio EPA’s 2014 assessment. CRWP’s ORAM assessments indicated Category 2 (moderate quality) habitat within two restored wetlands, which was expected as these restored wetlands continue their establishment.

Figure 6. Restored 3.5-acre wetland (left) and vernal pool habitats (right) at the Pleasant Valley Park floodplain restoration project site. Photo source: Chagrin River Watershed Partners, July 2017.

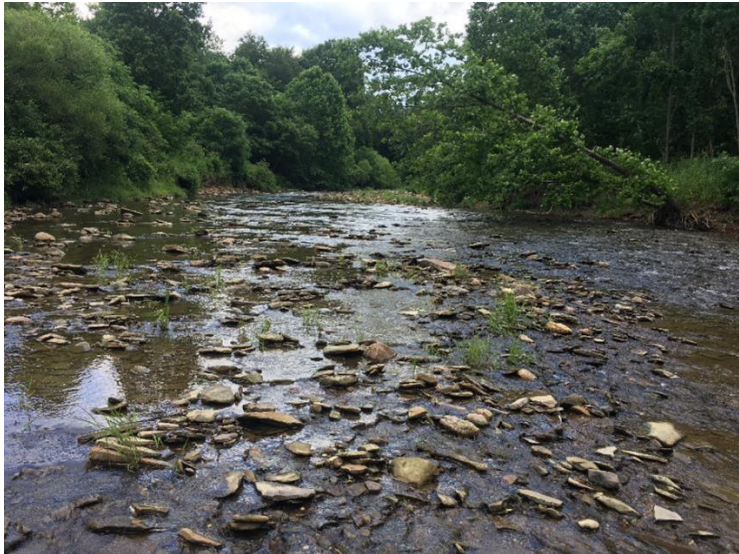
CRWP's 2017 assessment results indicated habitat assessment QHEI scores of 70.0 ("good" narrative rating) within the restoration reach and 81.0 ("excellent" narrative rating) downstream of the restoration reach. These results mirror 2014 post-construction habitat monitoring results, affirming that habitat had improved both within and downstream of the restoration reach since construction. Further, 2017 habitat assessment scores were slightly higher than post-construction stream habitat monitoring results from 2014, possibly indicating even further habitat improvement in the years since the post-construction monitoring period; however, it should be noted that the QHEI is a qualitative assessment and this improvement may not be significant enough to determine further habitat improvement since 2014. Riparian vegetative cover was estimated >95 percent (based on visual assessment). Coverage of invasive plant species within the restoration site was approximately 25 percent. This site was observed during high flow conditions after a heavy rain event in July 2017. It was noted that floodplain access was not optimal upstream of the modified dam; future quantitative assessments could be conducted to confirm this.

Figure 10. Upstream end of the restoration reach at the Ivex of Ohio lower dam modification and stream restoration project. Photo source: Chagrin River Watershed Partners, 2017.

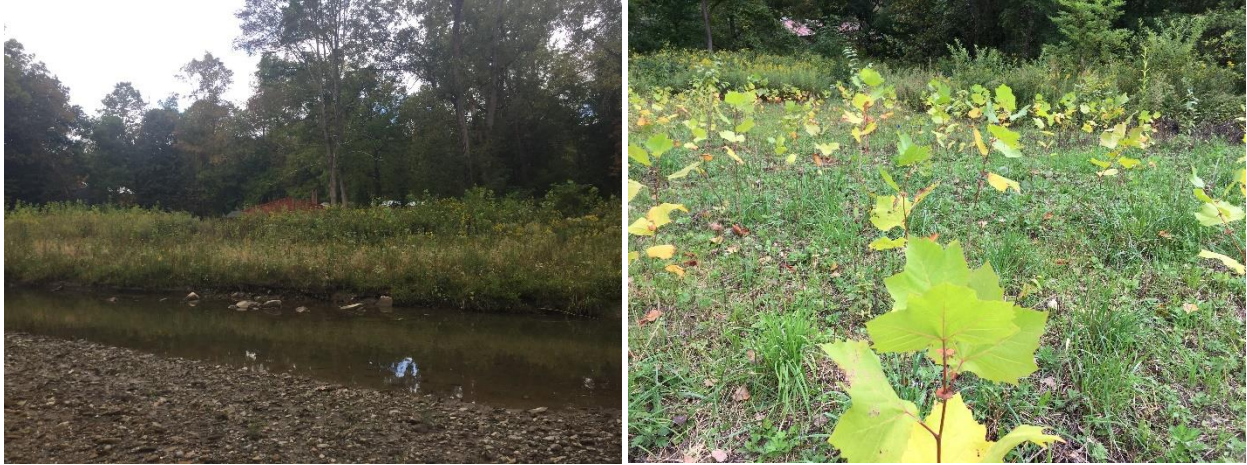
To assess the East Branch Chagrin River stream restoration project at Riverwood, CRWP replicated Ohio EPA’s post-construction QHEI assessment and conducted visual assessments of vegetative cover in the riparian zone, invasive plants, and floodplain access. CRWP’s 2017 assessment results indicated a habitat assessment QHEI score of 75.75 (“excellent” narrative rating) within the restoration reach, indicating maintenance of excellent habitat conditions. Riparian vegetative cover was estimated >95 percent (based on visual assessment). Coverage of invasive plant species within the restoration site was very low (approximately <5 percent based on visual estimate). Due to adequate invasive plant species management by Holden Arboretum, the facilitation of installed native plant species was good. Visual evidence indicated that the East Branch of the Chagrin River now has access to its floodplain (on the left bank) at the site, which will assist with dissipation of high flow energies and will help reduce flooding and erosion in downstream areas.

Figure 12. Post-construction conditions at the East Branch Chagrin River stream restoration project at Riverwood indicated the East Branch's access to its floodplain within the restoration reach (left) and good establishment of installed native plant species (right). Photo source: Chagrin River Watershed Partners, 2017.

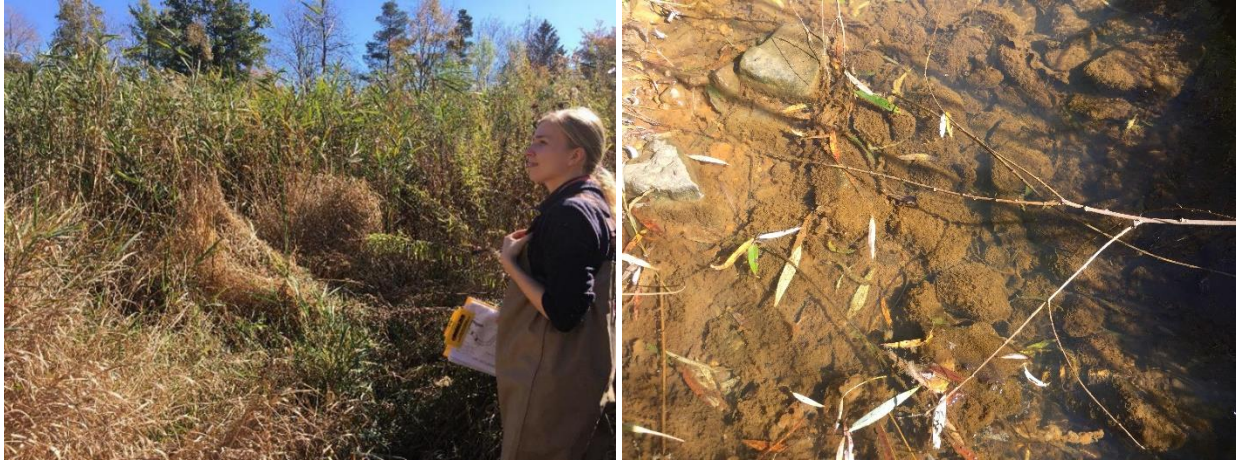
Invasive and nonnative plant species were observed at every assessed restoration site and visual estimates identified the three most commonly encountered invasive plant species as common reed (*Phragmites australis*), reed canary grass (*Phalaris arundinacea*), and narrowleaf cattail (*Typha angustifolia*). However, the estimated percent cover of invasive plant species within the restoration area varied by site. Based on discussions with project implementers and site managers, CRWP staff expect that the degree of invasive plant species cover (and the successful establishment of installed native plant species) is influenced by the degree of active invasive species management by the implementer or site manager within the first few years following restoration. At one site, the installed woody species were being outcompeted by *Phragmites australis*, leading to lack of riparian cover and shade within the stream restoration reach. CRWP staff believe these conditions may have contributed to the observed growth of algae within this stream. At another site, one reach of a restored headwater stream was totally inaccessible for assessment due to the cover of *Phragmites australis* and vegetative litter associated with this invasive plant. To ensure the growth of woody species that provide bank stabilization and stream shading, restoration implementers and site managers should expect to do some initial invasive plant species management within the first few years after the completion of the project or until installed native plant species are well established.

*Figure 13. At one site, installed woody plant species were being outcompeted by *Phragmites australis*, which may have contributed to lack of riparian vegetative cover and shade and the growth of algae in a restored stream reach. Photo source: Chagrin River Watershed Partners, 2017.*

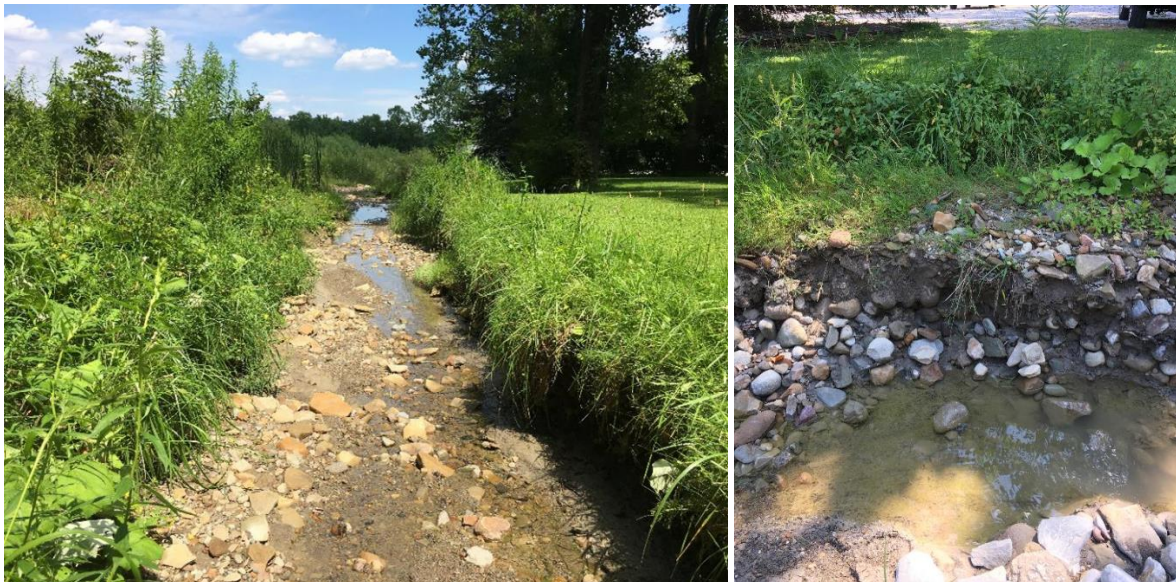
Figure 14. At one site, a practice of mowing to the edge of the stream was contributing to a lack of deep-rooted and woody vegetation and may have been contributing to minor erosion within the stream restoration reach. Photo source: Chagrin River Watershed Partners, 2017.

In addition to initial invasive plant species management, it is important for land managers to develop the use of best landscape management practices as they maintain a restoration site. This includes the maintenance of an adequately sized vegetated buffer area along restored streams and wetlands. At one site, CRWP staff observed minor erosion occurring at the upstream end of the restoration reach where a land manager on the adjacent parcel was mowing directly to the stream's edge. The lack of deep-rooted and woody vegetation along this portion of the restored stream may have contributed to this erosion. In this case, CRWP recommended that the restoration implementer reach out to the land manager on the adjacent parcel to suggest a "no mow" approach along the stream. Similar situations may serve as opportunities for natural resource managers to educate landowners and project partners about riparian zone management.

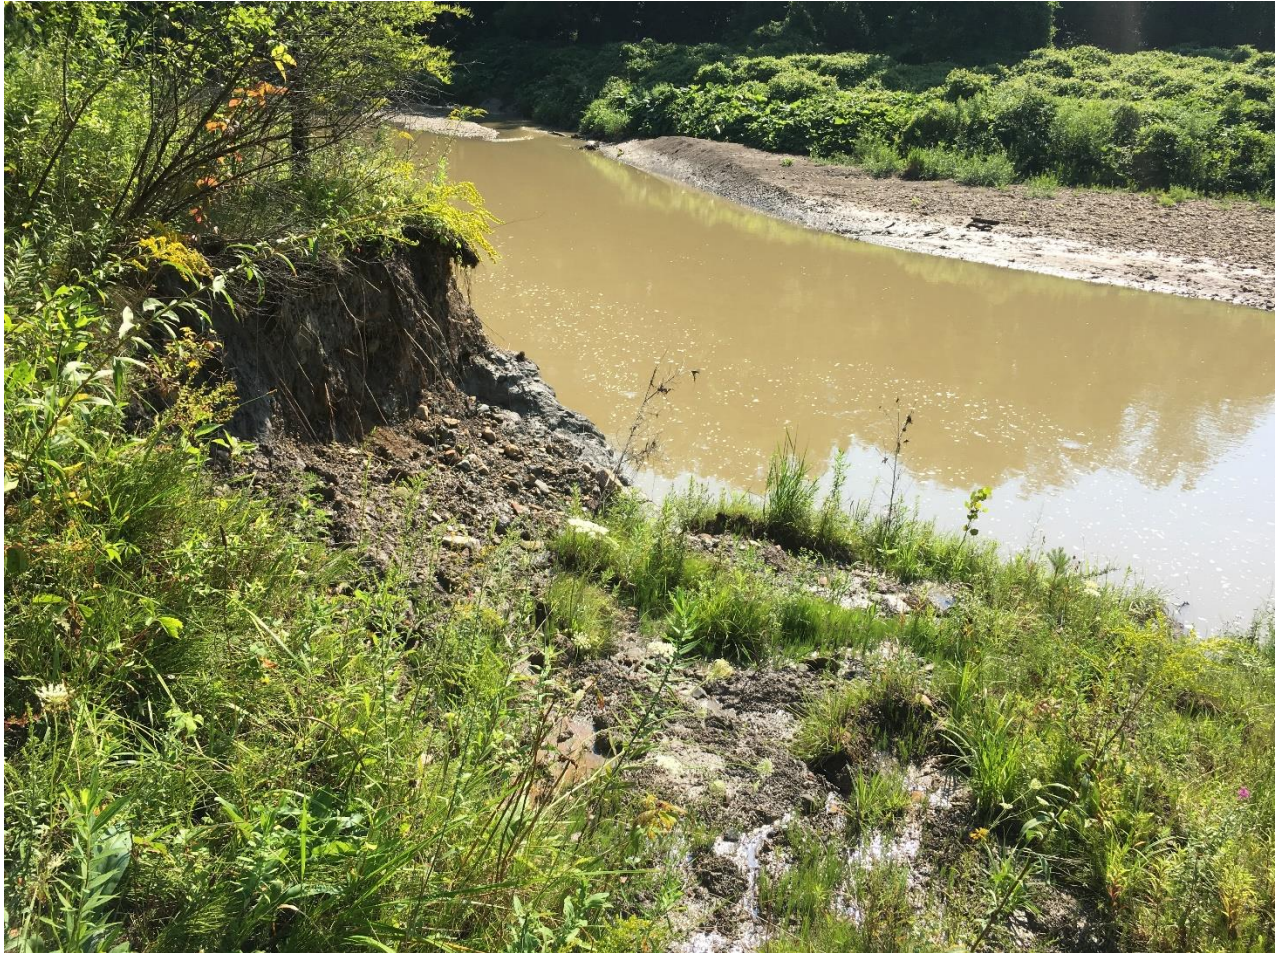
CRWP staff also observed that there may be unintended downstream consequences of hardening streambanks in an effort to improve streambank erosion. At one site, a bioengineered streambank stabilization approach was used to stabilize eroding streambanks with rock and vegetation. The goal of this project (bank stabilization) was being met within the project reach; however, erosion was occurring immediately downstream of the stabilized reach. In this case, the stream's flow energies may have been directed to the hardened streambanks and then transferred downstream where there was no bank protection. It may be beneficial for future restoration implementers to consider the use of strategies that dissipate and slow down high energy flows, such as the establishment of a floodplain bench or reconnection of the stream to its floodplain.

Figure 15. At one site, hardened streambanks within a streambank stabilization project reach may be contributing to erosion immediately downstream. Photo source: Chagrin River Watershed Partners, 2017.
