Pepper/Luce Creek Watershed Stream Assessment

Summary of Findings

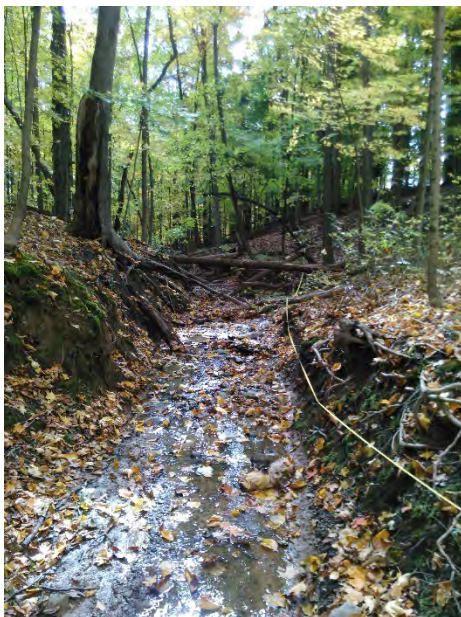
Figure 2. Class III PWH Stream in Hunting Valley.

HHEI and BEHI scores were compared to the percent of impervious surface from the 2019 National Land Cover Database. All high-quality, Class III stream channels were located in areas of the watershed with 0% impervious surface at the sampling site. Where possible, efforts should be made to ensure that these areas remain healthy by maintaining native vegetation in the riparian zone (Figure 4).

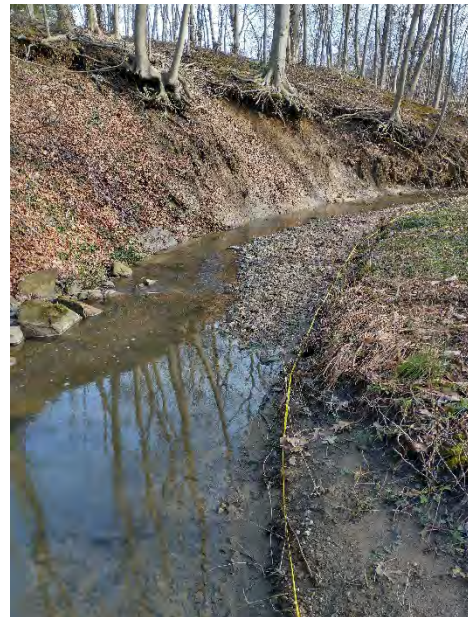
CRWP staff reviewed the field assessments and compiled the data into a spreadsheet and geographic information system (GIS) software to further analyze the information. In general, widespread erosion was witnessed throughout, which is indicative of watershed scale issues rather than localized problems. This

widespread erosion can be caused by excess stormwater entering the system from impervious surfaces and lack of riparian vegetation.

Figure 3. Streambank in Pepper Pike with a BEHI rating of "very high."

Communities should consider implementing watershed wide stormwater management practices to lessen the erosion that is occurring within the Pepper/Luce Creek subwatershed.

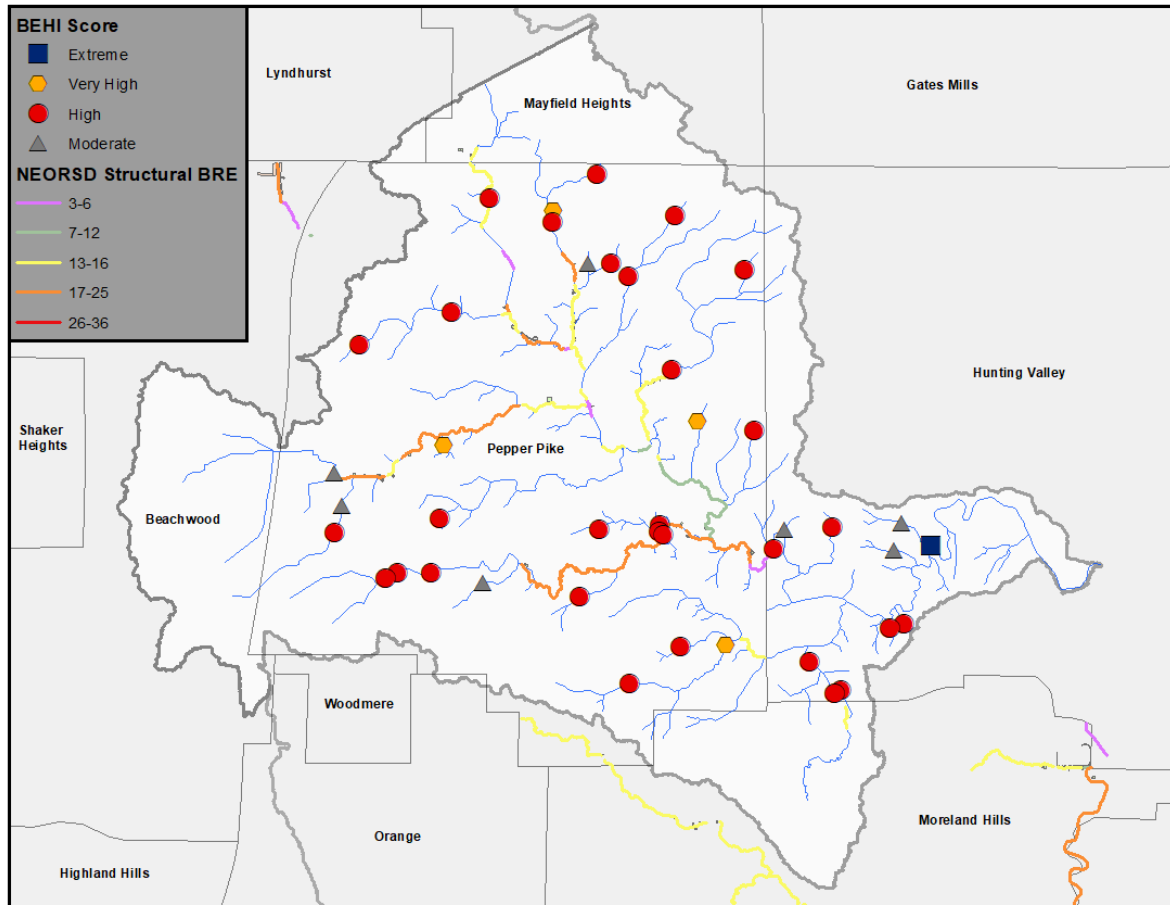
Bank erosion throughout the sampling area ranged from “moderate” to “extreme” with no sites scoring as “low”. Only one site, 2% of the assessment area, received a BEHI narrative rating of “extreme” with a score of 38.5, this is primarily due to the streambank lacking root density and surface protection while being comprised of highly erodible materials (silt, sand, and gravel). For the remaining sites, 17% received a narrative rating of “moderate,” 71% received a narrative rating of “high,” and 10% received a narrative rating of “very high” (Table 3). The BEHI scores were distributed throughout the watershed. Figure 3 shows the location of each narrative score along with the NEORS Structural Business Risk Exposure rating.

Figure 5. BEHI scores throughout the Pepper/Luce Creek Subwatershed.

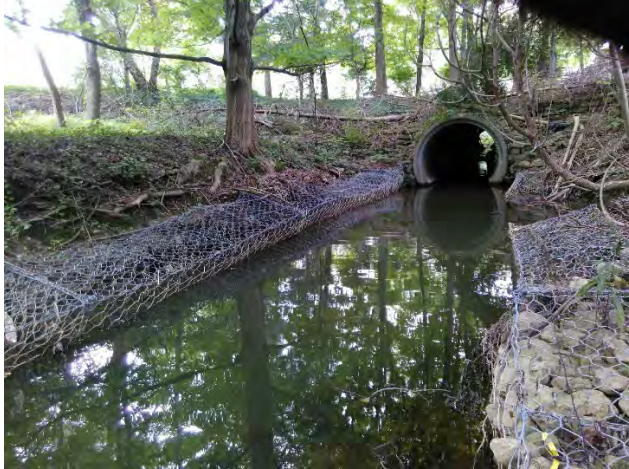
Figure 6. Gabion baskets are present at 2733 Sinton Place, Pepper Pike, Ohio.
