SUNNYBROOK PRESERVE

STREAMBANK STABILIZATION AND RIPARIAN RESTORATION

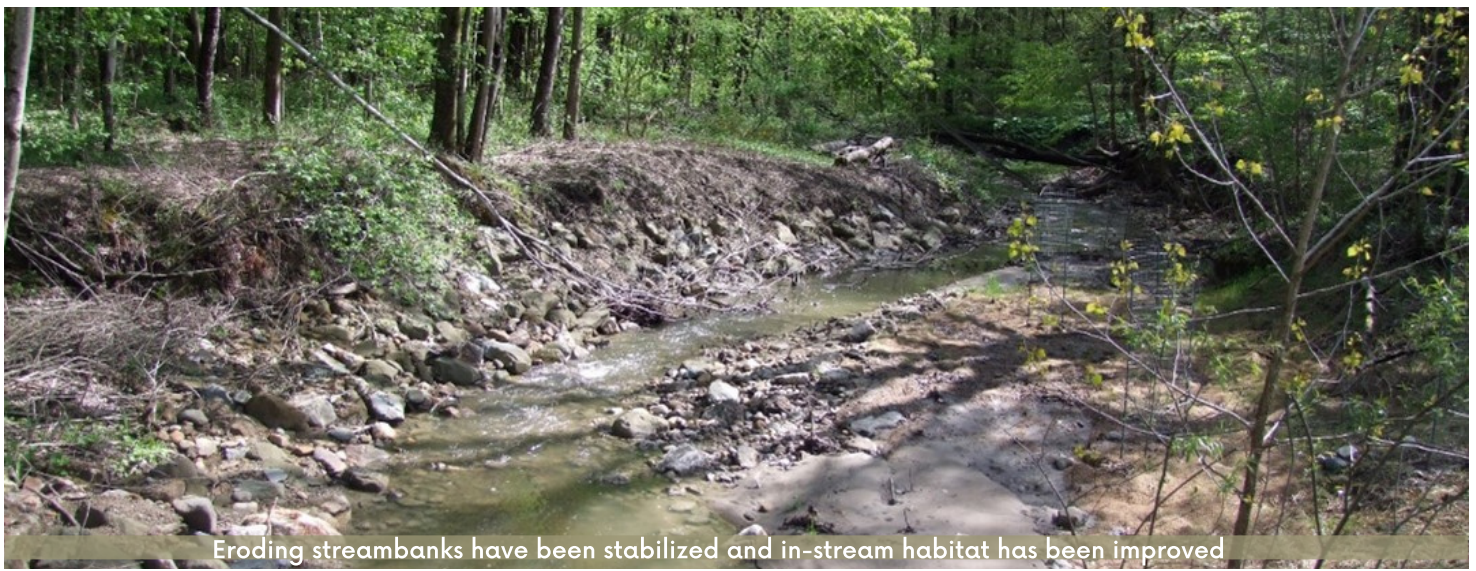
Eroding streambanks have been stabilized and in-stream habitat has been improved

The restoration approach combined enhancement of aquatic habitat, treatment of invasive plants, revegetation, and streambank stabilization using woody vegetation, branch layering, regrading to a gentler slope, and stacked rock. Five hundred linear feet of stream was improved through this effort. Two acres of wetland and riparian forest were enhanced by planting native vegetation and removing invasive species. The design-build team used a raise-grade approach to build up the riffles to reattach the stream to its floodplain. In some areas, excavation was used to create a new floodplain bench. Buried rock vanes were used to guard against future channel incision or migration around riffles. Good floodplain connection dissipates energy and provides flood storage, which helps to decrease downstream flooding and erosion. Restoration work occurred fall 2020 through spring 2021.

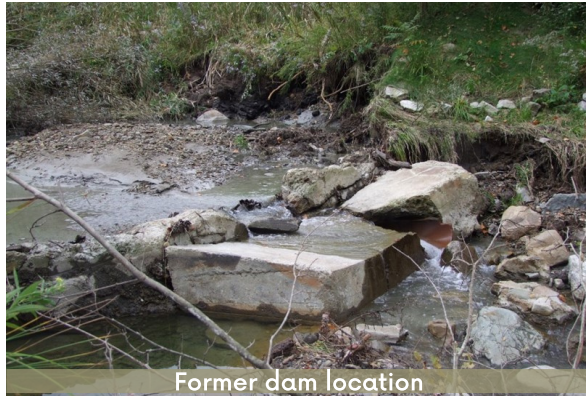
Former dam location

Need for Restoration: During the early twentieth century, a log dam was installed at Sunnybrook within the restoration area to form a swimming hole. In 1934 the log dam was replaced with a concrete dam. The concrete dam was soon undermined and the pond disappeared overnight in late the 1930s. Remnants of the dam remained in 2020, and the stream suffered from erosion and siltation. Before restoration, riparian wetlands were infested with the nonnative invasive plant species of common reed (*Phragmites australis*), reed canary grass (*Phalaris arundinacea*), and European black alder (*Alnus glutinosa*). If unaddressed, invasive nonnative plant communities outcompete native plants and decrease biodiversity.

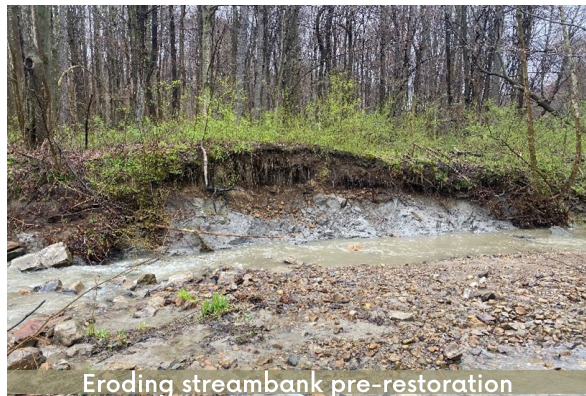
Eroding streambank pre-restoration
