## Where is the Ordinary High Water Mark of a River?

### Definition of the Ordinary High Water Mark

### The Ordinary High Water Mark in the Chagrin River Watershed

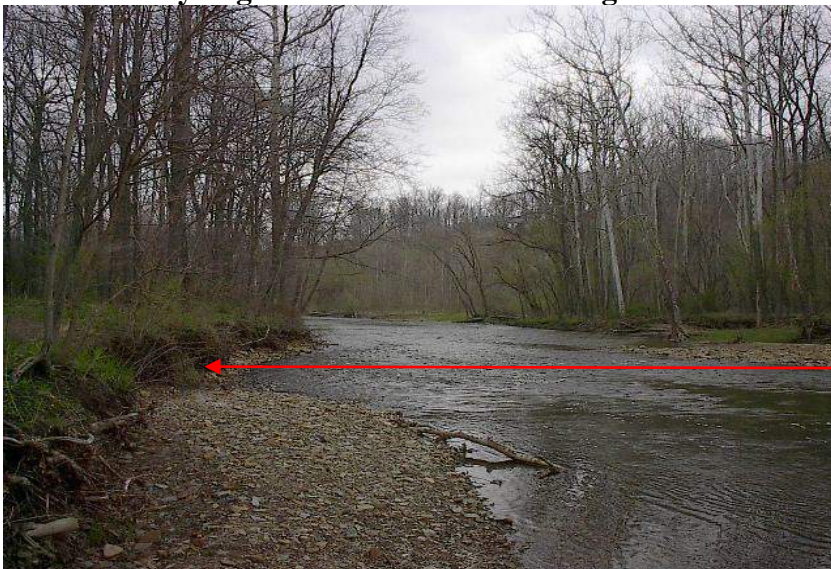
Figure 1: South Chagrin Reservation, Village of Bentleyville

The ordinary high water mark on this section of the Chagrin is clear at the point where gravel meets terrestrial grasses along the stream bank.

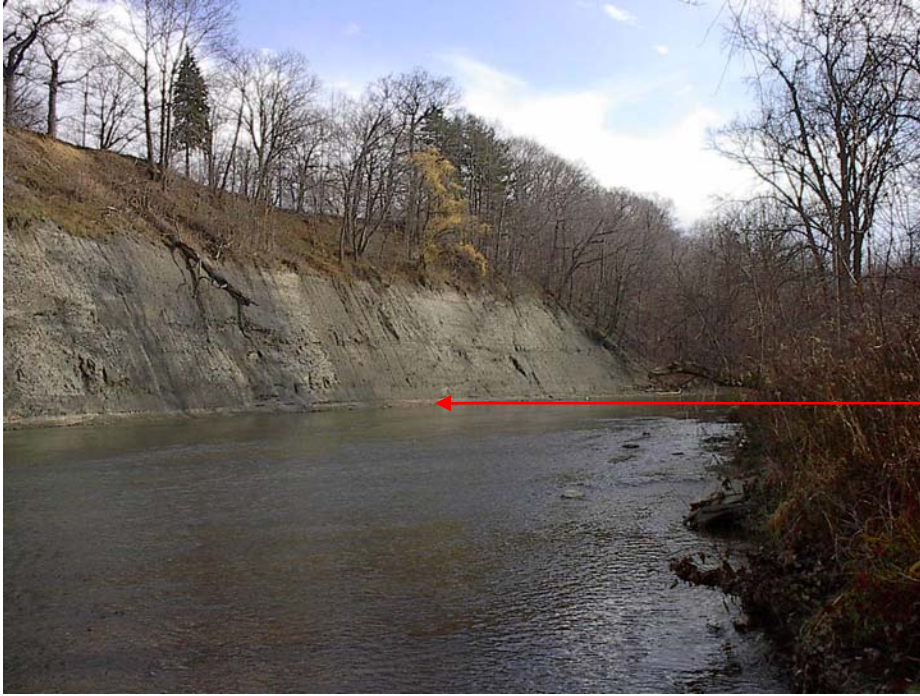
**Figure 2 Todd Field, City of Willoughby Hills**

This horizontal line along the bottom of this steep bank shows the ordinary high water mark. On this section of the Chagrin River, active erosion defines the area.

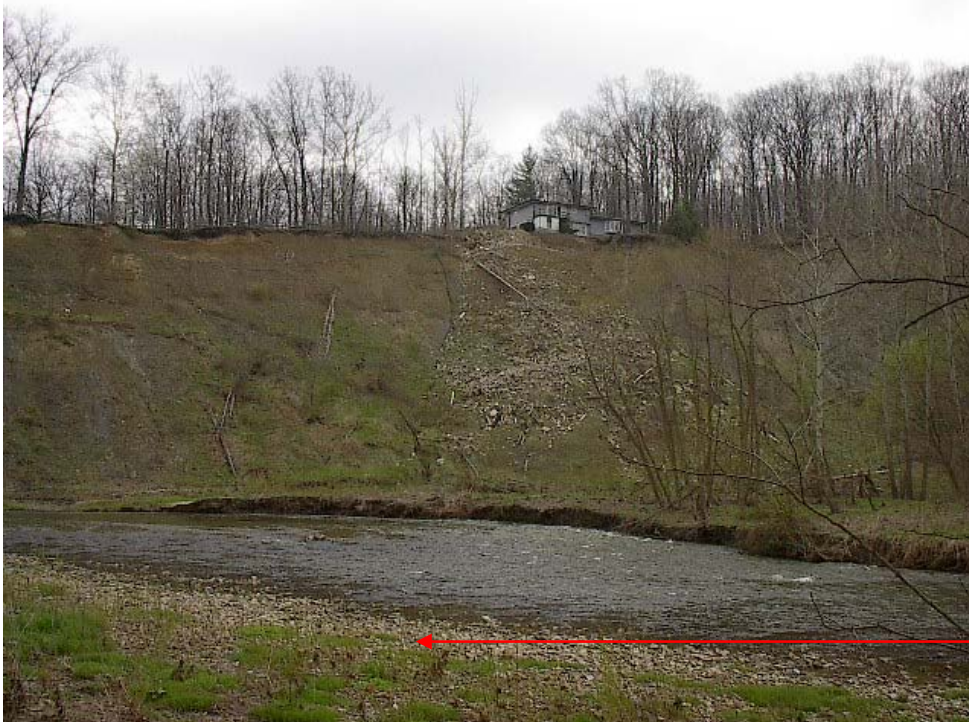
**Figure 3 Village of Moreland Hills**

This ordinary high water mark area highlights a transition between aquatic plants and terrestrial plants.
