STORMWATER SOLUTIONS IN OHIO

URSULINE COLLEGE BIORETENTION

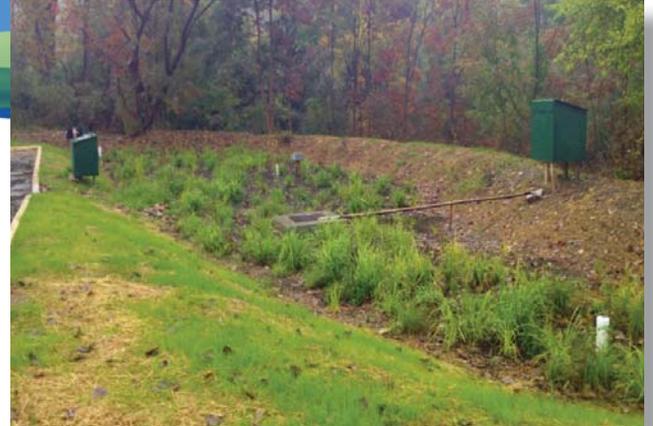
Bioretention cell installed at the edge of parking lot with installed monitoring equipment at Ursuline College.

Monitoring equipment was installed both during and post-construction. The monitoring contractor installed an automated rain gauge and two auto-samplers. One autosampler collected stormwater runoff samples as water entered the bioretention cell. The second collected combined drainage and overflow to allow for direct comparison of inlet and outlet water quality. Inflow hydrology from the parking lot

was estimated using the curve number and rational methods. The drainage system was kept separate from the existing storm sewer to isolate flows for monitoring purposes. Within the catch basin, a weir and baffle system was installed to collect hydrologic data from combined drainage and overflow. The cell was monitored for hydrology and water quality. A temperature sensor nest and a water table well were installed within the cell to measure drawdown rates between rain events.
