Chagrin River Watershed Partners, Inc. Willoughby, Ohio

For IMMEDIATE RELEASE (March 15, 2021)

Beaver Creek Restoration Project Underway in Munson Township

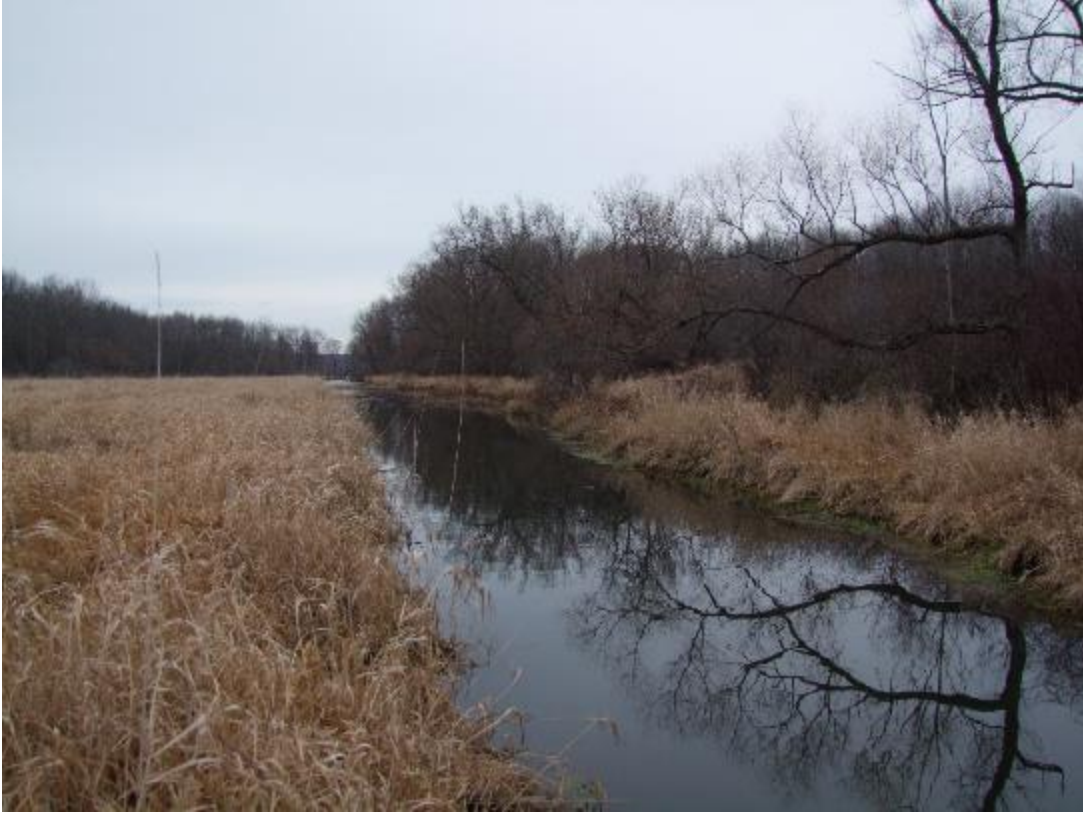
Figure 1. Beaver Creek at the project site (approximately river mile 0.6); facing downstream (north). Photo source: Geauga Park District, December 2016.

However, conditions at the lower mile of Beaver Creek and its associated wetlands within the project area have been exacerbated by human activities. Development within the watershed has resulted in more impervious surfaces, which has increased the volume of polluted stormwater runoff entering the site. This has adversely affected the wetland quality through increased nutrient input and increased erosion. Channelization has also isolated the stream from the floodplain and decreased habitat diversity. Channelized streams tend to lose their ability to naturally process water pollutants as the water cannot spread up and over a floodplain to settle out nutrient-loaded sediment. Additionally, the site's riparian area currently lacks its historical forest cover. These changes have led to the degradation of the surrounding wetlands and promoted conditions for invasive species, causing a significant ecological loss at the site. Restoration of lower Beaver Creek is necessary in order to reconnect its floodplains and restore its forested wetland habitat within the riparian corridor.

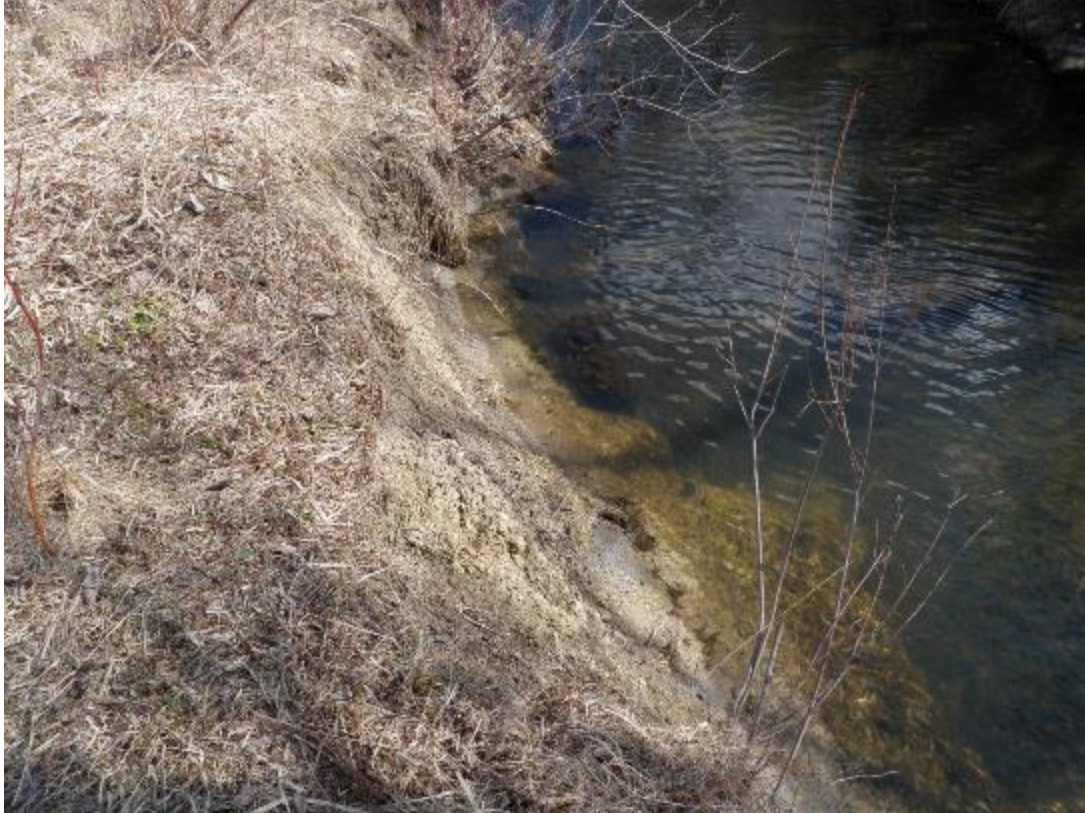
Figure 1. River bank left (facing downstream towards Bass Lake). Lack of woody riparian vegetation has led to bank erosion and stream sedimentation in Beaver Creek at the project site. Photo source: Chagrin River Watershed Partners, Inc., April 2013.

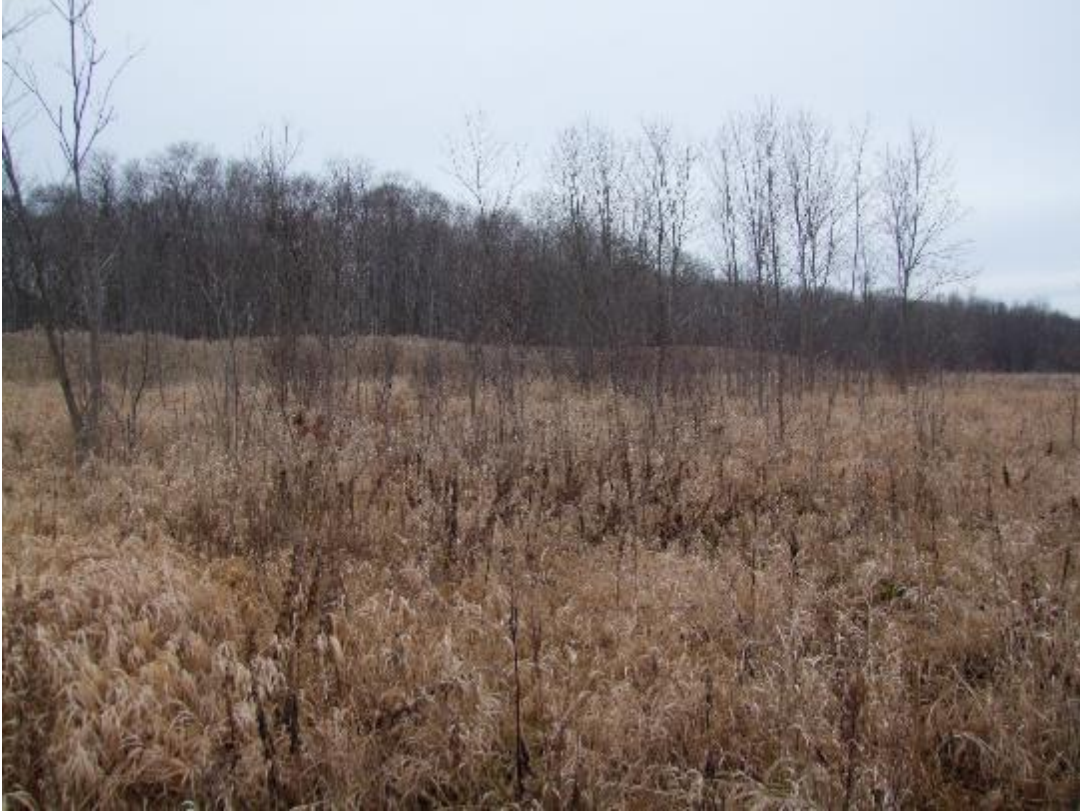
Figure 2. Riparian area of Beaver Creek. Photo source: Geauga Park District, December 2016.

interconnected pools and wetlands. Re-creating high-quality wetlands is a primary goal of this project, as Beaver Creek runs through a wetland preserve possessing rare and endangered plant species. The riparian habitat corridor will be restored and stabilized by scarifying and decompacting floodplain soils, creating wetlands, and constructing habitat features from coarse woody debris. The project will also establish new vegetative communities through the planting of more than 8 acres of native seed mixes, herbaceous plugs, clusters of live stakes, woody trees and shrubs, and available onsite material. This restoration will help improve water quality within Bass Lake Preserve by reducing sediment and nutrient loading, and by directly addressing other known water pollution concerns for this tributary. It will also benefit amphibians, birds, and other wildlife that requires large, connected corridors of high-quality forested wetland habitat. Overall, this project will facilitate the recovery of the ecological functions of Beaver Creek and Bass Lake Preserve, buffer Bass Lake from the stressors in the Beaver Creek watershed, and provide habitat to sensitive wildlife.

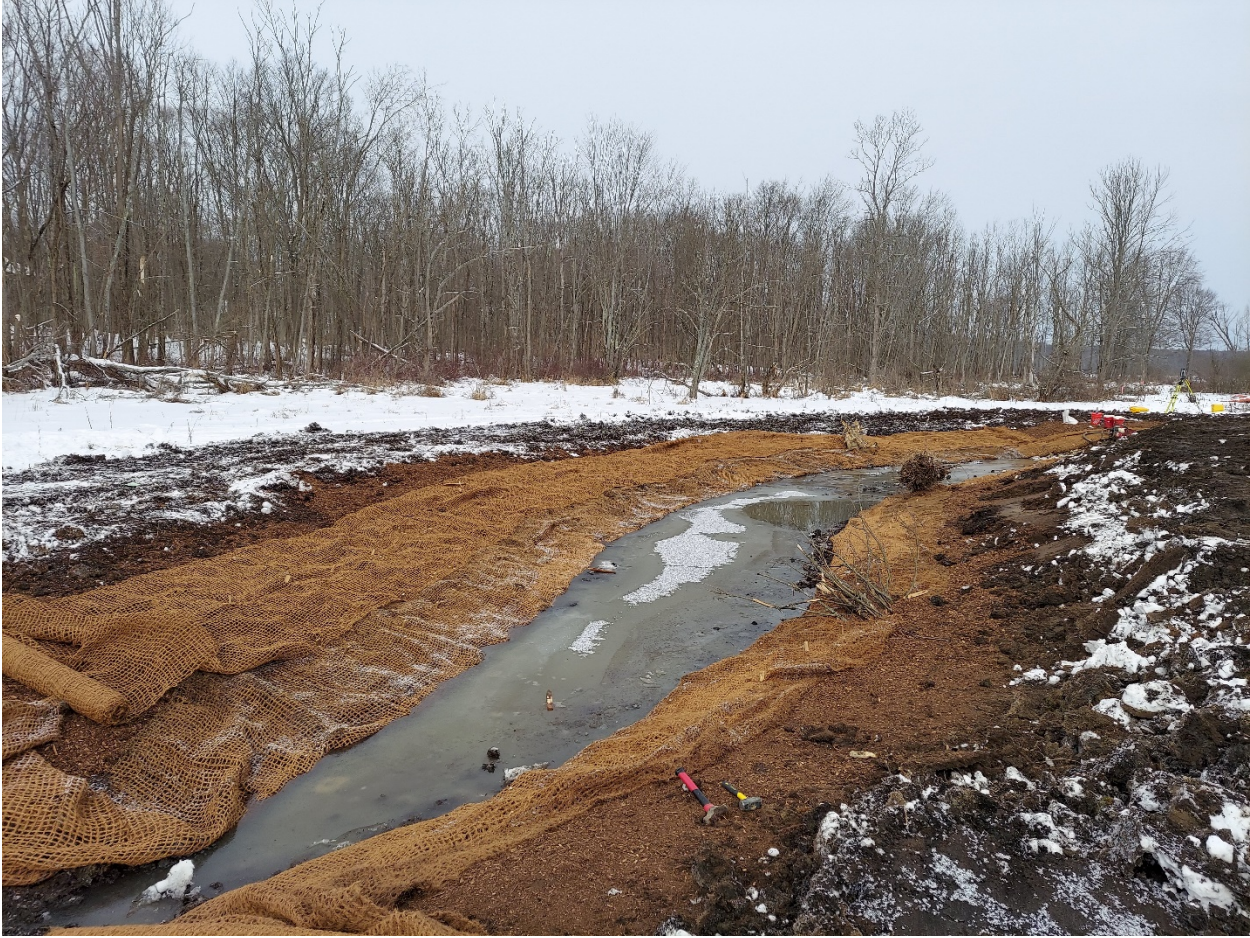
Figure 4. Beaver Creek Restoration Project during construction. Photo source: BioHabitats, February 2021.

This project will restore natural floodplain connectivity along approximately 1,800 linear feet of Beaver Creek using bioengineering techniques and by converting the channelized creek to a series of

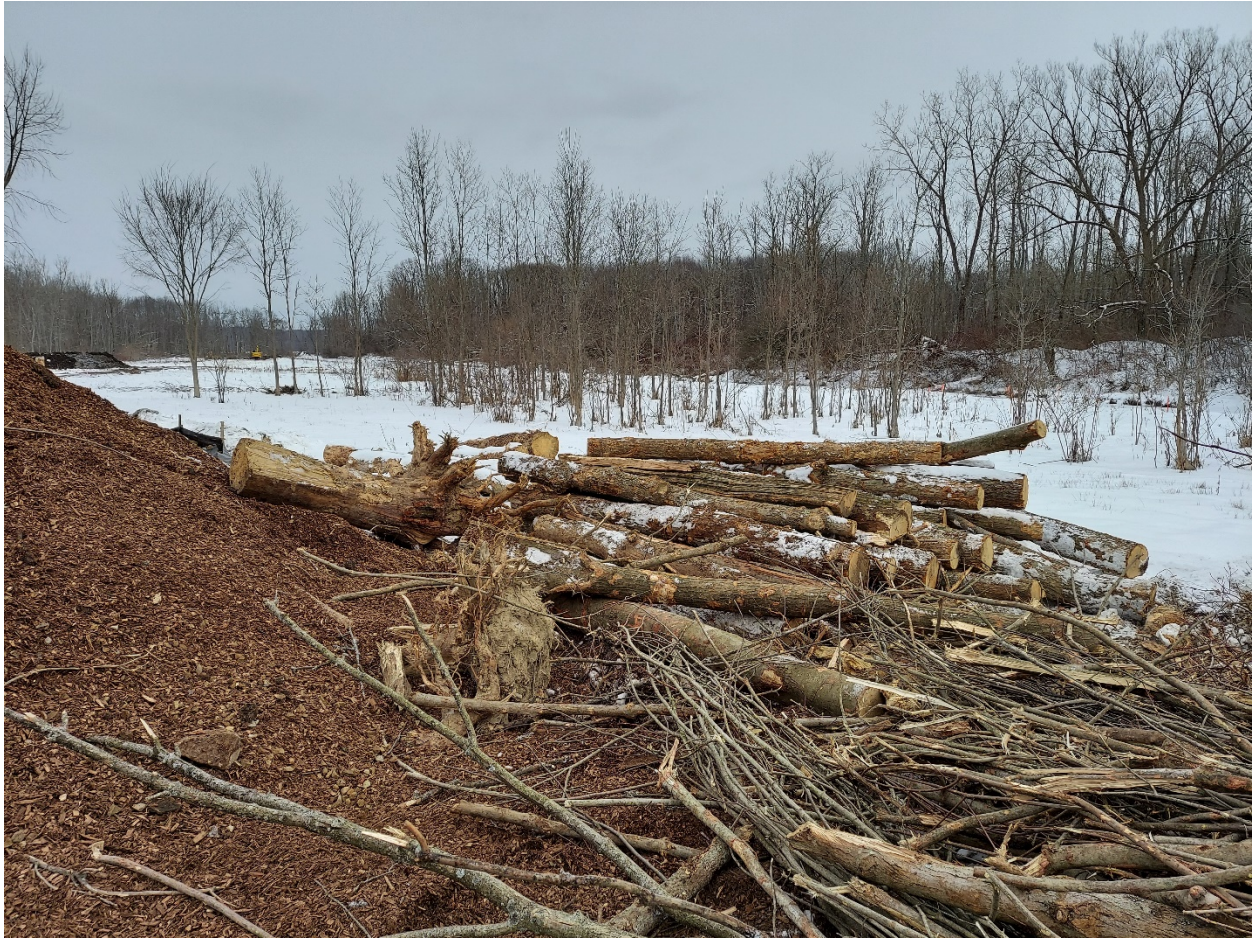
Figure 5. Woody debris materials to be used in the Beaver Creek Restoration Project during construction. Photo source: BioHabitats, February 2021.

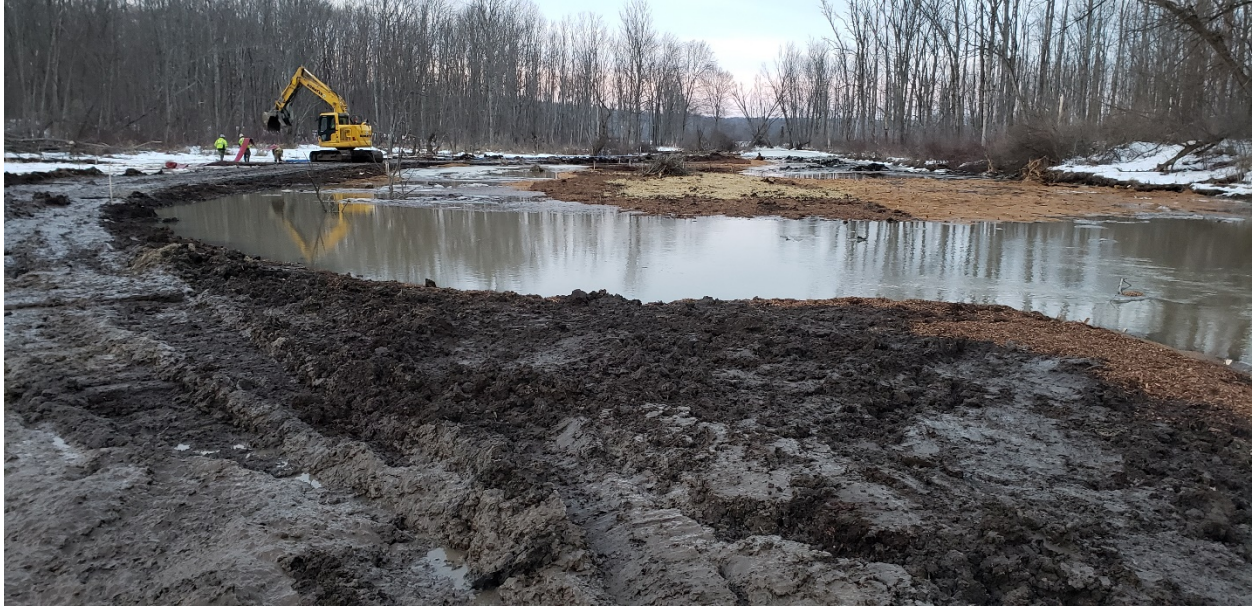
Figure 6. Beaver Creek Restoration Project during construction. Photo source: BioHabitats, February 2021.
