Stream Restoration Improves Water Quality, Play at Lost Nation Golf Course

by Matt Fredmonsky, Project Manager, The Davey Tree Expert Company

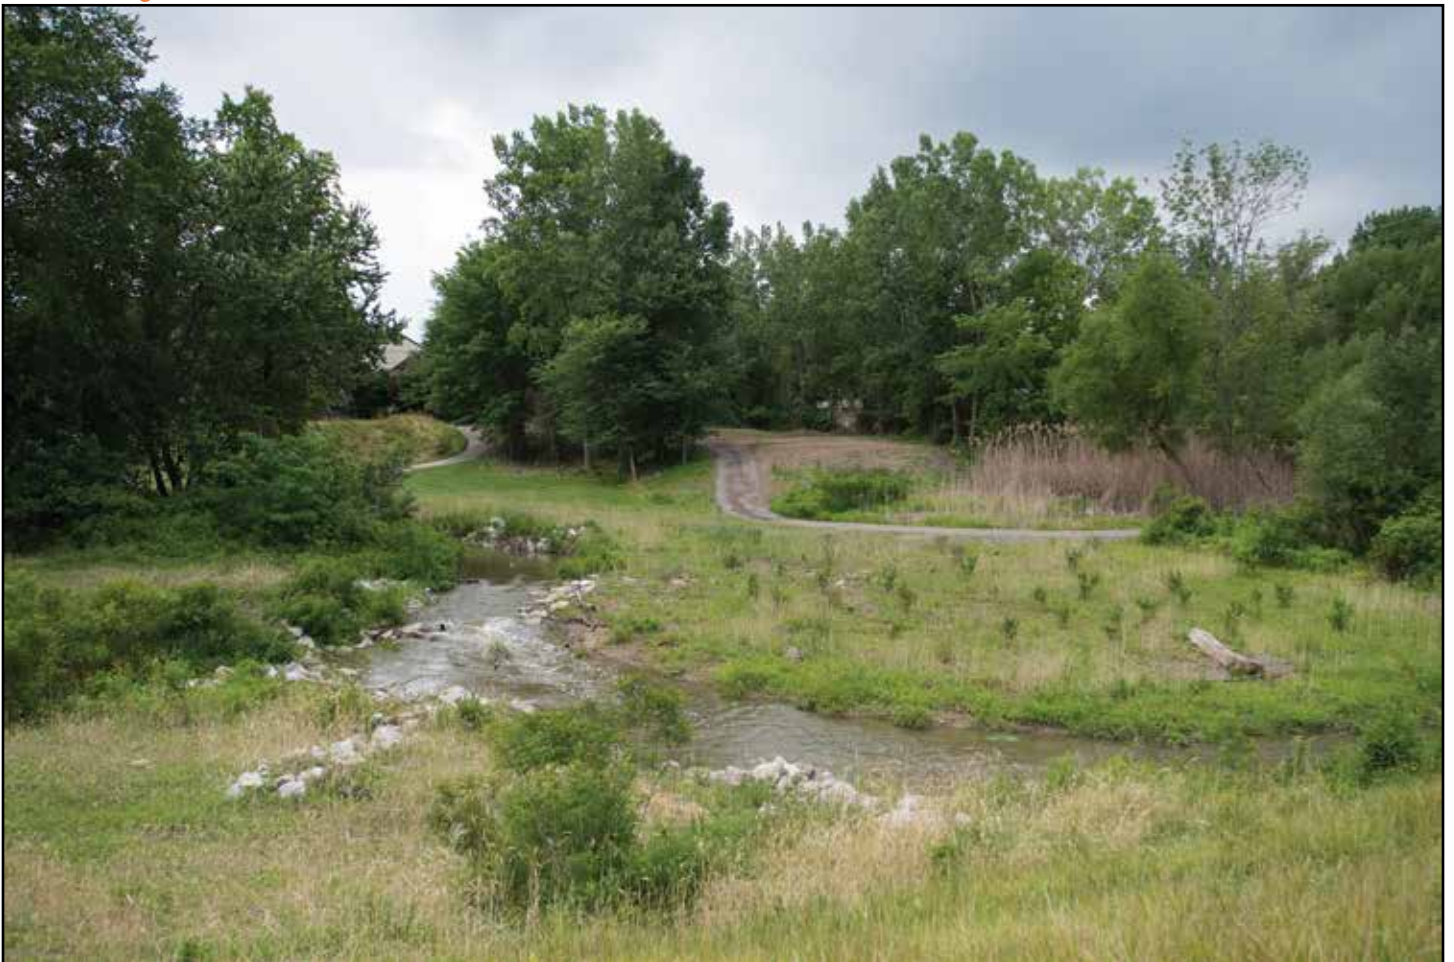
After just a few months, native grasses and woody shrubs have taken root in the riparian area at hole 13, where rock-enhanced stream banks combine with deep-rooted plants to prevent erosion.

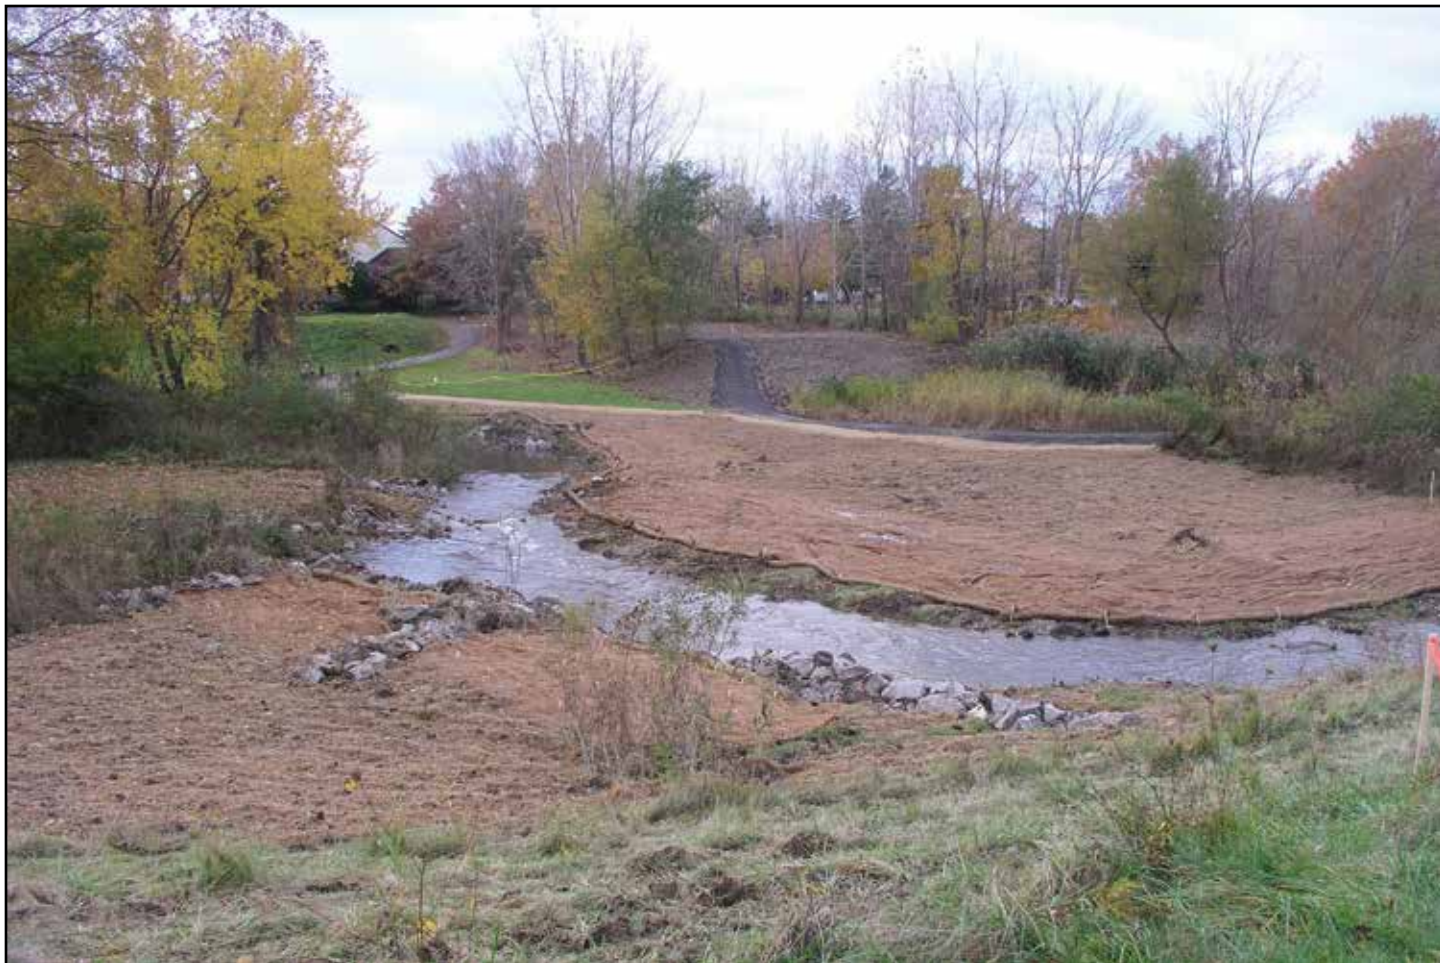
Erosion control matting at hole 13 kept soil and fledgling plants in place through the winter in the newly excavated riparian flood plain.

Some erosion control fabric was used to hold soil in place through the winter as grasses and shrubs developed, and biodegradable matting was used. Christensen said such restoration projects always provide lessons and teachable moments, and in this case that moment came from the matting.

“The fabric we used was designed to handle the stream velocities present in Ward Creek, but it didn’t allow for as much light and soil penetration as I would have liked for germination underneath,” he said. “The plants are coming up fine, but a more open weave would have allowed for better light penetration.”

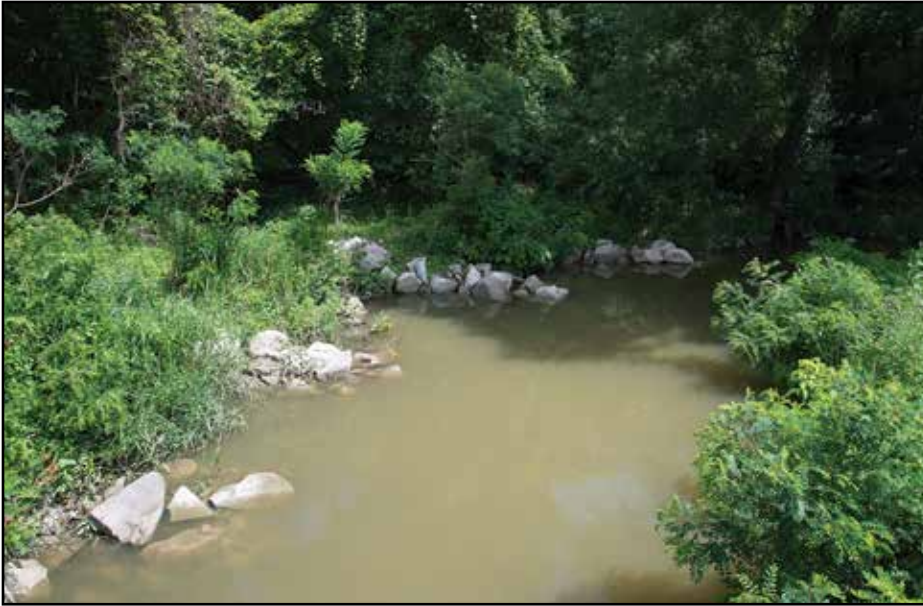
Above: New bendway weirs protect the stream bank upstream of hole 18. Below: Construction at hole 13 involved rerouting a section of the stream away from a heavily eroded embankment, which was reinforced with rock.

Keely Davidson-Bennett, project manager for CRWP, said stream bank stability has vastly improved since construction ended thanks to the native vegetation’s deeper roots, re-grading of banks to a more stable slope and installation of the bendway weirs.

Another immediate benefit has been a reduction of sediment and nutrient loading. In one example, at hole 14 a bendway weir directs the main current away from the bank towards the center of the channel near an existing bend. The redirection slows the water velocity and, as a result, the water loses energy and can no longer sustain the weight of the silt it had been carrying to that point. The result is the silt has been deposited in a natural bend of the stream, creating a new sandbar that is filling in what had previously been eroded.
