**Targeting Best Management  
Practices and Monitoring Stream  
Hydrology in the Chagrin  
Watershed:  
Analysis of Riparian Corridor  
Connectivity and Urban  
Stormwater Infrastructure**

**Chagrin River Watershed Partners, Inc.  
PO Box 229  
Willoughby, Ohio 44096-0229  
(440) 975-3870  
[www.crwp.org](http://www.crwp.org)**

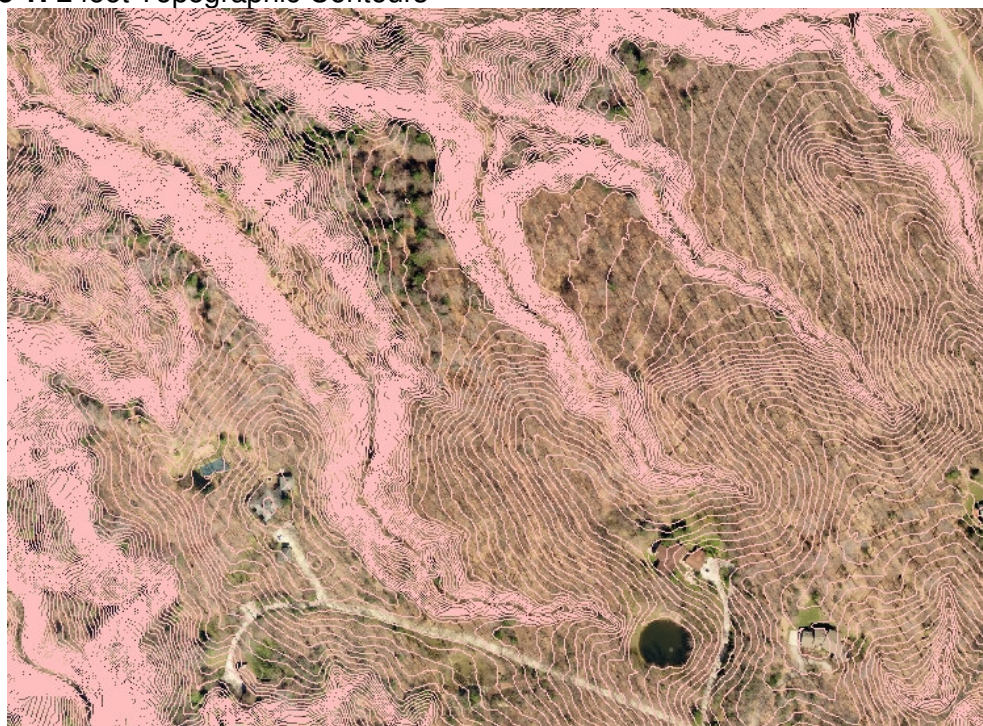
**Figure 1:** 2 foot Topographic Contours

Since LiDAR is able to map the ground surface, contour maps for all the CRWP member communities were developed. These were developed as 2 foot contour interval maps and were made available as GIS shapefiles. To produce these maps, CRWP first converted the raw ground return LiDAR data to a Triangular Irregular Network, or TIN. A TIN is essentially a rough 3 dimensional representation of a surface. Figure 1 shows the 2 foot contours as developed for an area of Hunting Valley. These topographic maps are accurate as of spring 2006, when the LiDAR flights were made.

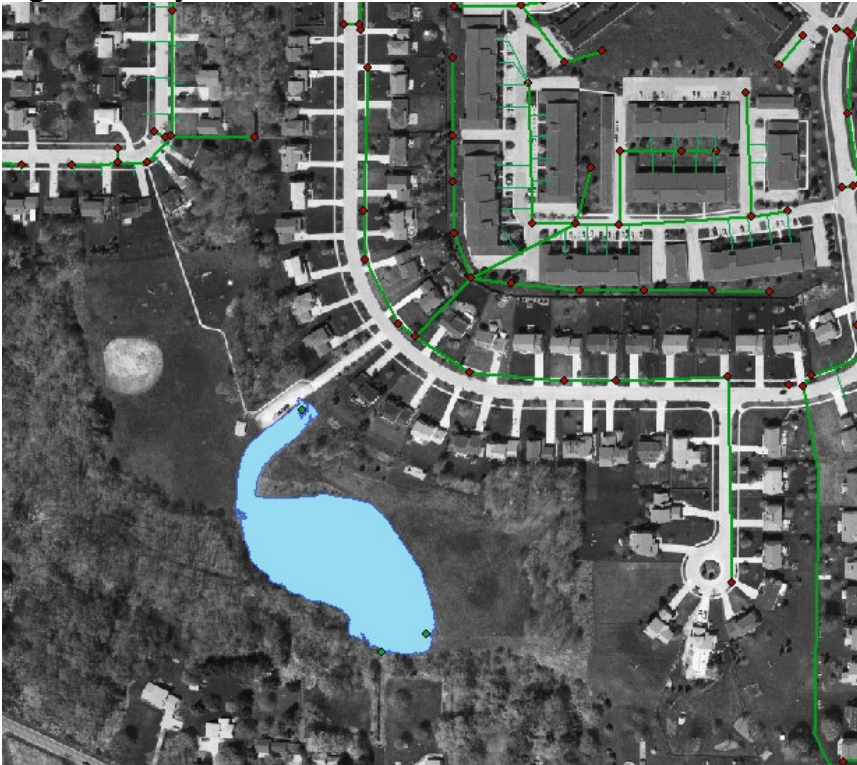
**Figure 8: City of Solon Stormwater Infrastructure**

It is important to note that while most communities had some data, it was often not complete. For example, the basin and outfall data for Geauga County communities is limited to outfalls within the Phase II urbanized areas of communities and new basins that have been permitted or built since the tracking mechanisms were established. Of the CRWP members, the Cities of Solon and Mentor had the most extensive data sets. Figure 8 shows a portion of the City of Solon with the various data layers shown. The storm water structures including manholes and yard drains are included in this data set. Storm water mains as well as laterals are delineated for the City. In addition, the City of Solon distinguished between ponds and lakes and detention basins in their community. Although this data set is extensive, the City of Solon found it necessary to complete additional, and more detailed, stormwater infrastructure mapping to complete modeling of their storm sewer system.
