# **Monitoring the Performance of Bioretention and Permeable Pavement Stormwater Controls in Northern Ohio: Hydrology, Water Quality, and Maintenance Needs**

Chagrin River Watershed Partners, Inc. under NOAA award No. NA09NOS4190153

**August 15, 2015**

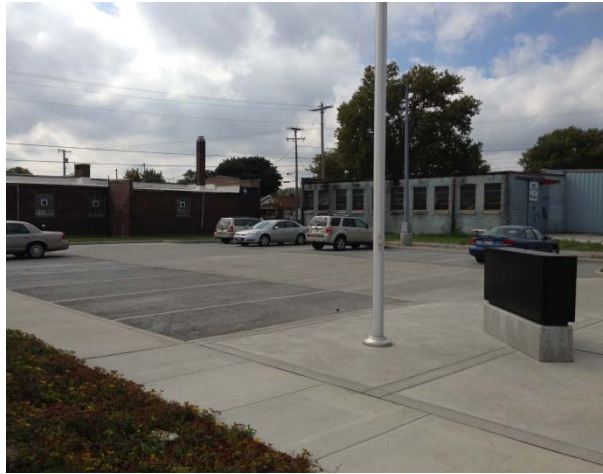
Figure 3. Pervious concrete monitoring site at Perkins Township, Ohio.

The monitored pervious concrete system at Perkins Township was installed as part of a redevelopment in October-December 2012 adjacent to the township administration building. Two areas of pervious concrete parking stalls, with a total PC surface area of 2600 ft<sup>2</sup>, were separated by and received runoff from an impermeable concrete drive aisle (Figure 3 and Figure 4). The design included open-graded aggregate beneath the impermeable concrete drive aisle, and thus the effective infiltrative surface area was increased to 4,820 ft<sup>2</sup> (Table 1). Runoff from the rooftop of the adjacent administration building (0.43 acres, shown in gray in Figure 4) was routed from the downspouts into the aggregate of the permeable pavement. A small (0.1 acre) pervious area drained to a catch basin with a surface inlet, then connected to the pipe delivering roof runoff to the aggregate beneath the pavement. This resulted in a total drainage area of 0.53 acres. Given this, the HLR for exfiltration for the Perkins Township pervious concrete

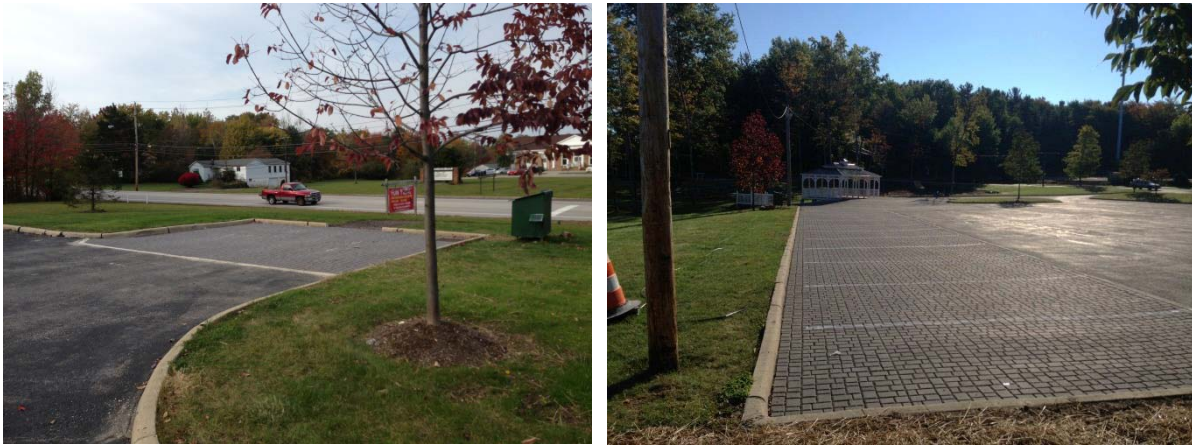
Figure 5. Small (left) and Large (right) permeable pavement applications at Willoughby Hills.

the water balance (Figure 5 and Figure 6). Both cells employed a 20-in total aggregate depth. The Small application, 480 ft<sup>2</sup> in surface area, had a flat infiltrative surface (Table 1). The HLR for exfiltration for the Small application was 8.2, the largest HLR monitored in this work. The Large application (surface area of 4420 ft<sup>2</sup>) had a stepped subgrade to make up for the 1-2% surface slope; this resulted in four steps in the subgrade with the underdrain at the bottom of the cross-section (i.e. no IWS in the stepped portion of the subgrade). Thus, the effective infiltrative surface area was reduced to 2210 ft<sup>2</sup>. The HLR for clogging was near the maximum recommended value of 3.0 for Ohio, at 3.2 (ODNR 2006). Due to the stepped subgrade, however, the HLR for exfiltration was 5.3. The contributing drainage areas for both the Small and Large applications were impermeable asphalt, except for parking lot islands and a Small portion of concrete sidewalk in the Small application watershed.

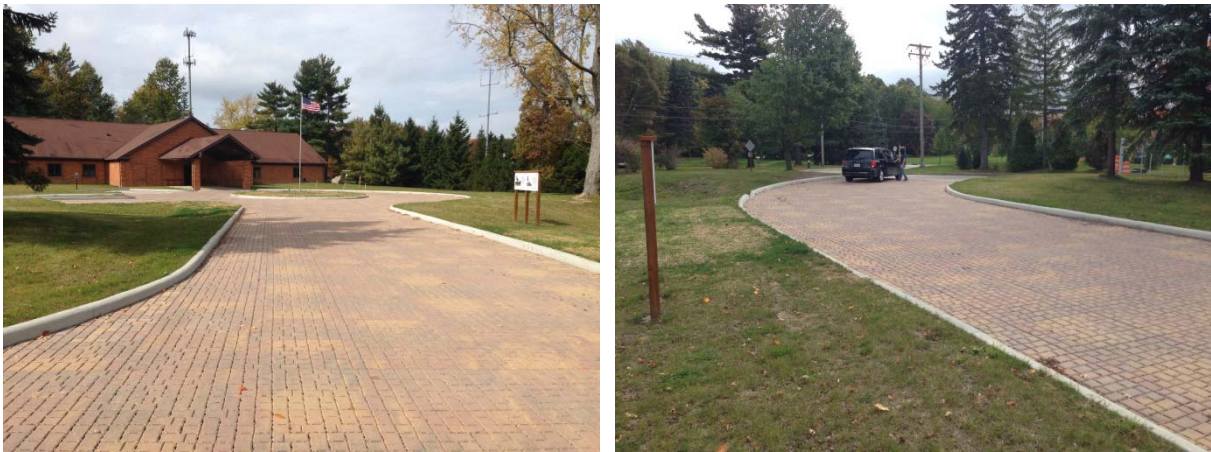
Figure 7. Photos of the Orange Village PICP parking lot.

A newly constructed PICP parking lot was built at the Orange Village recycling facility during September-October 2013 (Figure 7 and Figure 8). The total aggregate depth at the site varied from 23-29 inches. This site was unique since it had no run-on from impermeable pavement (i.e. the parking lot treated only direct rainfall), resulting in an HLR for both clogging and exfiltration of 1.0 (Table 1). The total surface area of the parking lot was 9,490 ft<sup>2</sup>, and a 6-in IWS zone was incorporated in the cross-section. Additionally, two 6-in diameter curtain drains were installed 2.75 feet below the permeable pavement cross-section (~5 feet below ground surface) to mitigate a potentially high water table at the site. The approximate locations

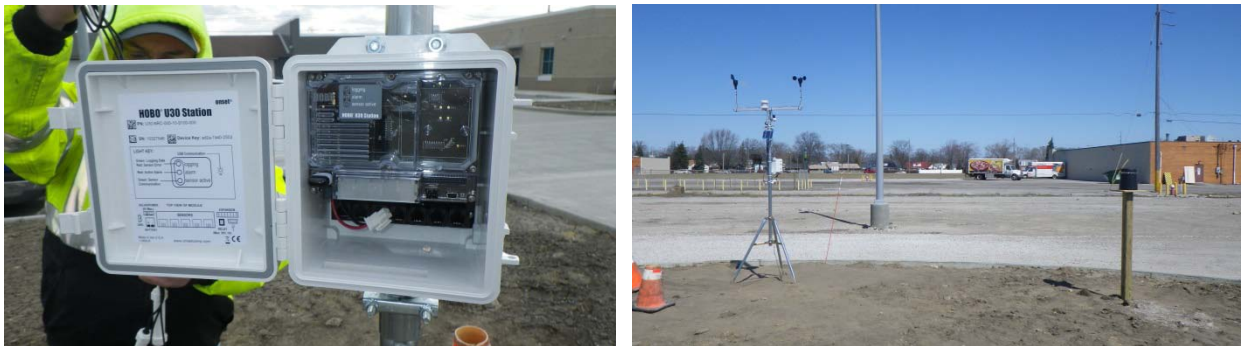
Figure 9. Hobo U30 data logger attached to weather station mast (left). Photo of rain gauge and weather station located at Perkins Township (right).

Each site was instrumented to monitor rainfall, climatic parameters, and the hydrologic performance of each permeable pavement application. Rainfall was measured at each site using a 0.01-inch resolution tipping-bucket rain gauge affixed approximately 6 feet above the ground (Davis Instruments, Hayward, California). Rainfall data were stored in the Hobo U30 data logger attached to the nearby weather station (Figure 9). The weather station deployed at each site was a 6-ft tall, Hobo weather station that included separate sensors for wind speed, wind direction, air temperature, relative humidity, and solar radiation (Figure 9, Onset Computer Corporation, Bourne, MA). Rain gauges and weather stations were located in an open area, free from overhanging trees. All rainfall and climatic parameters were recorded on a 1-minute interval.

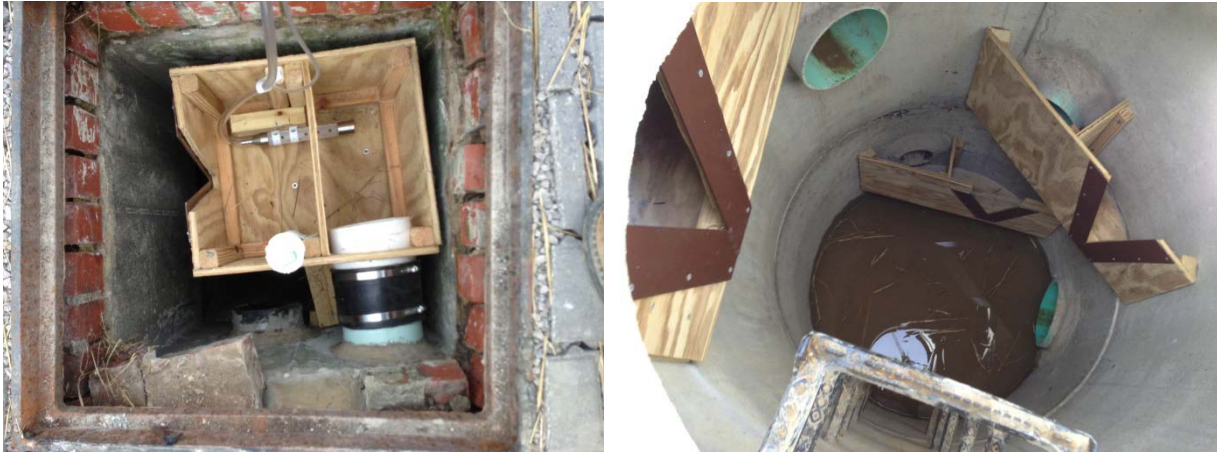
Figure 10. Weir boxes at Willoughby Hills Small application (left) and Orange Village (right). Note 6” underdrain tying into weir box at left. Note presence of three weir boxes at right. The upper weir box is connected to the underdrain for the permeable pavement, while the middle and lower ones measure drainage from the bioretention cell and the curtain drains at Orange Village.

(Figure 10). A variety of v-notch weirs were utilized depending on the expected flow rates from the underdrain (Table 3). No overflow occurred during the monitoring period at Perkins Township or Orange Village. At Willoughby Hills, overflow monitoring began on August 5, 2014 after an overflow event was observed the week prior due to surface clogging.

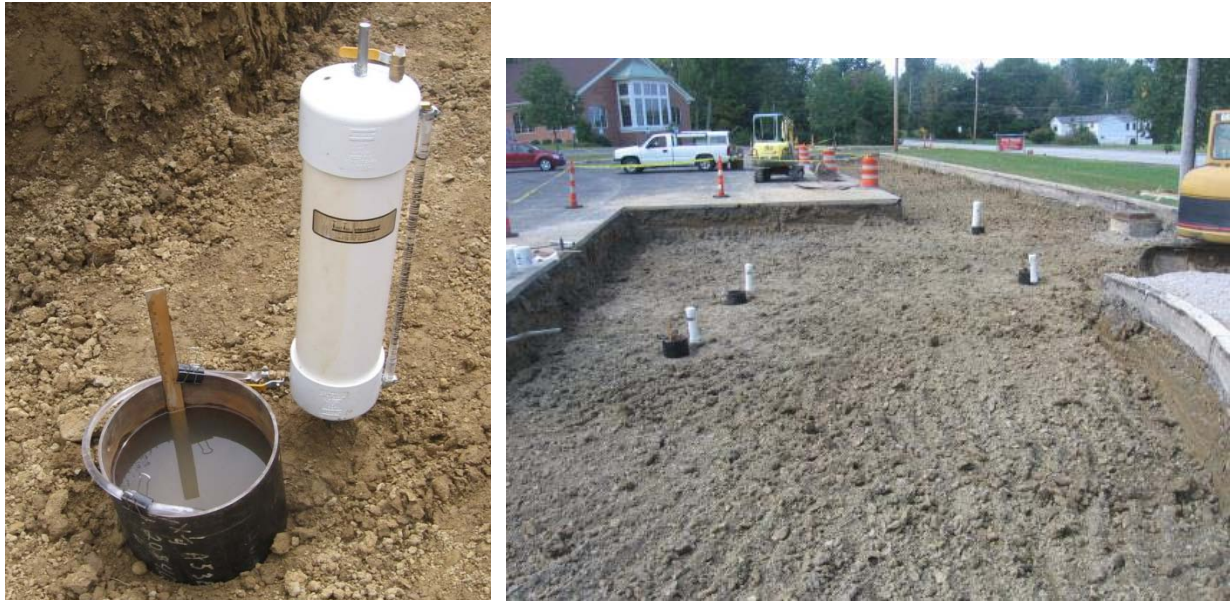
Figure 11. Single ring, constant head hydraulic conductivity test with Mariotte syphon (left) and hydraulic conductivity tests being carried out at the Willoughby Hills Large application (right).

During the installation of each of the four permeable pavement SCMs, construction was halted for one day as the excavation reached the final subgrade elevation to undertake soil infiltration testing (Figure 11). Between two and six single-ring, constant head hydraulic conductivity tests were completed in the subsoils beneath each of the permeable pavement applications (Table 5). In some cases, the subsoils had been raked with the excavator bucket teeth prior to the commencement of soil testing to reduce compaction; if this was the case, then a garden hoe (hand-held) was used to remove loose soil and the test run on the uncompacted subsoil. A Mariotte bottle was used to keep a constant head on the soil, and mathematical

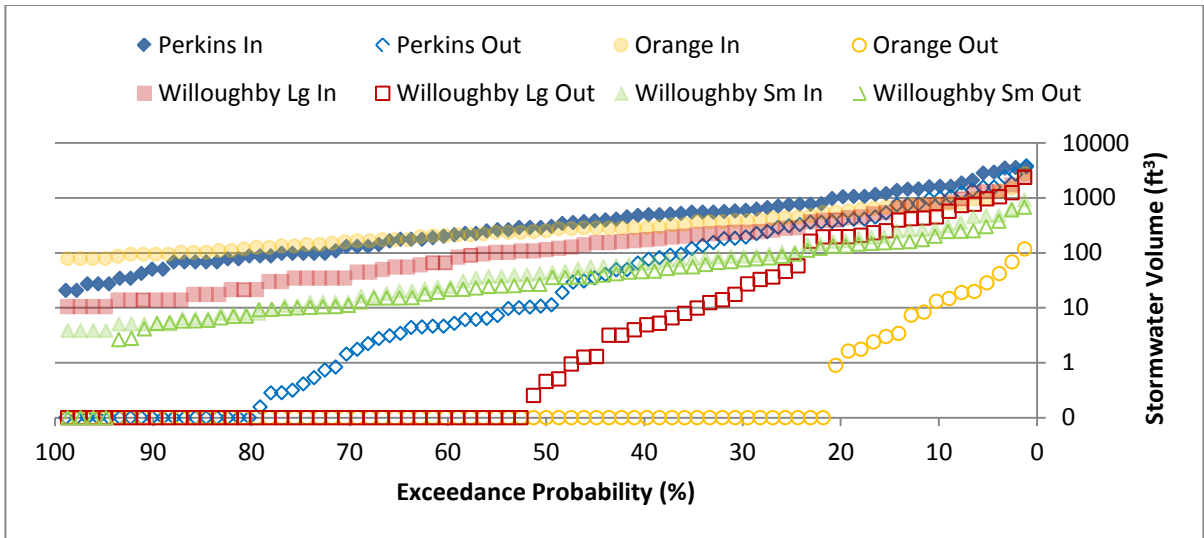
Figure 15. Exceedance probability for inflow and outflow volumes over the monitoring periods.

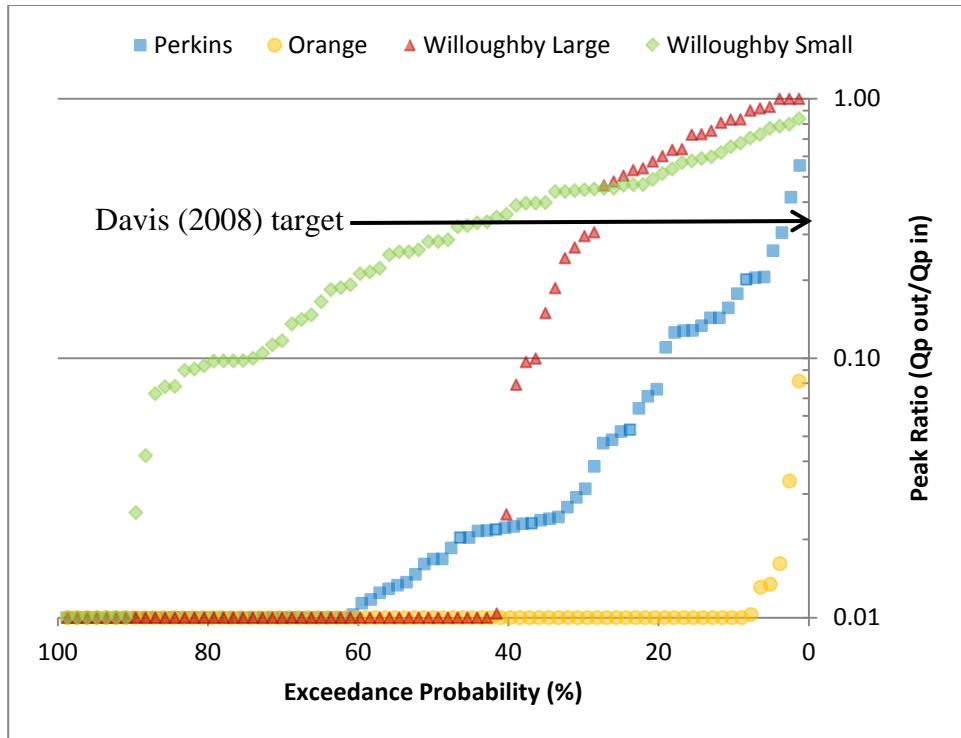
Figure 16. Analysis of peak ratio for monitored storm events at Perkins Township, Willoughby Hills, and Orange Village.

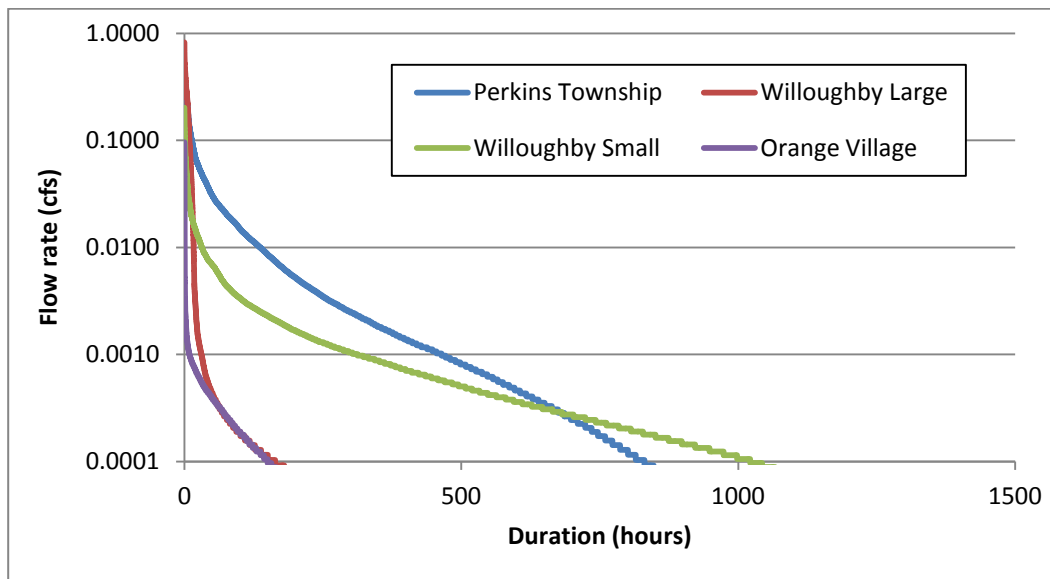
Figure 17. Flow duration curves for outflow from the monitored permeable pavement applications.

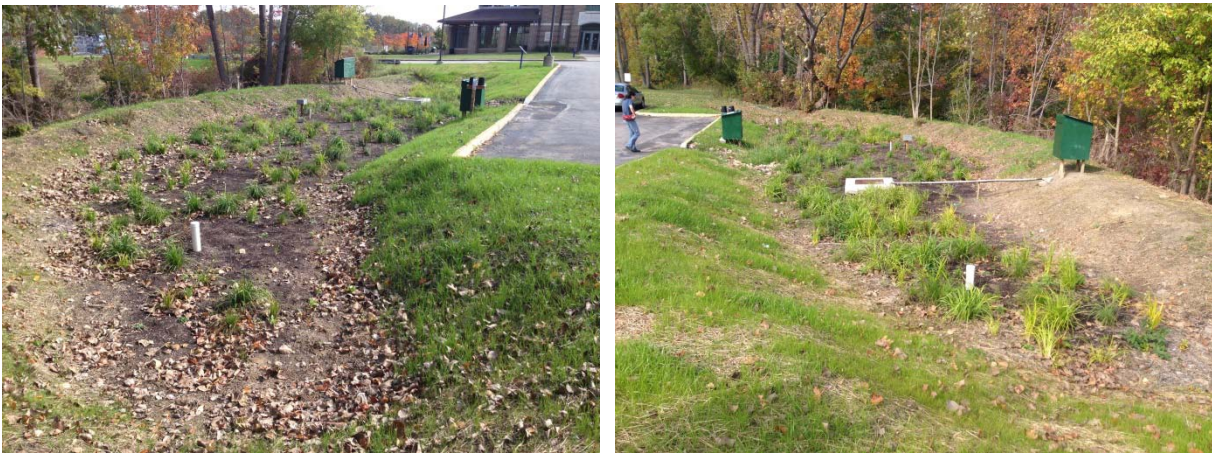
Figure 20. Photographs of the Ursuline College bioretention cell six months post-construction.

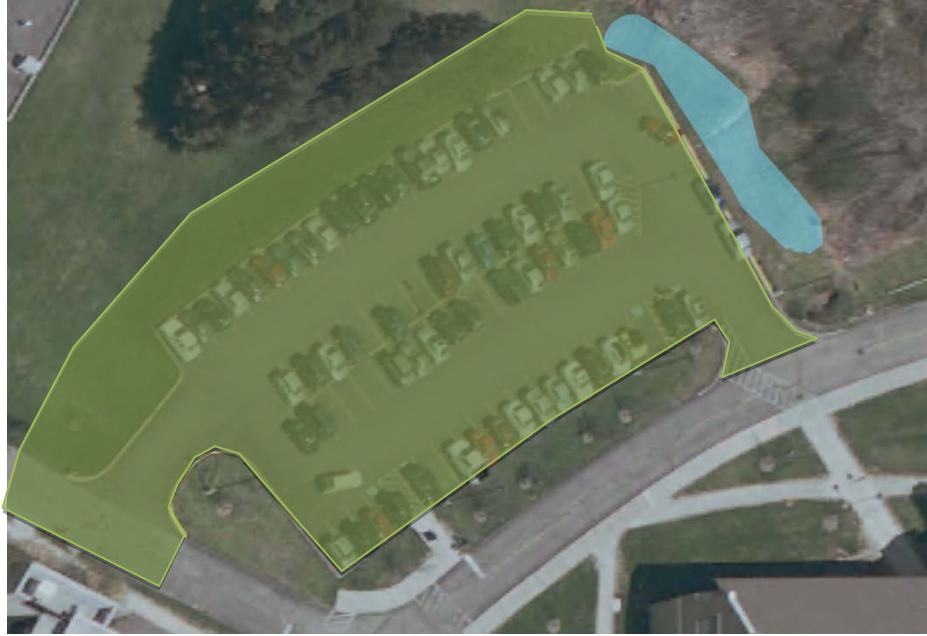
Figure 21. Watershed overview for the Ursuline College bioretention cell site. The watershed is outlined in green and the bioretention cell in blue.

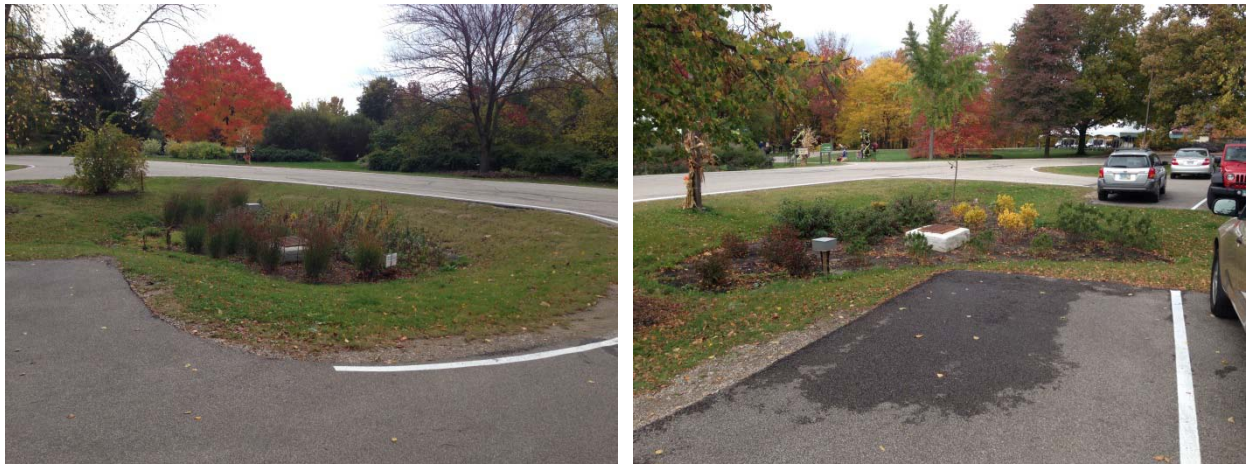
Figure 22. Photographs of the Holden Arboretum South (at left) and North (at right) bioretention cells 13 months post-construction.

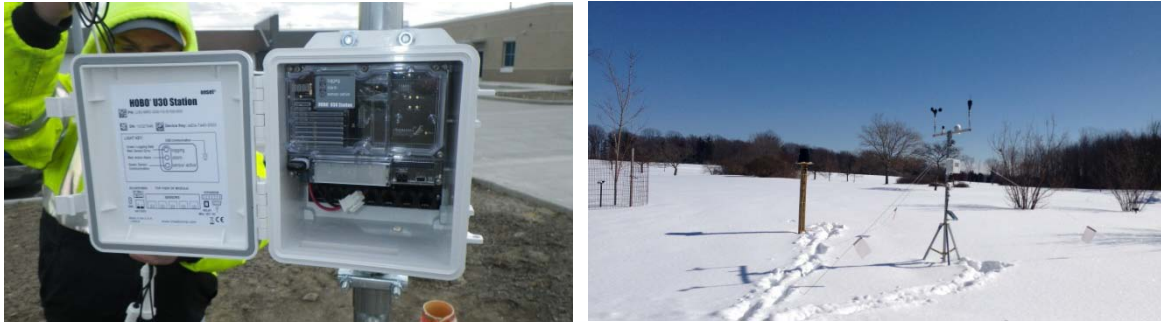
Figure 24. Hobo U30 data logger attached to weather station mast (left). Wintertime photo of rain gauge and weather station located at Holden Arboretum (right).

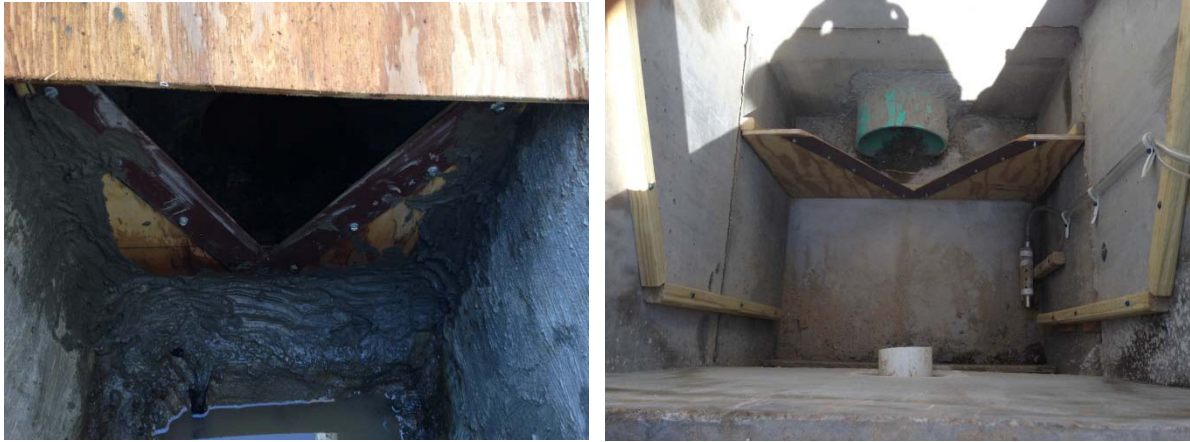
Figure 25. Weir installed in the outlet structure of the south bioretention cell at Holden Arboretum (left) and top view of weir installed in Ursuline College outlet structure (right).

Combined overflow and drainage from each bioretention cell was monitored using a sharp crested, v-notch weir and a Hobo U20 pressure transducer (Onset Computer Corporation, Bourne, MA). Each outlet structure had an internal baffle to calm the flow upstream of the weir and an awning structure to force all overflow and drainage behind the baffle (Figure 25). The pressure transducer was placed immediately downstream of the baffle, as far upstream from the weir as possible. A variety of v-notch weirs were utilized depending on the expected flow rates from the bioretention cells (Table 15). Water level in the bioretention media was measured as a function of time using a Hobo U20 pressure transducer within 1” diameter water table wells located in each bioretention cell. Since the pressure transducers were non-vented, an additional U20 pressure transducer was placed in the rain gauge housing at each site to measure local barometric pressure. All pressure transducer measurements were obtained on a 2-minute interval. Data at each site were downloaded approximately every 3 weeks. Upon arrival at the office, data QA/QC was performed, data were backed up on a server, and data sent to NCSU staff for analysis.

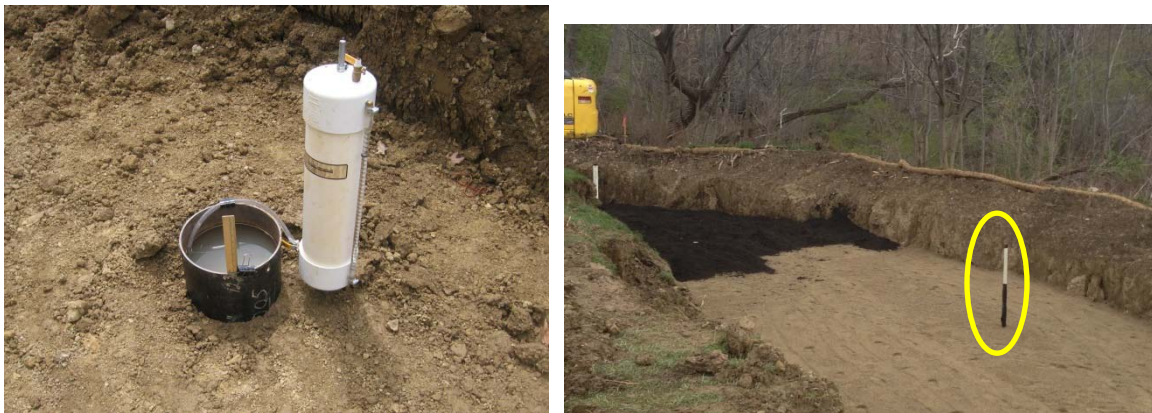
Figure 26. Single ring infiltrometer with Mariotte bottle used for pre-construction infiltration testing (left) and monitoring well used for post-construction drawdown rate measurement.

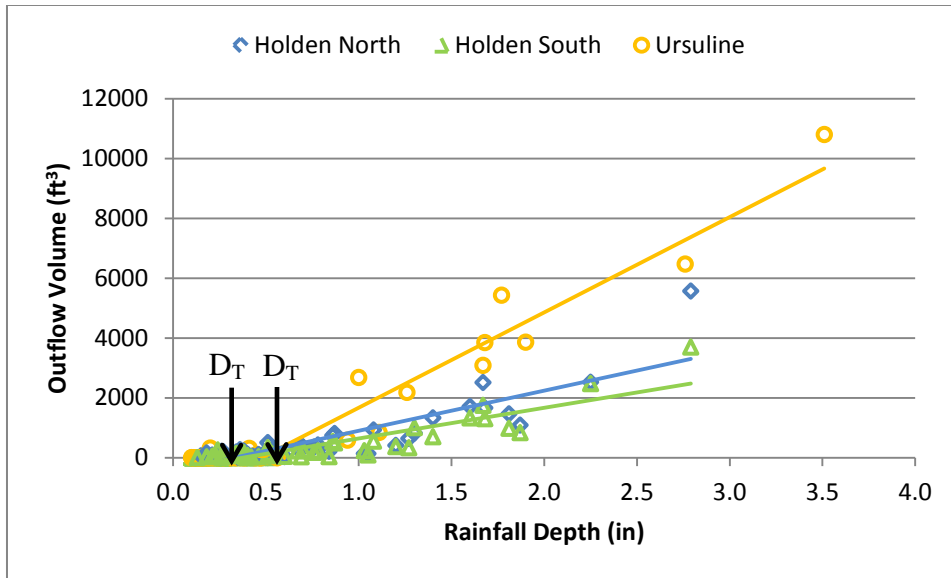
Figure 30. Determination of the discharge threshold at each bioretention monitoring site.

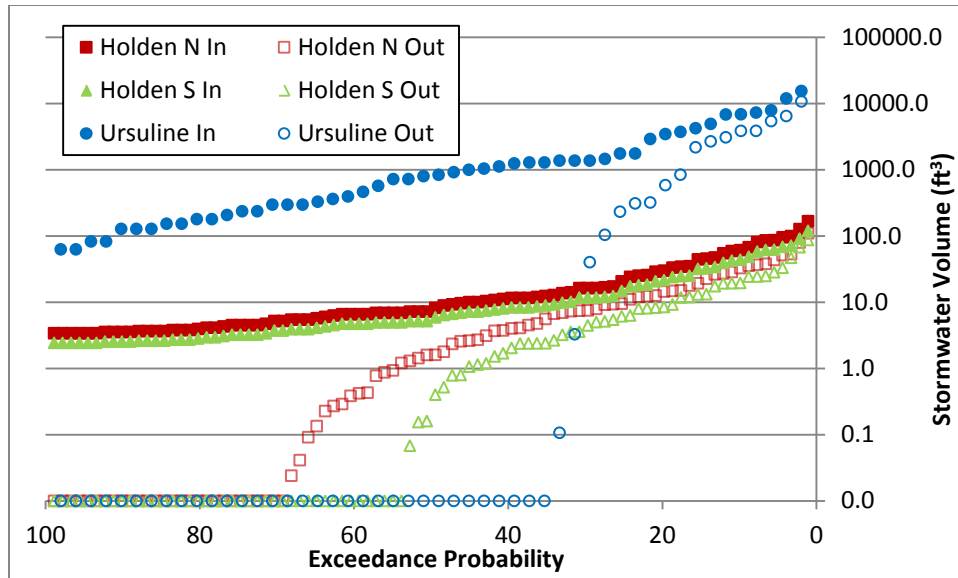
Figure 31. Exceedance probability for inflow and outflow volume over the monitoring periods.

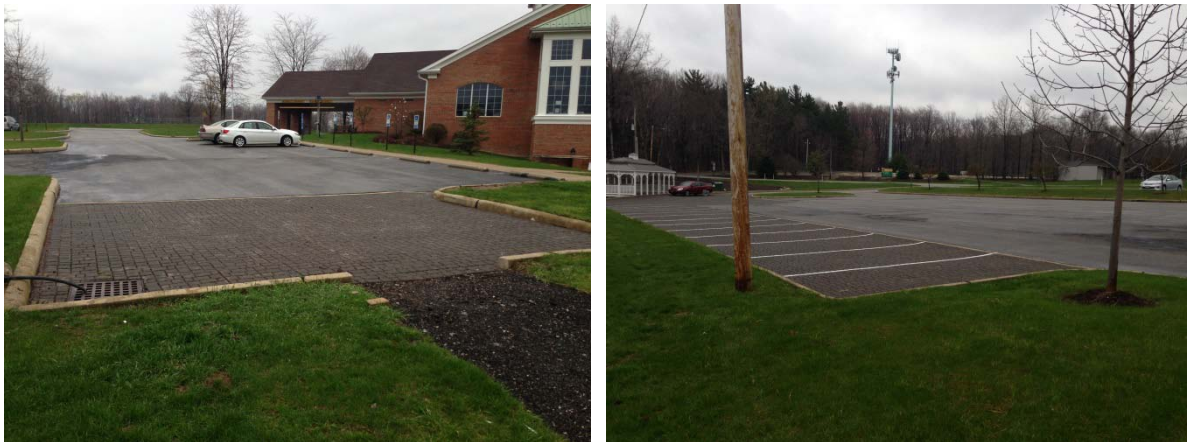
Figure 34. Small (left) and Large (right) permeable pavement applications at Willoughby Hills, Ohio community center.

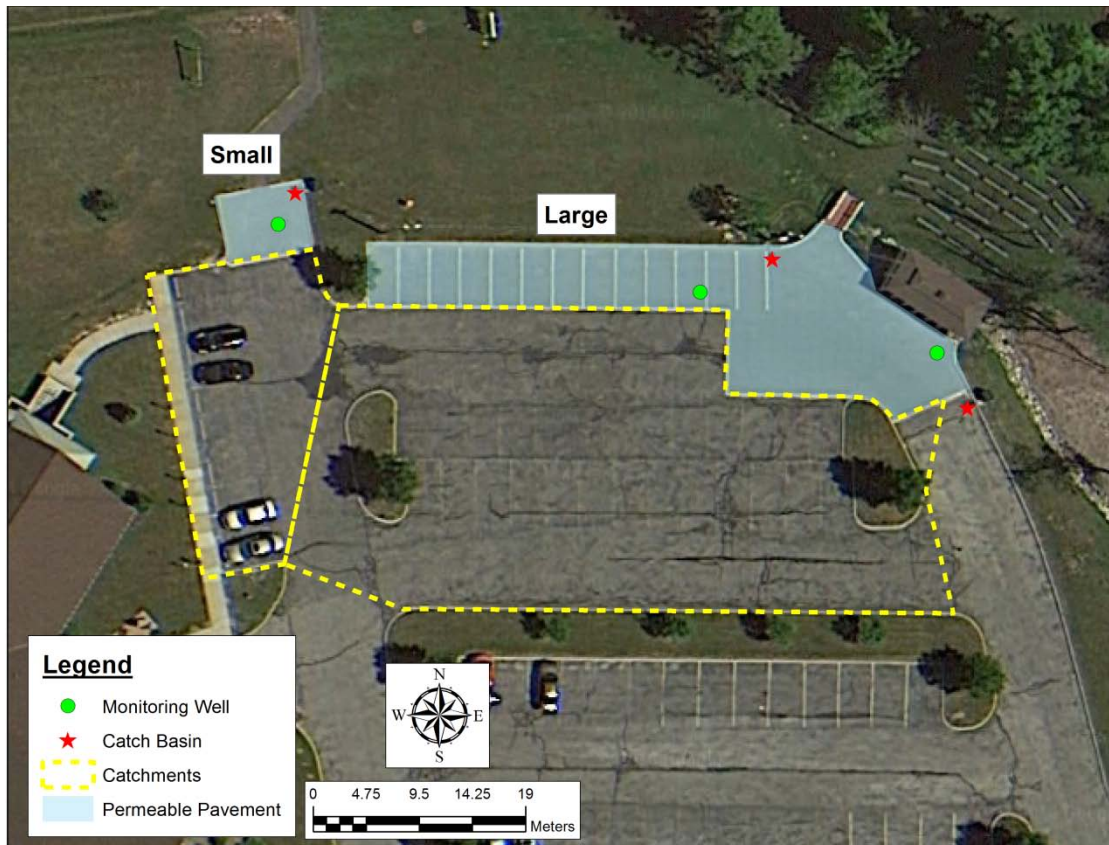
Figure 35. Willoughby Hills site water quality sampling overview. Photo credit: Google earth.

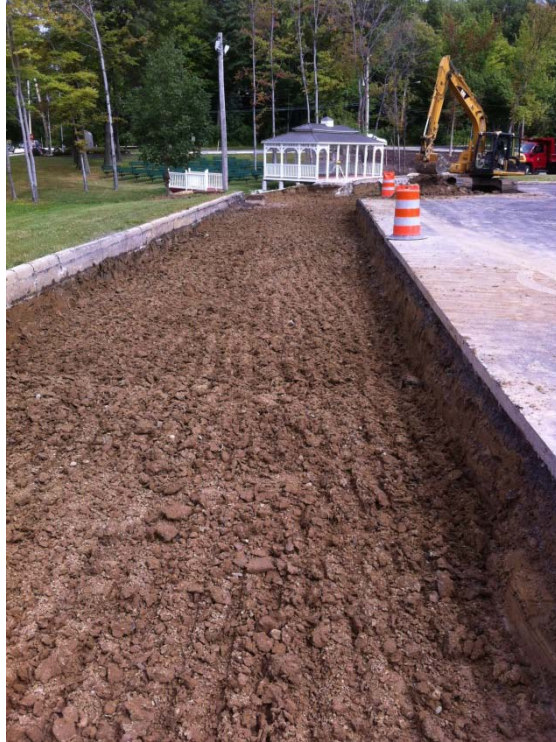
Figure 38. Raked soil at the bottom of the subgrade at Willoughby Hills.

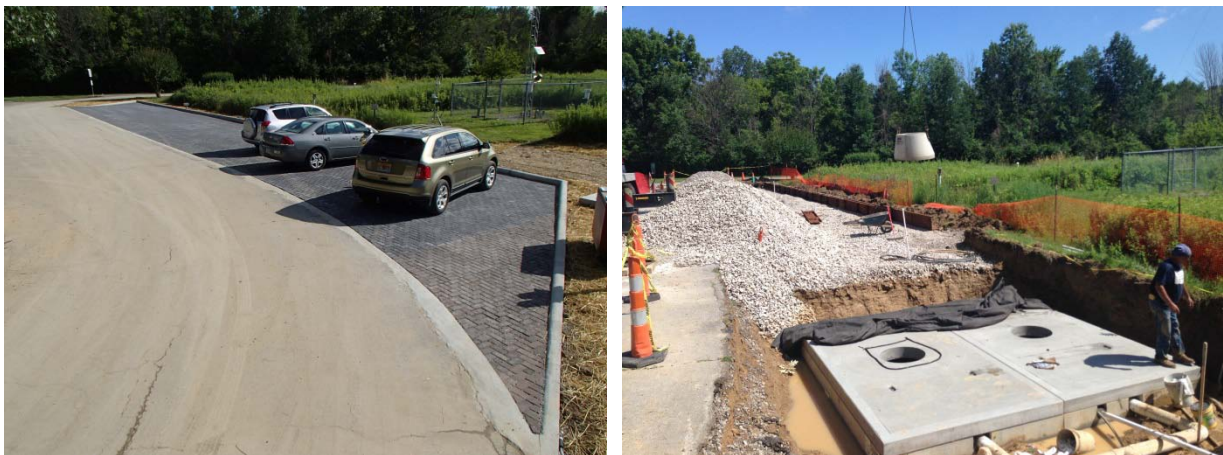
Figure 42. Permeable interlocking concrete pavers (PICP) with standard asphalt watershed (left) and underground cisterns located beneath PICP (right) at Old Woman Creek NERR.

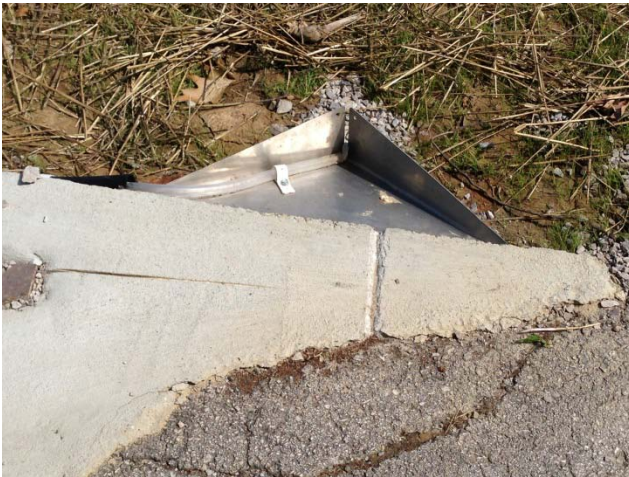
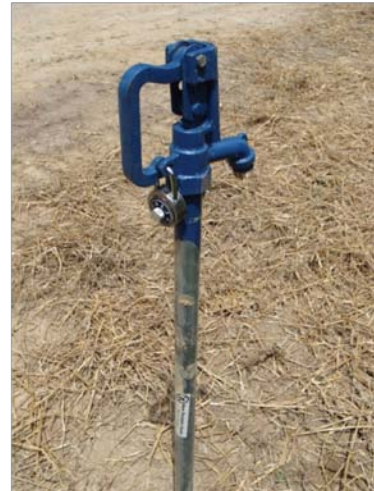
Figure 44. Sampling trough with sample intake to sample runoff quality from the asphalt pavement (left) and the spigot from which water quality samples were obtained to characterize the quality of the water at the point-of-use (right) at Old Woman Creek NERR.

To represent the quality of stormwater as it exited the cistern, water quality samples were obtained from the spigot, which utilized an on-demand, submersible pump to provide pressure (Figure 44). The pump intake had a basic gross solids filter, but lacked UV or grit filtration. Therefore, samples were representative of the quality of the water at the point-of-use. A grab sample was taken from the spigot (in conjunction with sample collection from the water quality samplers) 30 seconds after opening the spigot to obtain a well-mixed sample.

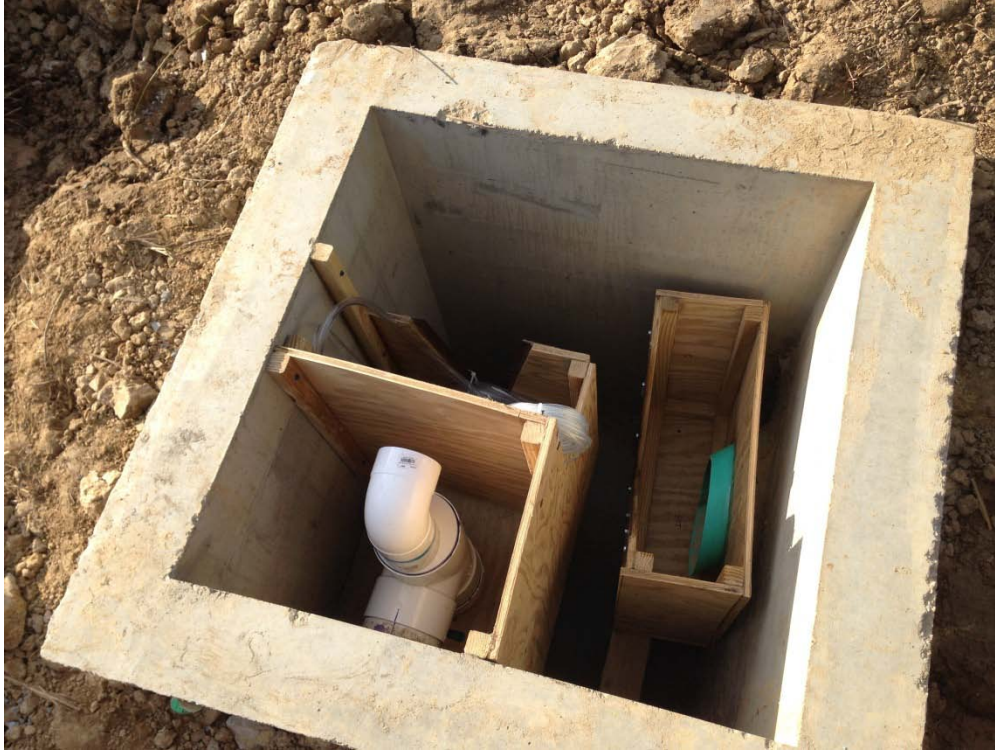
Figure 45. Weirs for drainage (at left) and overflow (at right) measurement in the monitoring vault at Old Woman Creek NERR.

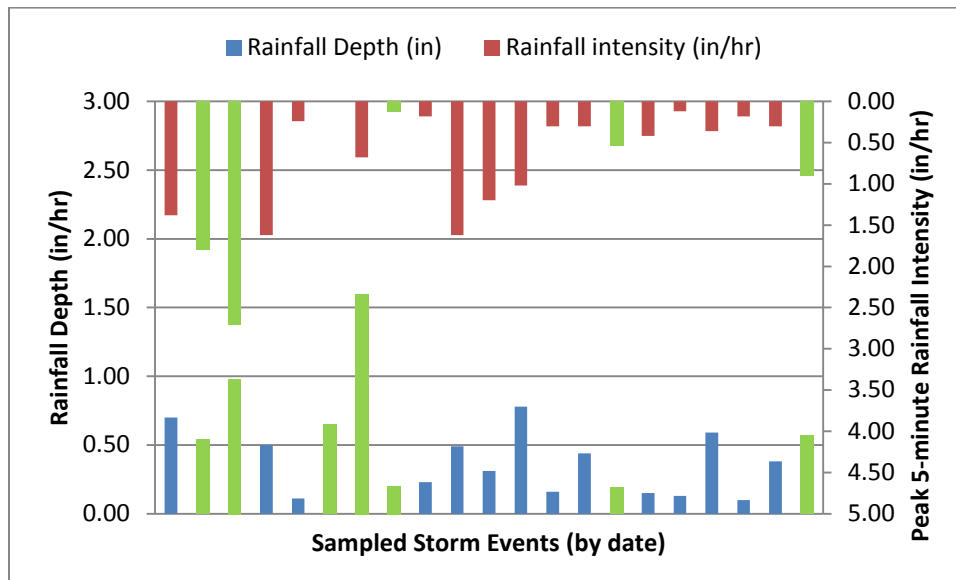
Figure 46. Storm events characteristics at the Old Woman Creek NERR permeable pavement and underground cistern treatment train. Sampled storms are shown in green.

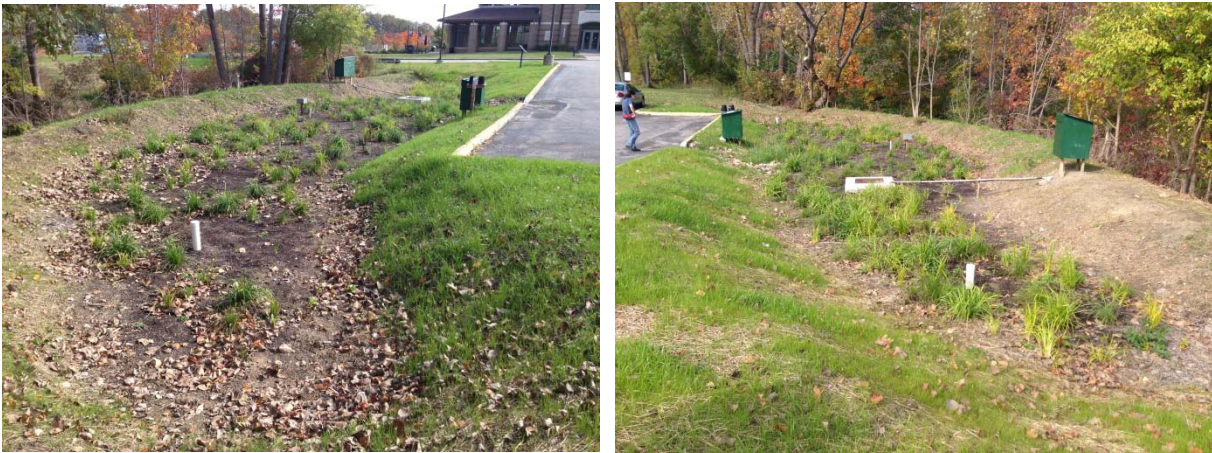
Figure 51. Photographs of the Ursuline College bioretention cell six months post-construction.

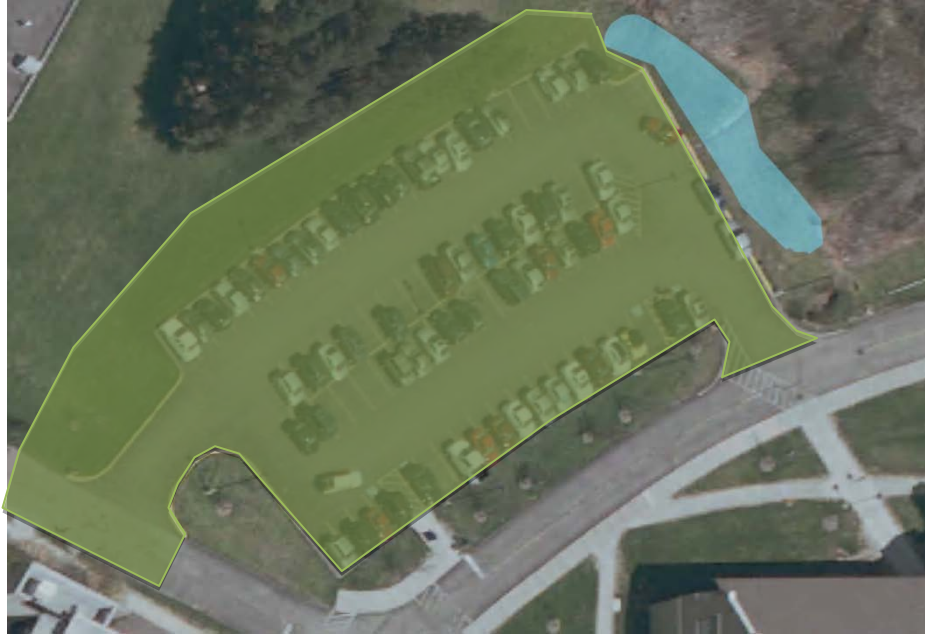
Figure 52. Watershed overview for the Ursuline College bioretention cell site. The watershed is outlined in green and the bioretention cell in blue.

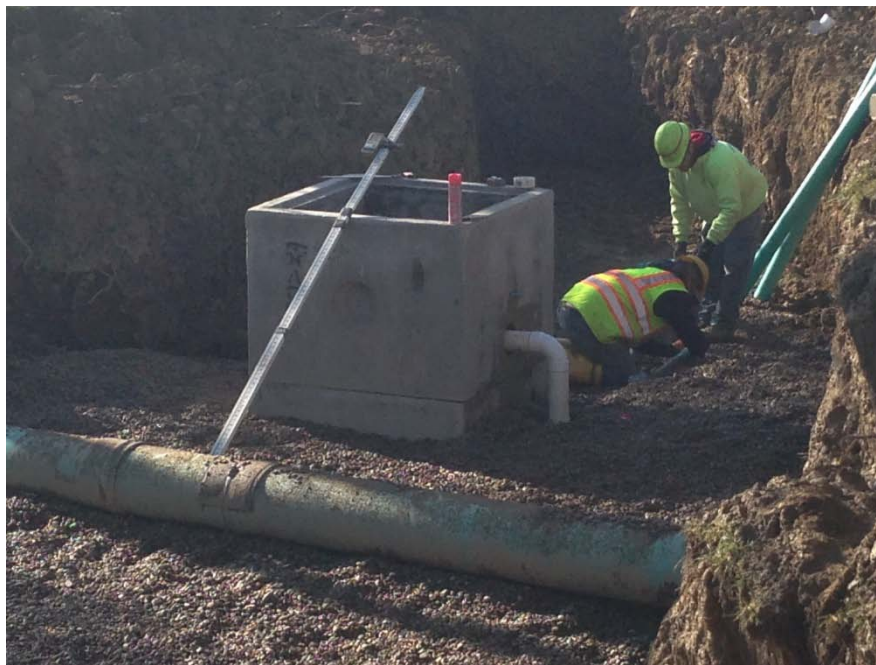
Figure 53. Internal water storage zone (IWS) installed using an upturned elbow in the underdrain at the Ursuline College bioretention cell.

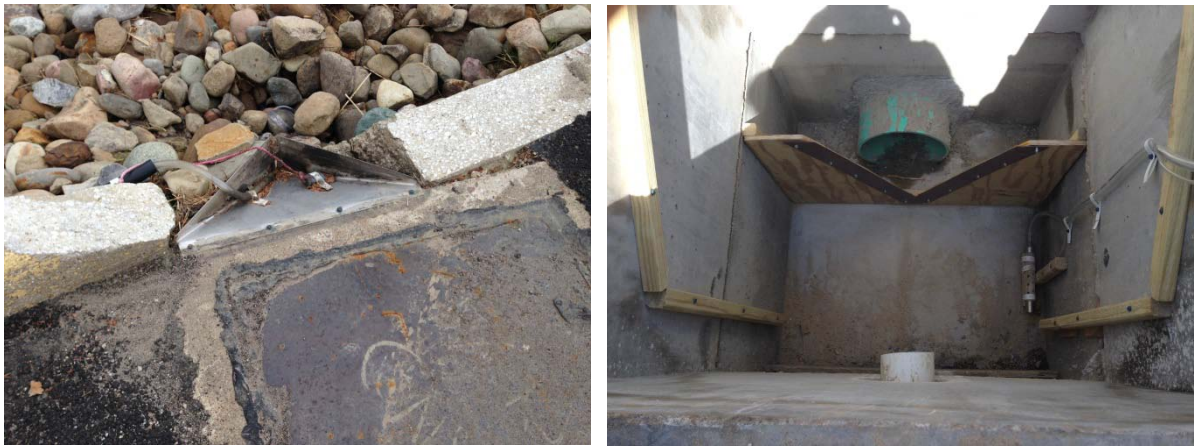
Figure 54. Inflow monitoring structure located between the parking lot and the forebay (left) and top view of weir installed in Ursuline College outlet structure (right).

Water quality samples were obtained from the inlet to and outlet from the UC BRC to characterize its performance. A sampling trough was installed in the curb cut separating the asphalt parking lot from the rock-lined forebay of the bioretention cell (Figure 54). Influent samples were paced based on rainfall depth, a direct indicator of runoff volume (Chin 2006). An ISCO 6712 sampler was utilized to obtain 200 mL sample aliquots from the sampling trough after each 0.05 inches of rainfall, thus obtaining flow proportional, composite samples (Teledyne

ISCO, Lincoln, NE). Since a monitoring structure (e.g. weir or flume) was not able to be located at the inlet to this BRC, the Curve Number method was used to calculate inflow volume from the 77% impervious watershed (NRCS 1986). Combined overflow and drainage from the BRC was monitored within the outlet structure using a sharp crested, v-notch weir and an ISCO 730 bubbler module (to measure flow depth) connected to an ISCO 6712 sampler (Figure 54). Flow depths were converted to flow rate by the automated sampler using:

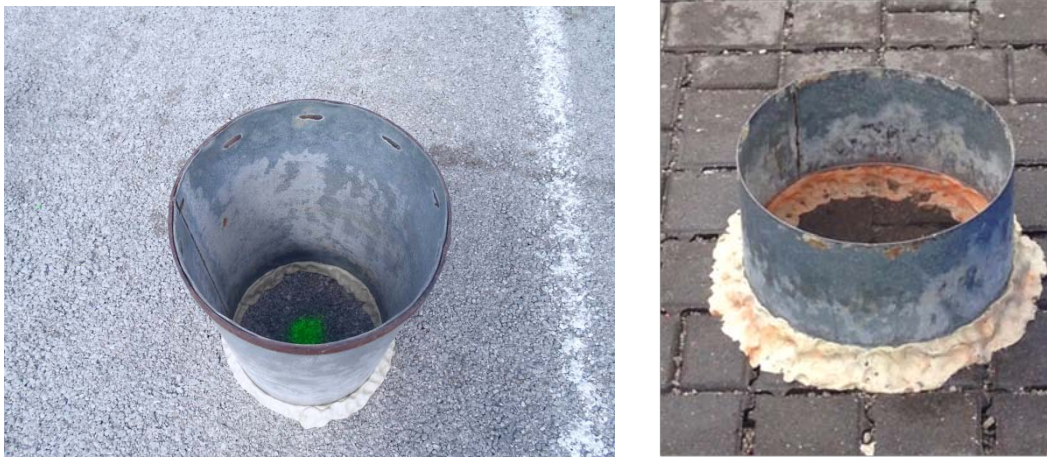
Figure 64. ASTM surface infiltration rate tests on PC (left) and PICP (right).

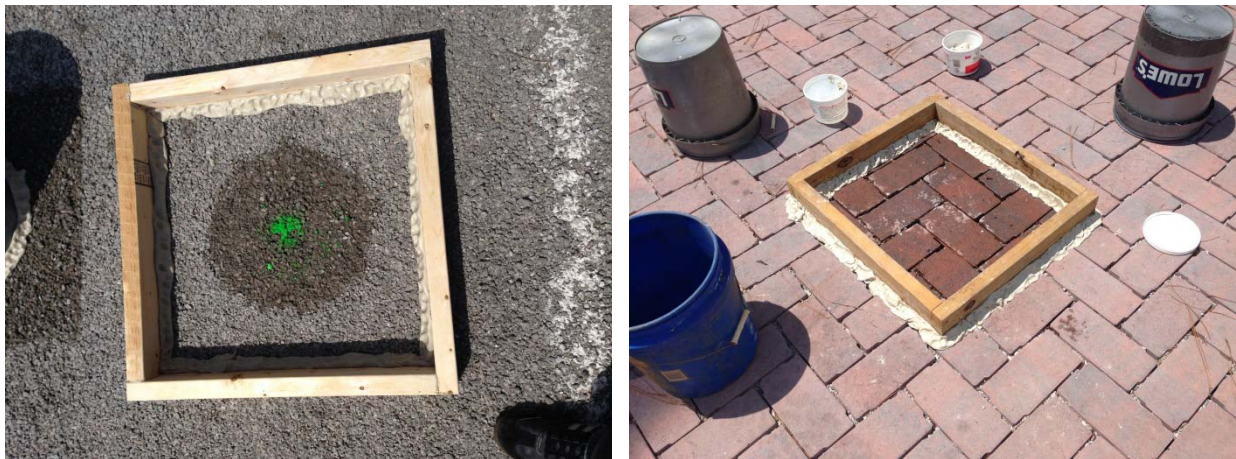
Figure 65. Surface infiltration rate testing using the SIT method on PC (left) and PICP (right).

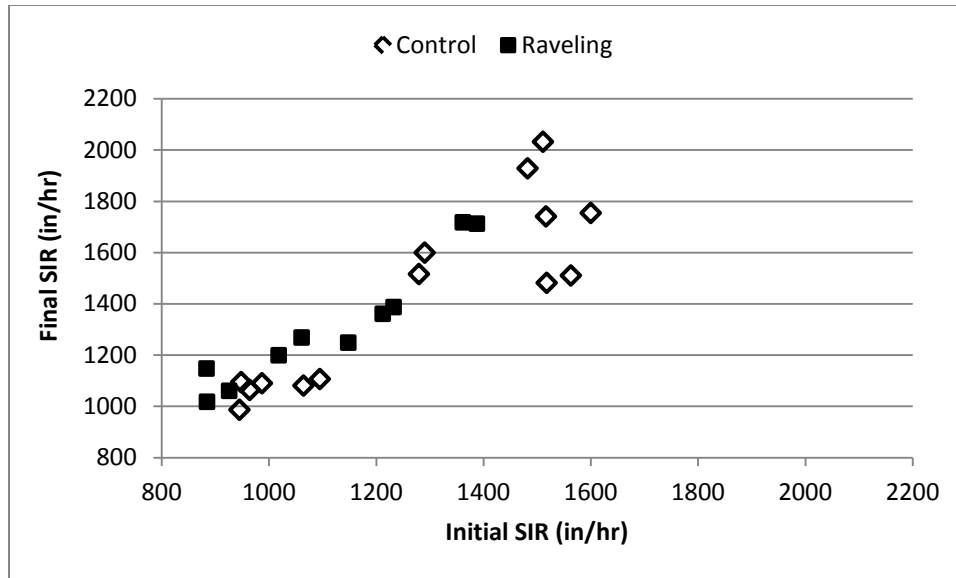
Figure 67. Pervious concrete SIR for control and raveled locations at Perkins Township at the beginning and end of each quarter.

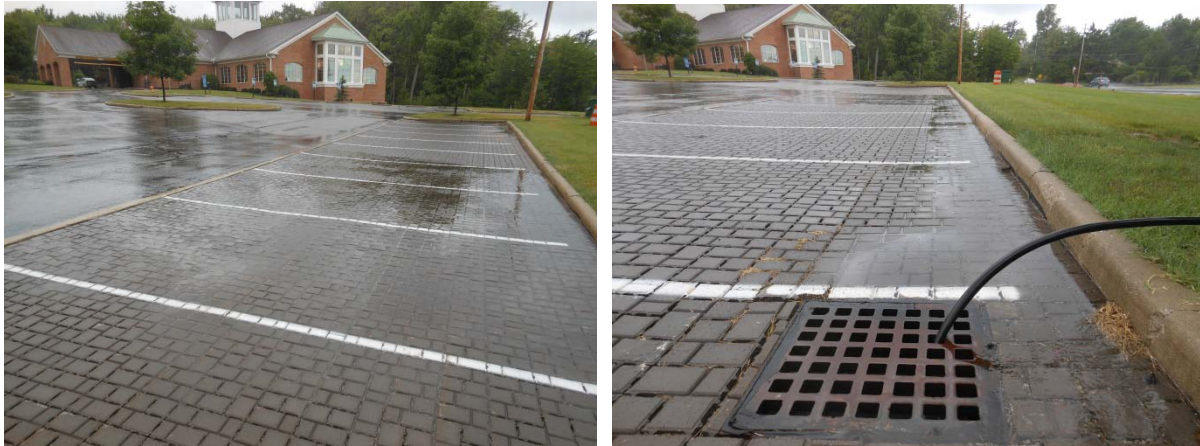
Figure 69. Runoff entering PICP at Willoughby Hills on July 17<sup>th</sup>, 9 days after infiltration testing. Shallow concentrated flow created by parking lot island (left) and flow passing all the way to the catch basin, bypassing treatment (right).

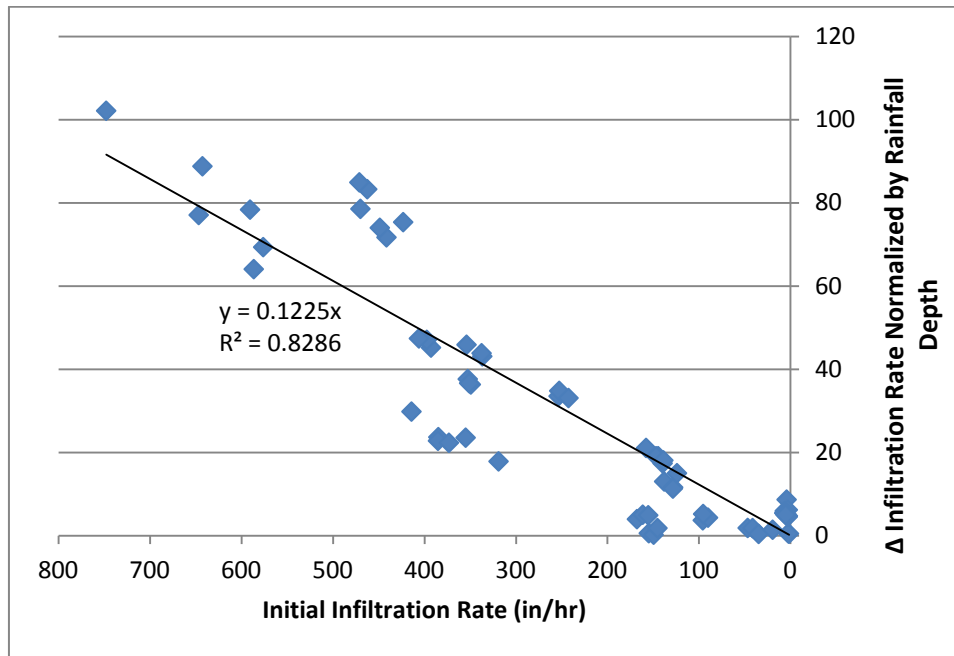
Figure 71. Change in infiltration rate for sites near the PII normalized by rainfall depth as a function of initial infiltration rate of the permeable pavement.

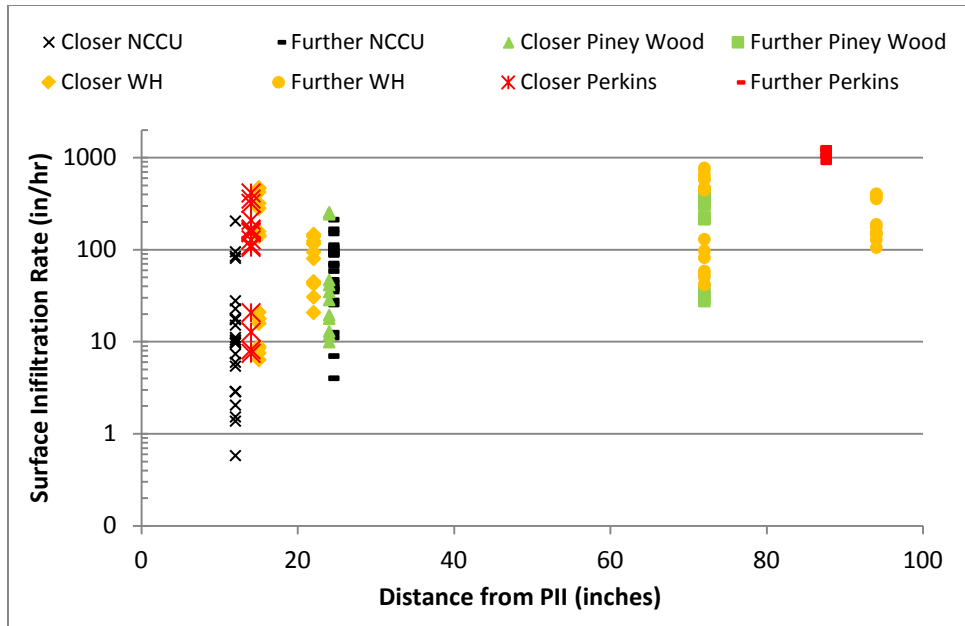
Figure 72. SIR as a function of distance from the PII by site. Symbols of similar color are from the same site.
