# **Monitoring the Performance of Bioretention and Permeable Pavement Stormwater Controls in Northern Ohio: Hydrology, Water Quality, and Maintenance Needs**

Chagrin River Watershed Partners, Inc. under NOAA award No. NA09NOS4190153

**August 15, 2015**

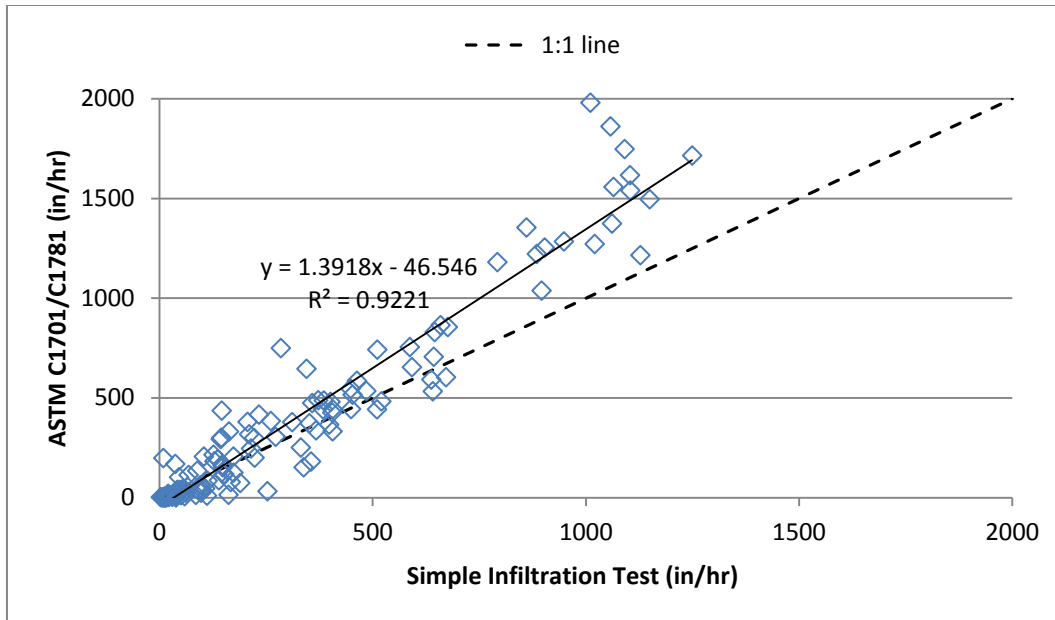
Figure 73. Linear relationship between surface infiltration rates among SIT and ASTM tests.

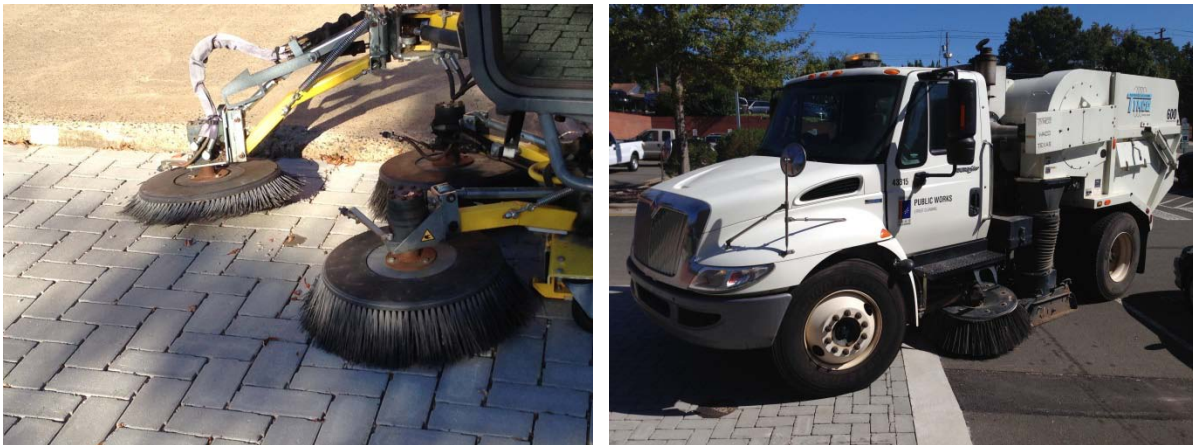
Figure 75. Standard bristle street sweeper (left) and regenerative air street sweeper (right) performing maintenance at NCCU.
