Chagrin River Watershed Action Plan

Chagrin River Watershed Partners, Inc.

Revised December 2009

Updated September 2011

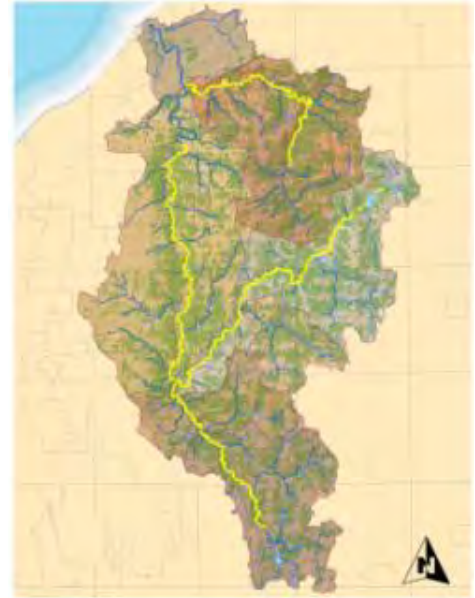
Figure 3: Scenic River Portions of Chagrin

Seventy-one miles of the Chagrin River have been designated as a State Scenic River. The original designation of 49 miles includes the Aurora Branch from S.R. 82, 12 miles downstream to its confluence with the main stem of the Chagrin, 23 miles of the main stem from its confluence with the Aurora Branch downstream to US Rt. 6, and 15 miles of the East Branch from Heath Road Bridge downstream to its confluence with the main stem was made in 1979. The river’s Scenic designation was extended in November 2002 to include the headwaters of the Chagrin, also known as the Upper Chagrin from the Woodiebrook Road bridge to the confluence with the Aurora Branch of the Chagrin River in Bentleyville. Scenic designated reaches of the river are characterized by exceptional aquatic habitat and adjacent high quality forests. Figure 3 shows the scenic river sections of the Chagrin River highlighted in yellow.

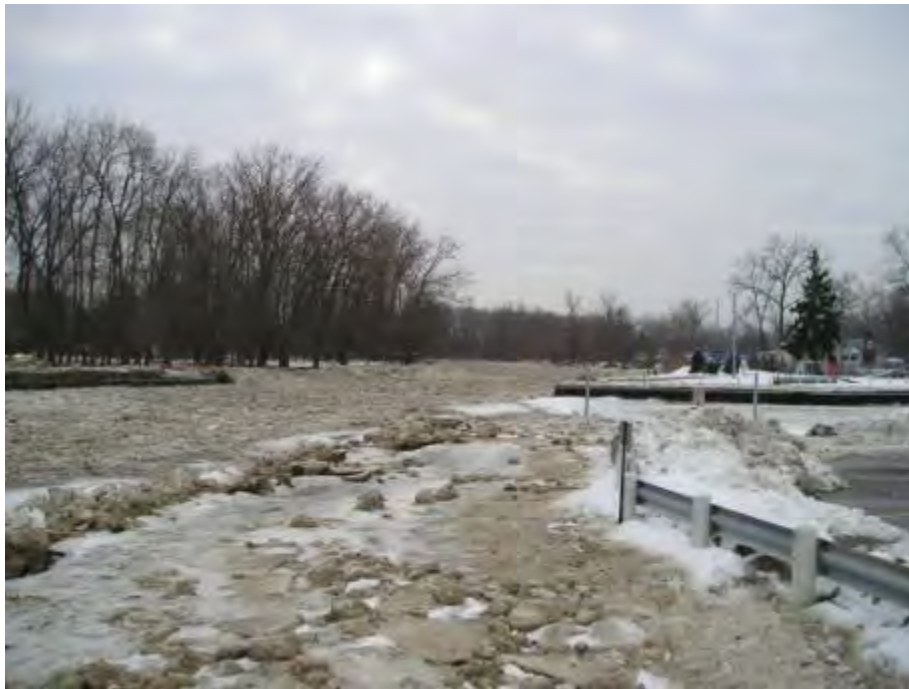
Figure 14: Ice Jams on Chagrin River in December 2004

In reviewing Table 8, it is important to note that annual peak flow is only one factor in flood events in the Chagrin River watershed. Many floods are caused by ice build-up or localized heavy rainfalls that may not show in the annual peak flow flood records. These flooding events are a public health and safety concern for communities located in the lower portion of the watershed. The following photograph shows the ice flows and localized ice jams formed during a high flow event at the end of December 2004 just upstream of the Lakeshore Drive bridge in the City of Eastlake. It was during this flow event that the Daniel's Park Dam breached. This flow event also caused localized flooding in Eastlake.

On February 28, 2011, a high flow event caused a breach and failure of the Gates Mills Dam, as well as heavy flooding in Eastlake in multiple locations such as Boracs Landing, Willoughby Hills along Dodd Road, Daniels Park in Willoughby, Chagrin River Road, and several other secondary roads along the Chagrin River.

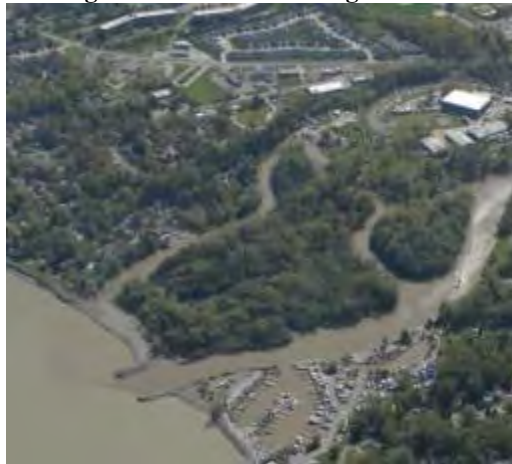
Figure 22: Mouth of Chagrin River

The mouth of the Chagrin River was changed to its present location by the US Army Corps of Engineers circa 1930. As seen in Figure 22 the original mouth of the river was situated to the east of the existing mouth. During high stream flows the City of Eastlake typically uses a backhoe to open up a channel through the sand bar that forms over the former mouth.

The mouth of the Chagrin River also has a wide 100-year floodplain delineated. In addition nearly all of the channel from Lakeshore Blvd. north is armored with steel sheet piling along both banks. Directly south of the Lakeshore Blvd. crossing on the left bank of the river is Boracs Landing. This property has been explored for several development scenarios. The next 3.8 miles of the Chagrin River are either constricted by levees, entrenchment, or natural constrictions due to high shale cliffs. Just downstream of the confluence with the East Branch of the Chagrin, at river mile 4.6, are remnants of a low head dam at Daniels Park. This dam was created around 1920 to impound water for the City of Willoughby municipal water supply. The impoundment has not been used as a water supply source since the 1970's. The dam had eroded a dangerous plunge pool directly downstream of the dam and several people have been injured or drowned here. Over New Year's weekend 2005, the dam breached and fell over into its own plunge pool. In 2000, students at Case Western Reserve University had completed a study and estimated that approximately 24,000 cubic yards of sediment were trapped behind the dam. Although this raised concerns about sedimentation near the mouth it is likely that much of this sediment was washed downstream as the river was flowing at approximately 20,000 cubic feet per second at the time of the breach. As of 2013, the area surrounding the dam has not been restored and the remnants of the dam remain in the location that they fell.

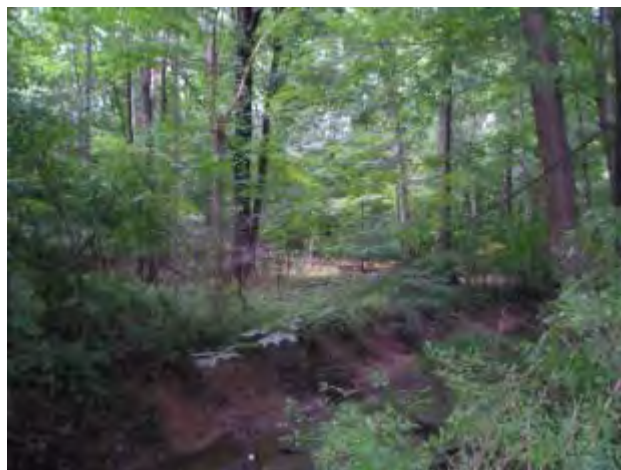
Figure 26: Channelized Stream

In the southwest corner of the watershed a branch of Ward/Newell Creek flows through existing development with limited stormwater management to a 73 acre parcel of land, noted for future development. This parcel has significant frontage on Johnnycake Ridge Road just west of Deepwood Boulevard and is zoned for residential development. It is critical that the stream corridor be protected during the site design of this development and that effective stormwater control measures are installed as this area develops.

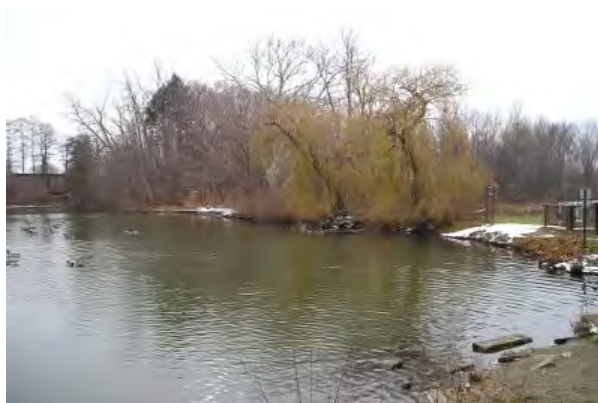
Figure 28: Garfield Park Pond

Garfield Park Pond is located downstream of the mall and has the highest potential for retrofit opportunities because it is within a City-owned park. Dredging accumulated sediment from this pond could reclaim some of its original storage volume. Further, modifying the outlet structure by both lowering the principal outlet structure and adding an additional outlet structure at a higher elevation would provide additional storage during storm events flow with a gradual outflow of this additional storage volume.

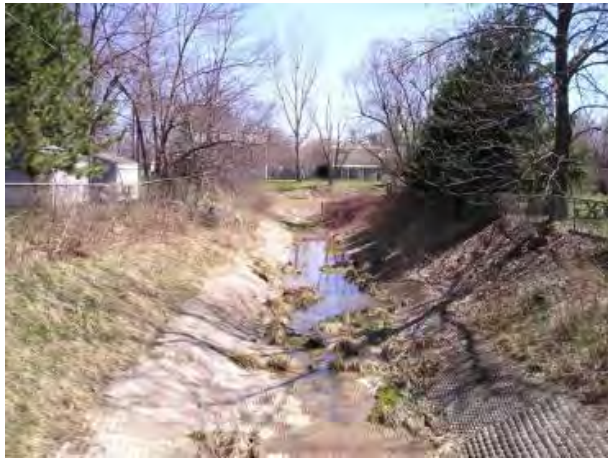
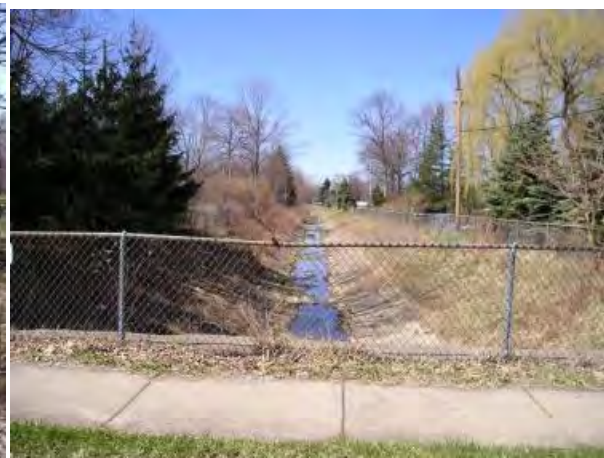
Figure 31: Concrete Channel along Hodgson Road

The portion of stream that flows behind the homes on Hodgson Road is currently in a pipe with an overflow concrete channel above it, shown below. The Hodgson Road stream could be daylighted to restore a natural stream channel with riparian vegetation. After having discussions with Mentor, it

appears that the residents along this portion of stream and downstream of it have not had complaints so this will not be one of the highest priority restoration sites. In addition, CRWP does not recommend completing this work until additional stormwater storage has been created upstream.

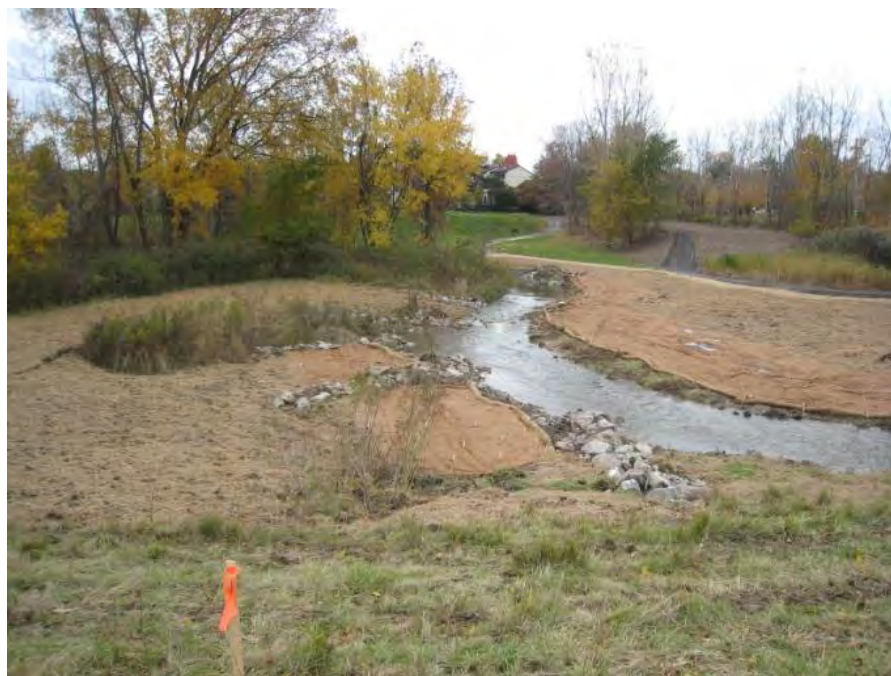
**Figure 33:
at Lost
Course**

The lowest reaches of Ward/Newell Creek flow through the Lost Nation Golf Course, owned by the City of Willoughby as shown in

Figure 33. CRWP and the City of Willoughby completed a stream restoration project in late 2013 to reconnect floodplain areas and add more natural vegetation through the golf course. This project is part of the larger GLRI project that includes the Great Lakes Mall retrofits and subsidized stormwater BMPs for Newell/Ward Creek residents.

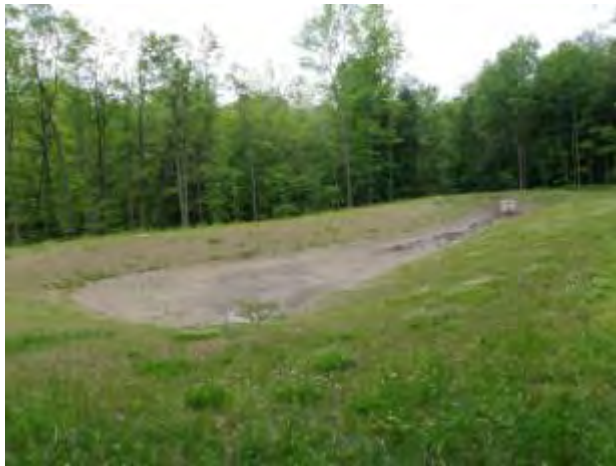
Figure 38: Relocated Rivendell Detention Basin

In June 2007 CRWP was asked by Russell Township Board of Zoning Appeals to review the Rivendell Subdivision Restoration Plan for the area behind Sublots 11 and 12 and make recommendations. This area is under a conservation easement held by the Russell Township Park Board. Under the easement no structures were to be built in the easement area. During the initial construction phase of the Rivendell Subdivision a stormwater detention pond, designed to be a water quality best management practice, was constructed in the easement area. Based on the site conditions and easement contract language, CRWP recommended the stormwater detention pond be filled and a new detention facility built outside of the easement area. CRWP recommended that the filled area be planted with vegetation and deciduous trees, and maintain the area to ensure at least 80% of trees survive and vegetated cover is established. A site visit was conducted with the Township Zoning Inspector on June 25, 2008 to evaluate if the property owner had completed the recommendations. The stormwater basin had been filled and 40 trees had been planted. The area had not been stabilized with additional vegetation leaving exposed bare soil, and several trees were wilted and stressed. Based on the site conditions CRWP recommended additional seeding on exposed soil, installation of erosion and sediment control BMPs until vegetation covered at least 80% of the area, and to reevaluate the area in the fall and spring, and reseed as necessary. The following photos show Griswold Creek as it flows through this site and the relocated stormwater basin. This basin must be maintained throughout its life.

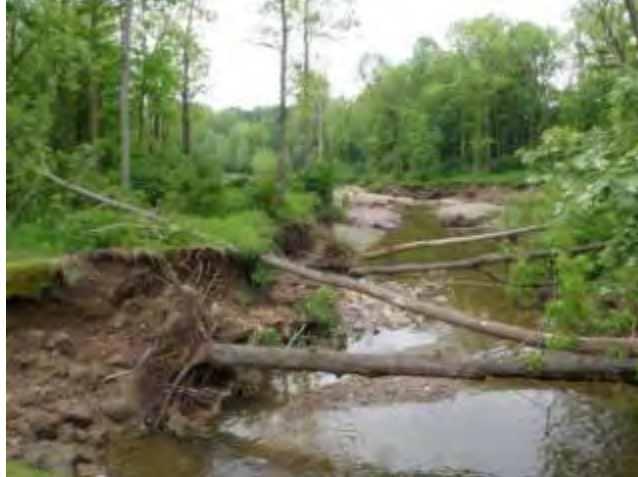
Figure 40: Erosion Downstream of Dines Road

CRWP has not visited the property downstream of Dines Road, however significant erosion was noted along the road and the downstream property following the Memorial Day 2010 flood event. Erosion in the road right of way has been repaired.

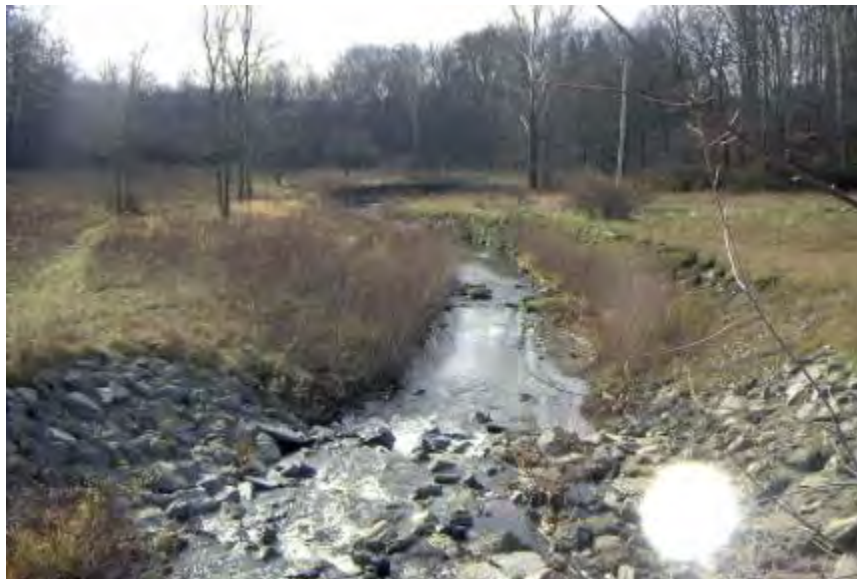
Figure 41: Downstream of Kirkham Dam

CRWP investigated this site as a possible stream restoration, but has not presented this plan to the property owners. The potential restoration discussed below is downstream of the breached dam. This reach has suffered impacts from dam breach, entrenchment, and riparian vegetation removal. The surrounding land is recovering from past use and there is a small livestock operation to the west. Portions of the site already contain streamside vegetation such as willows but a majority of the site could benefit from supplemental plantings. This project provides an opportunity to establish a wide riparian zone; as much as 150 feet on either side. This site may also provide the opportunity to establish floodplain wetland communities or other flood storage areas. Additional opportunities may be present directly upstream of this road crossing as well.

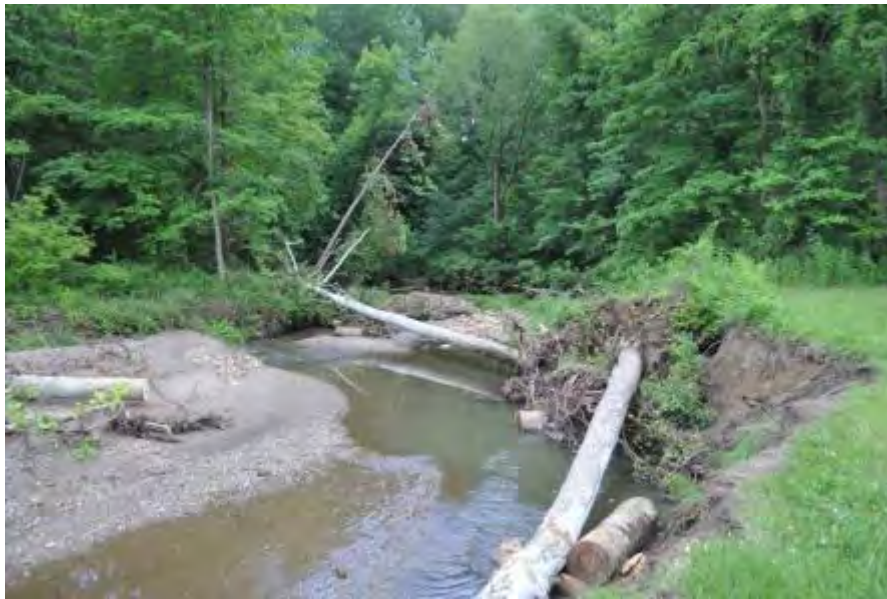
Figure 42: Erosion North of Pond, Griswold Creek

On December 12, 2006, CRWP visited the Thornberry property at 14357 Hillbrook Lane North for the first time and has made several more visits to follow up and provide input on additional concerns. At the time, the Thornberrys were relatively new property owners (1 year) concerned about bank erosion in two areas. Griswold Creek used to run through an inline Applebaum Lake, but the dam was breached in 1990. Griswold Creek now flows around an off-line pond. Two main areas of concern are present on this property. One area of concern is at the north end of the pond where Griswold Creek enters the property and makes an abrupt turn to the east as seen in the picture below. The stream is migrating into old fill when the stream was blocked from the pond. The erosion area is not threatening the house or pond but the erosion rate is extreme along approximately 150 feet of the stream bank. Bank heights are approximately 5 feet from the water surface. This area was stabilized in 2006/2007, but was eroded again during the Memorial Day 2010 storm event.

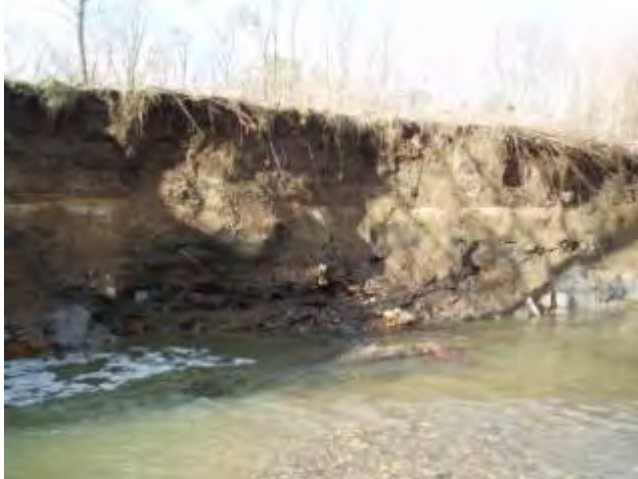
Figure 43: Thornberry Bank Erosion, 2006

The second erosion area is along Griswold Creek on the eastern side of the pond. This area has the potential to cause more serious problems as this slope is part of the dam forming the pond on the property. The stream had eroded approximately 75-100 foot long section of the pond berm (river right). The top of berm between the pond and bank edge was narrowed from erosion to only 15 feet wide. Bank heights were severe at 10-15 feet. Water seepage (flow) from the pond was noticeable in the exposed bank at two areas. The owner installed bank pins several months prior to the picture on the left below and observed lateral erosion of over 2 feet of bank. As the threat of berm failure was high, the owner regraded the stream banks and stabilized with willow postings in 2007. The willows became well established, however an additional erosion area was observed after the Memorial Day 2010 flood.

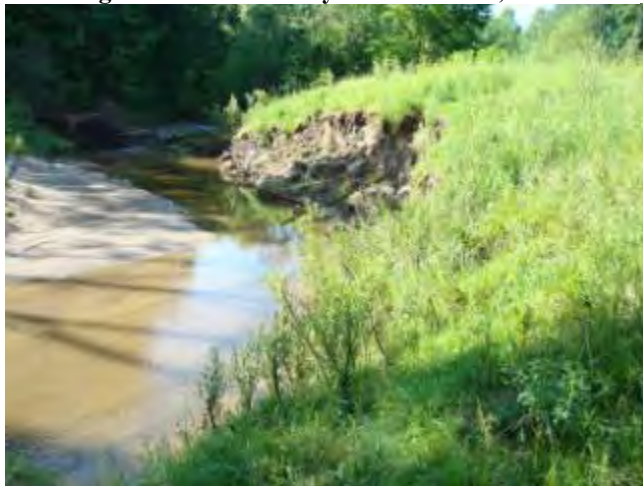
Figure 44: Thornberry Bank Erosion, 2010

Additional work was completed in 2012 that caused the stream to cut off a meander bend and cut a new shorter channel which should be observed for future instability. Restoration at this site could be accomplished, but would likely result in eliminating or significantly reducing the size of the existing pond which is not acceptable to the property owners.

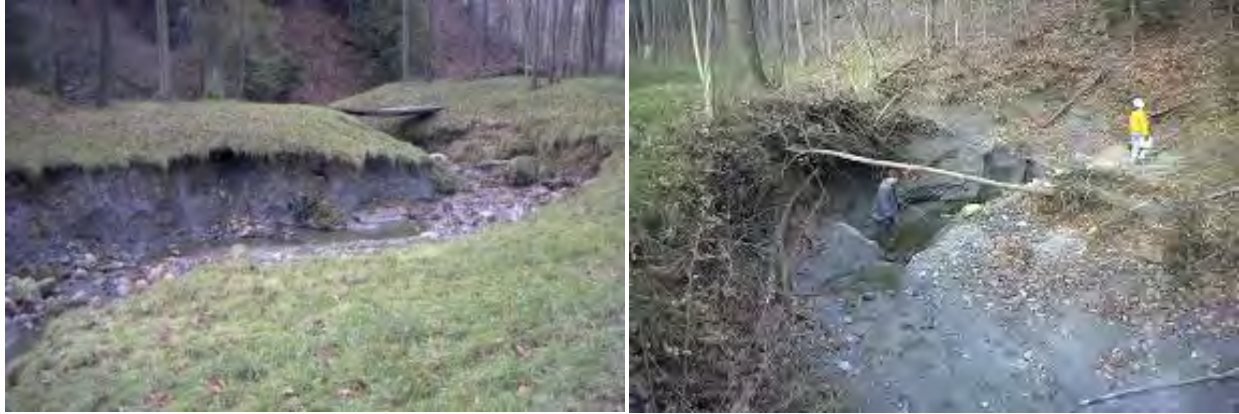
Figure 45: Examples of Headcut Erosion

- Install grade control structures such as step-pools in the stream channel,
- Reestablish the floodplain to allow for flood flows to spread out and reduce the stream energy during storms,
- Reestablish streamside vegetation once work the stream channel has been stabilized.

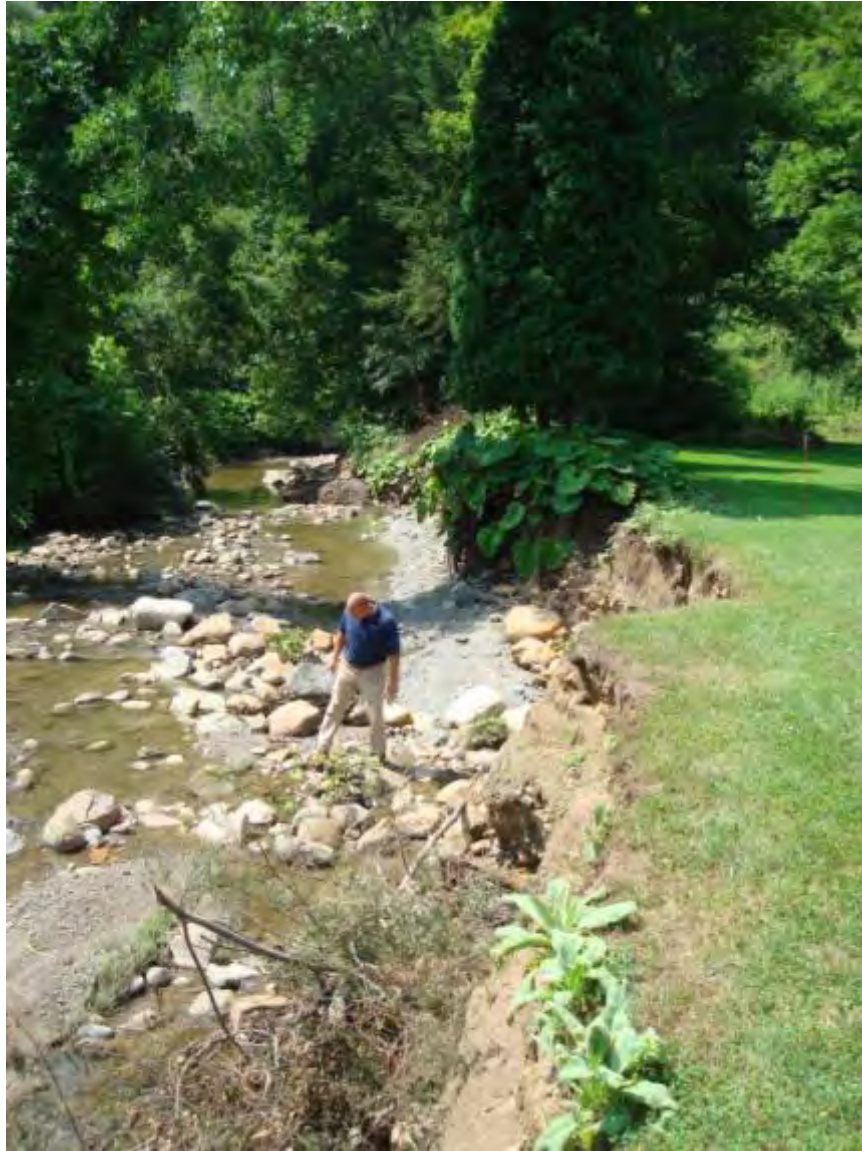
Figure 47: Streambank Erosion at Hillbrook Club

CRWP visited the Club at Hillbrook on July 14, 2010 to evaluate erosion concerns and potential solutions. Storm events over 2010 Memorial Day weekend caused additional erosion, particularly near the pool lawn area as observed in the picture below. The Hillbrook Club staff also noted concerns related to the old stone wall structures including erosion and a desire to maintain some of these structures.

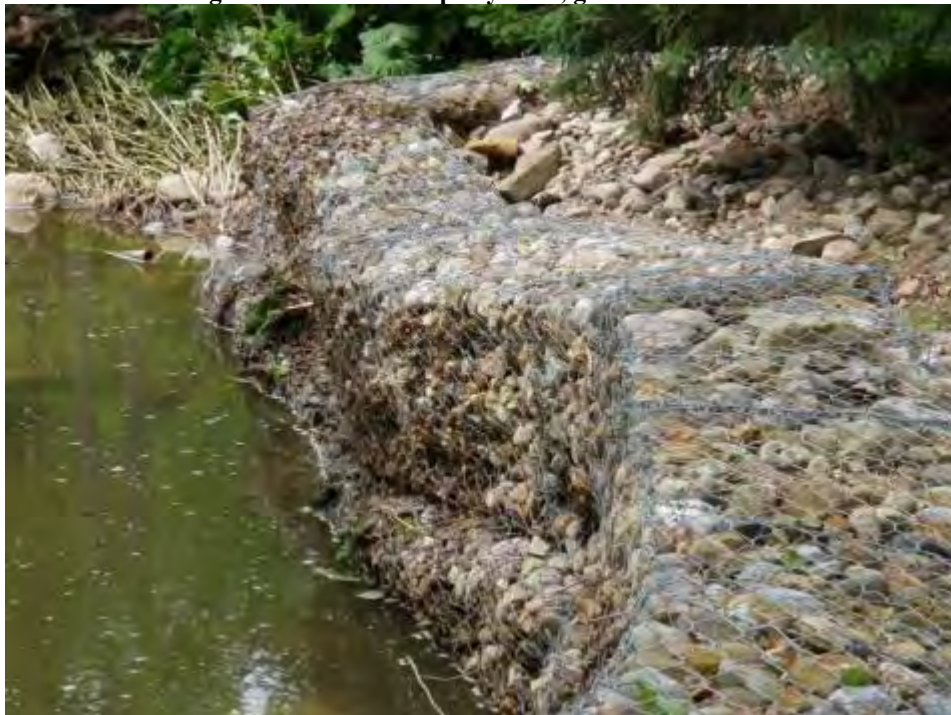
Figure 52: McNitt Property 2010, gabion structures

gabion baskets by the Russell Township Road Department. These gabions were damaged during the Memorial Day storm event.

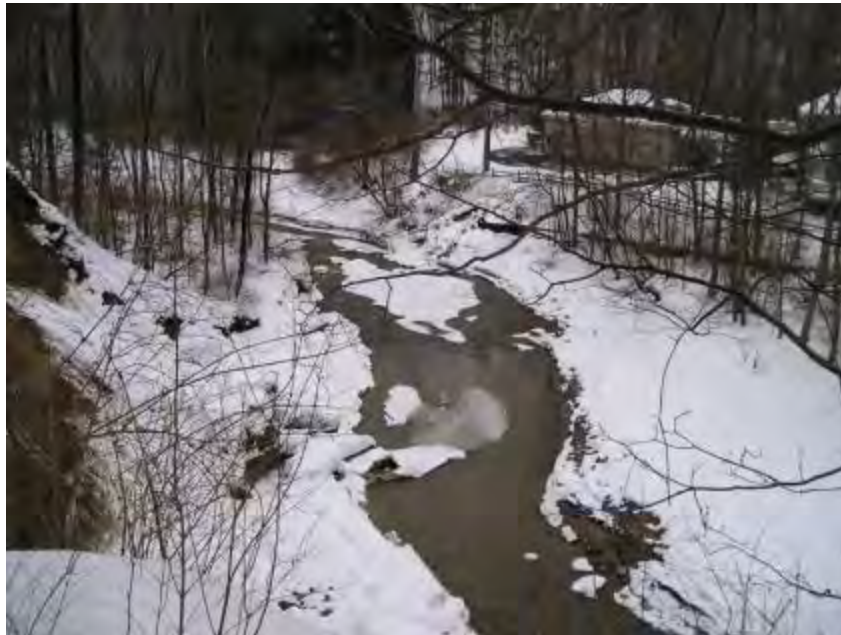
Figure 53: Terrell Property, Griswold Creek

On October 26, 2009 CRWP walked the property on 450001 Falls Road to discuss slope stability along Griswold Creek. The photo below is taken from the top of this slope. The slope leading down to Griswold Creek is very steep in several places and serious erosion has been occurring for a number of years. Adjacent parcels have experienced as much as 60 feet of lateral erosion at the top of this slope above Griswold Creek. The toe of the slope has small trees and shrubs growing along the edge of the stream that indicate that the toe of the slope has been stabilizing, however, slope failures along this area are still occurring. CRWP recommended the following:

- Allow vegetation to grow along the slope and do not deposit leaves, grass clippings, or other materials over the top of the slope as these materials can smother slope vegetation. Vegetation along the slope can help to stabilize the slope through the vegetation's root structures.
- Do not mow the area regularly at the top of this slope. High, rough grasses and other dense vegetation will slow the flow of any water over the top of the slope and protect against future erosion.
- Retain a slope stability expert to investigate the concerns about this slope and determine next steps to slow slope erosion.

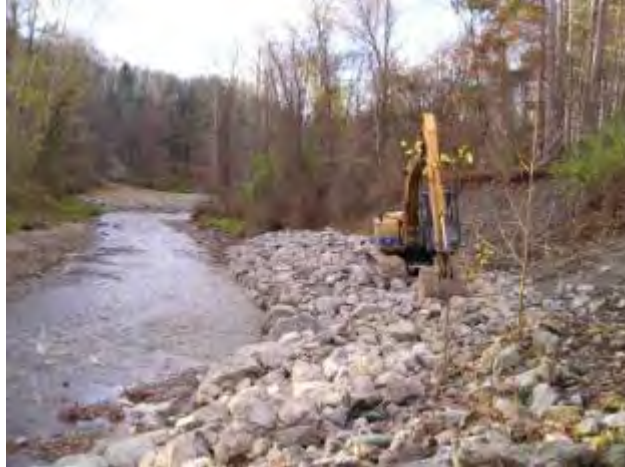
Figure 54: ODOT Repairs Near Crowley Bank Stabilization

The Crowley property is just downstream of multiple repairs along State Route 87 and follows the river to the mouth on the downstream side of Falls Road. A bank stabilization project was completed on this property as the stream bank had eroded over 35 feet and was jeopardizing the Crowley barn. The photos below show the latest ODOT repair near State Route 87 with the Crowley bank stabilization downstream in the background and a view of the stabilization work from Falls Road.

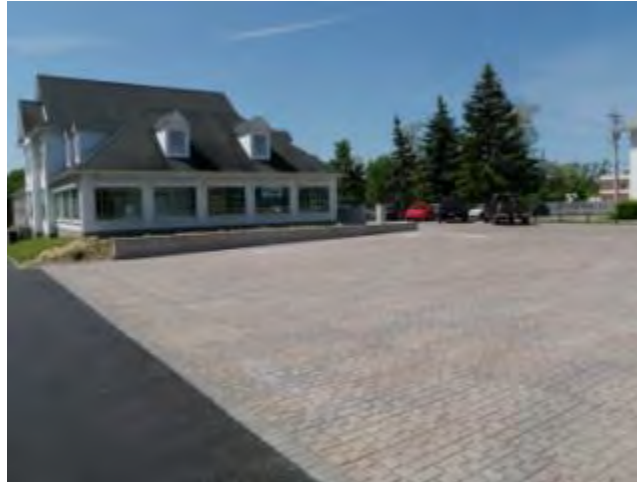
Figure 58: Permeable Pavers at 8555 Mayfield Road, Chester Township

part of the subwatershed is already at build-out, thus stormwater retrofitting and management of surface runoff is a primary goal in this area. CRWP assisted Chester Township with a Surface Water Improvement Fund grant from Ohio EPA to retrofit their Town Hall parking lot with pervious pavers and bioretention cells. In addition, a stormwater retention area was constructed along a headwater tributary to Marsh Hawk Run east of Opalocka Drive in early 2009 that mitigates the stormwater runoff from buildings and pavement located directly at the intersection of Chillicothe Road and Mayfield Road. Any future re-development in Chester Township should implement stormwater BMPs such as porous pavers, bioswales, and bioretention areas. Some businesses have already installed stormwater best management practices (Figure 58), and CRWP will continue to work with and provide technical assistance to both Chester Township and other local businesses looking to do the same.

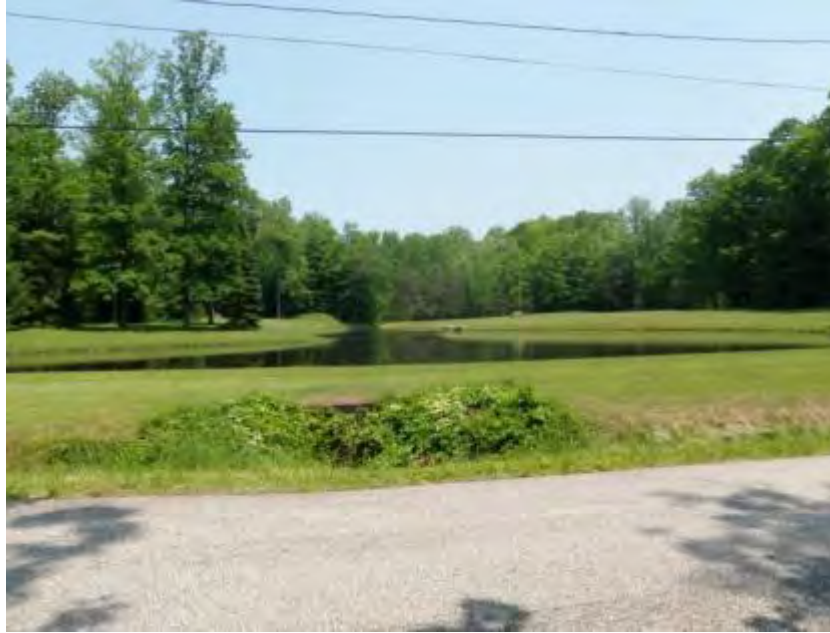
Figure 59: Impounded lake on Wyandot Road

Downstream of the Opalocka WWTP, Marsh Hawk Run flows southeast through older residential neighborhoods built mainly in the 1950s and 1960s with an average lot size of 1.5 acres. These properties, located along Vincent Drive, Wyandot Road, Ranch Drive, Camelot Drive, and Forest Lane have good riparian tree cover along the streams and most of the lots are wooded; however, an in-line 1.2 acre lake is located on Wyandot Road (Figure 60) that is mown to the edges. Downstream of the

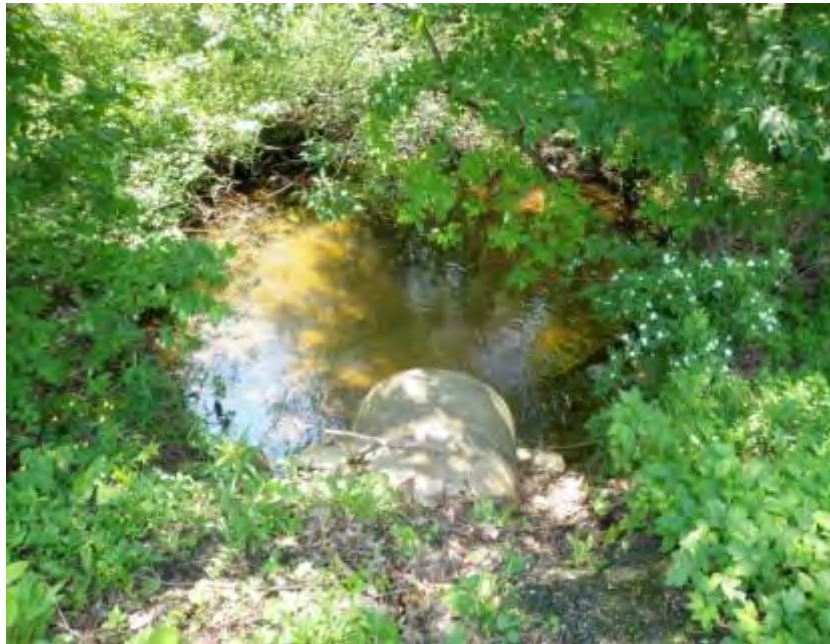
Figure 60: Scour pool at culvert downstream of Wyandot Road

impoundment on the south side of Wyandot Road was a clearly visible scour pool at the culvert outfall (Figure 61). Moderately embedded substrate was visible in the scour pool and immediately downstream of the culvert.

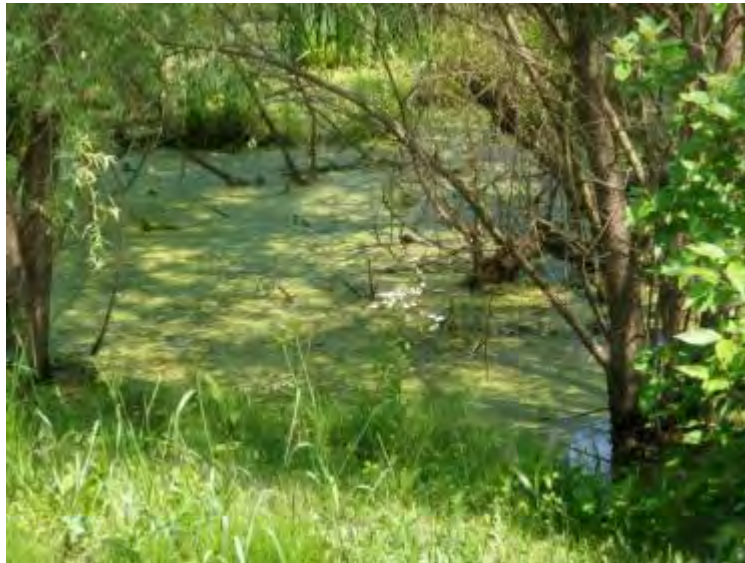
Figure 61: Wetland, Ranch Drive

Heavy vegetative cover was common along the stream crossings on Ranch Drive. The water exiting the downstream culvert on an unnamed tributary to Marsh Hawk Run at RM 1.33 appeared cloudy. Debris blocked a portion of the culvert on the upstream side. An adjacent wetland located immediately to the west of the tributary on the upstream side (Figure 62) may function as flood storage on Ranch Drive. This area is serviced by HSTS. Approximately 200 feet upstream of the culvert crossing, the tributary appears to be straightened with riparian vegetation removed and portions enclosed in pipes before transitioning into a forested area. Downstream of the culvert crossing the vegetative cover is very heavy (Figure 63) and continues downstream to where the stream joins Marsh Hawk Run.

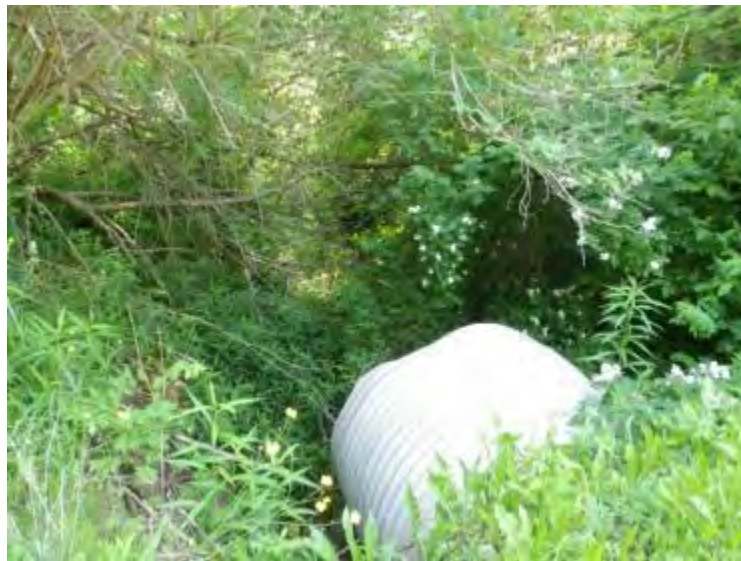
Figure 62: Heavy vegetation downstream of culvert, Ranch Drive

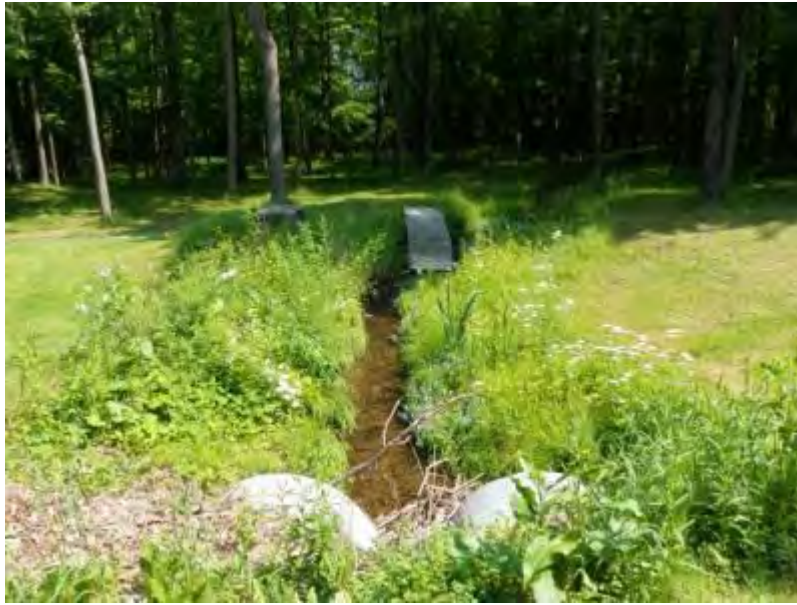
Figure 63: Debris blocking culvert upstream of Ranch Drive

Debris blocked one of the two culverts where an unnamed tributary to Marsh Hawk Run at RM 1.43 crosses Ranch Drive. This debris could inhibit flow through the culvert, causing water to back up and flood the banks during high flow events and could lead to flooding on Ranch Drive. The upstream side has minor grassy vegetative cover on the banks and is channelized through the residential property. Downstream of the culvert, vegetative cover was well-established with sufficient trees providing shade, but bank erosion and exposed roots were observed along the side where the unblocked culvert was located. The stream substrate was slightly embedded with fine silt, but included a good mix of boulder, cobble, and gravel.

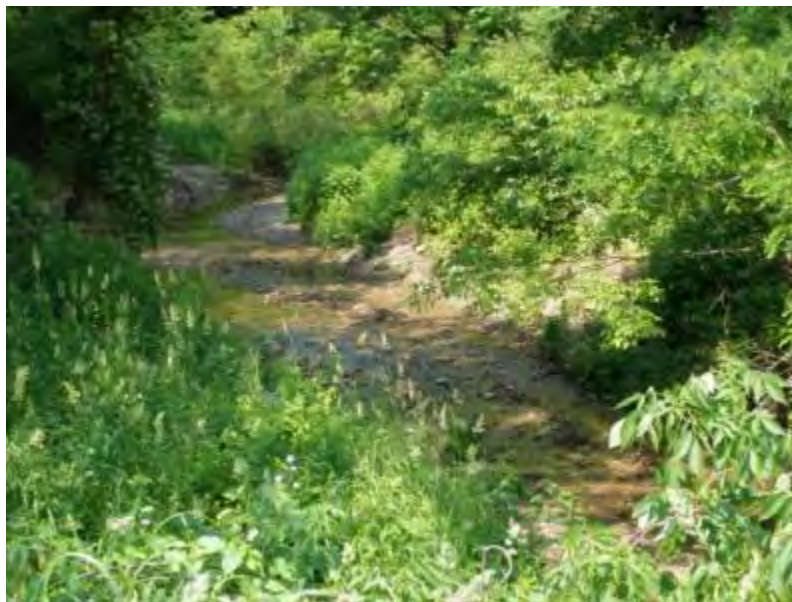
Figure 66: Upstream of Sperry Road

Good in-stream channel development with varied substrates can be seen upstream of the Sperry Road culvert (Figure 67). Bank erosion and a fallen tree were observed immediately downstream of the culvert, but the channel appeared to re-stabilize about 150 feet downstream. Overall the channel had good vegetative cover and stream shading. The upstream segment receives drainage from an adjacent road ditch that runs parallel to Sperry Road and joins with a minor tributary. Further upstream the channel runs alongside an approximately 4-acre lake that was initially an on-line impoundment, but was modified in 1998 to an off-line lake by restoring the stream channel to its original location to eliminate concerns regarding ODNR dam regulations. While the downstream channel exhibits good vegetative cover at this immediate location, it is joined by an unnamed tributary at RM 0.83 that is impacted from channel straightening, lack of riparian vegetation, and potential HSTS inputs. This unnamed tributary could be a primary source of nutrient and sediment stressors to the non-attaining reaches further downstream.

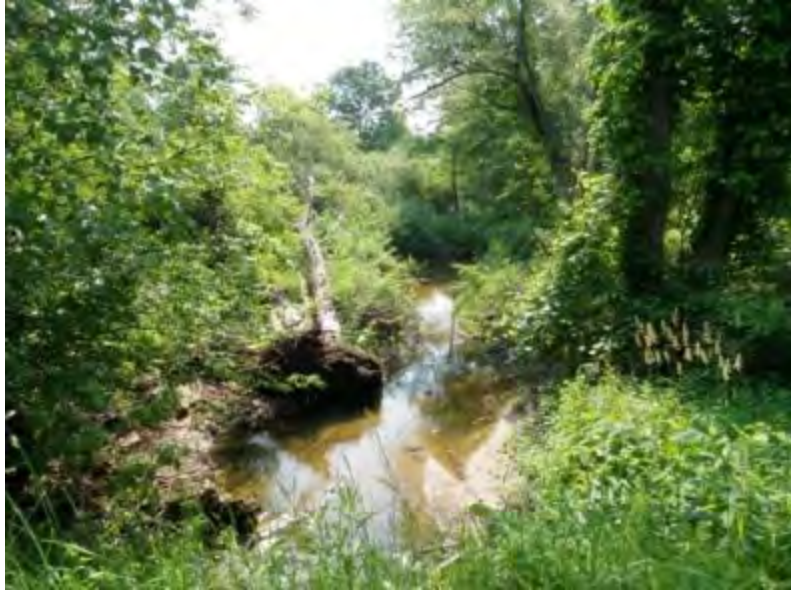
Figure 67: Bank erosion and fallen tree downstream of Sperry Road

From Sperry Road west to where Marsh Hawk Run crosses Ranch Drive, the riparian corridor was forested through residential lots, but these residential lots are old, fairly small and treat sewage with HSTS. Nutrient input from failed HSTS may be a water quality issue in this portion of the watershed.

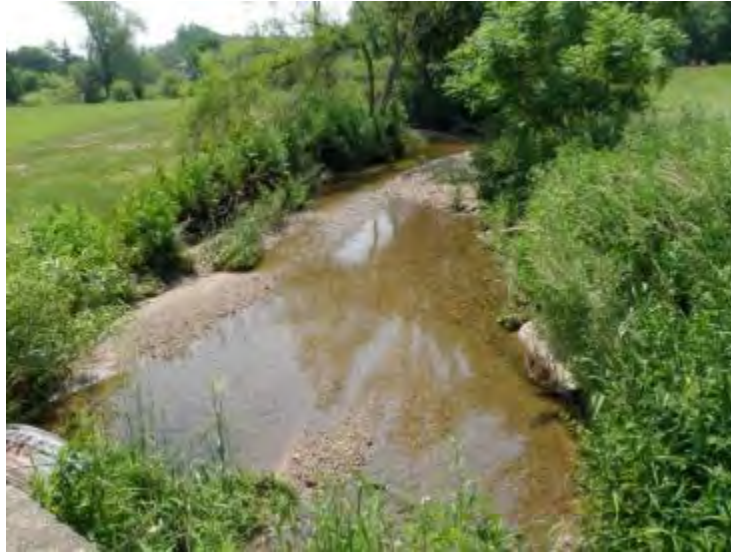
Figure 68: Downstream of Winchester Valley

A covered bridge is located on Marsh Hawk Run at RM 0.73 as it crosses Winchester Valley. Gravel and sandbar development were observed upstream and downstream of the culverts and bridge, and small fish were observed in the pool located at the upstream culvert mouths. A third culvert to the west of the bridge carries additional flow under the road to a small vegetated ditch, which outlets into the stream on the south side of the bridge (Figure 70). Moderate to heavy embeddedness was observed in the substrate immediately around the culverts. Downstream of the culverts, minimal riparian buffer is established before transitioning to a more heavily wooded area with relatively good floodplain connectivity (Figure 69). CRWP staff made a site visit to this location on November 3, 2008 and observed sediment buildup in both culverts potentially reducing flow capacity through the culverts. During a 2008 and 2011 site visits the stream bank was stable with good vegetation established. This area was dredged by the Chester Township Road Department and a private excavation company in the spring of 2009 to remove accumulated gravel and sediment. The gravel and sandbars re-formed after the next major rain event and have not been dredged since.

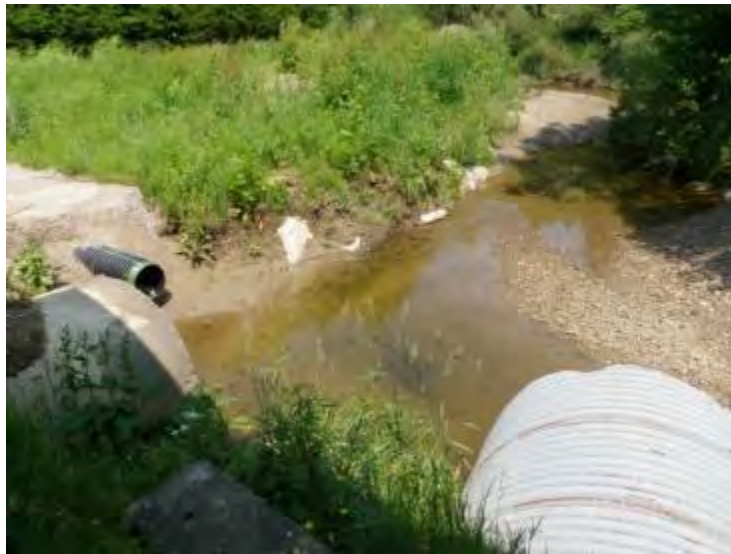
Figure 69: Upstream of Winchester Valley

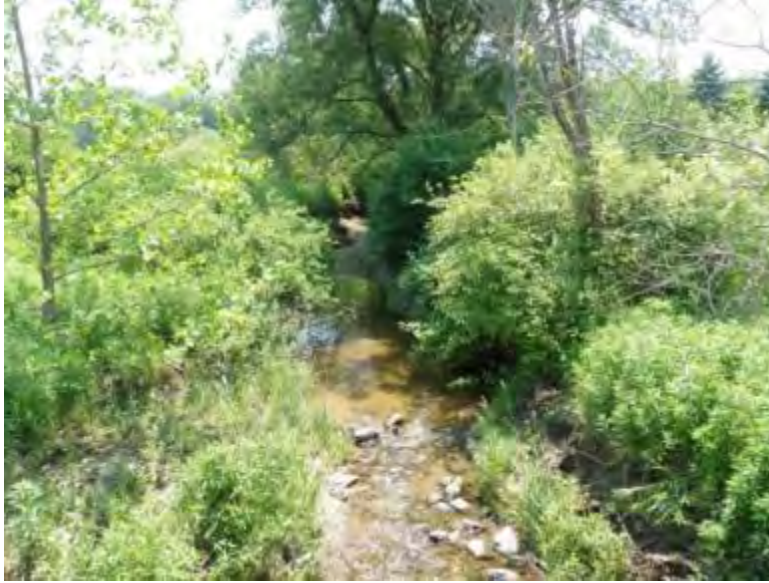
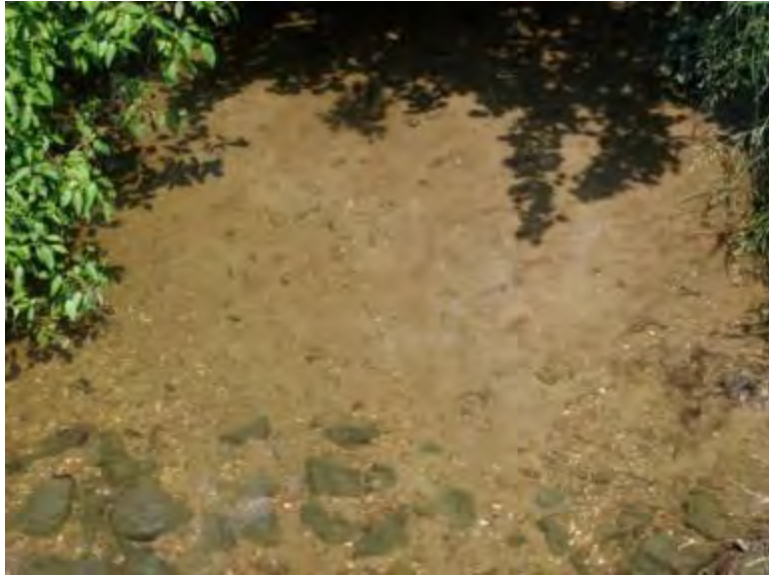
Marsh Hawk Run and two headwater tributaries cross Marsh Hawk Run Road. Substrate in this area is highly embedded. Flow exiting the culvert on the downstream side was significantly higher than the flow entering which may indicate debris blockage inside the culvert. This is also one of the flattest locations in the watershed which contributes to sluggish flow and subsequent siltation in this area.

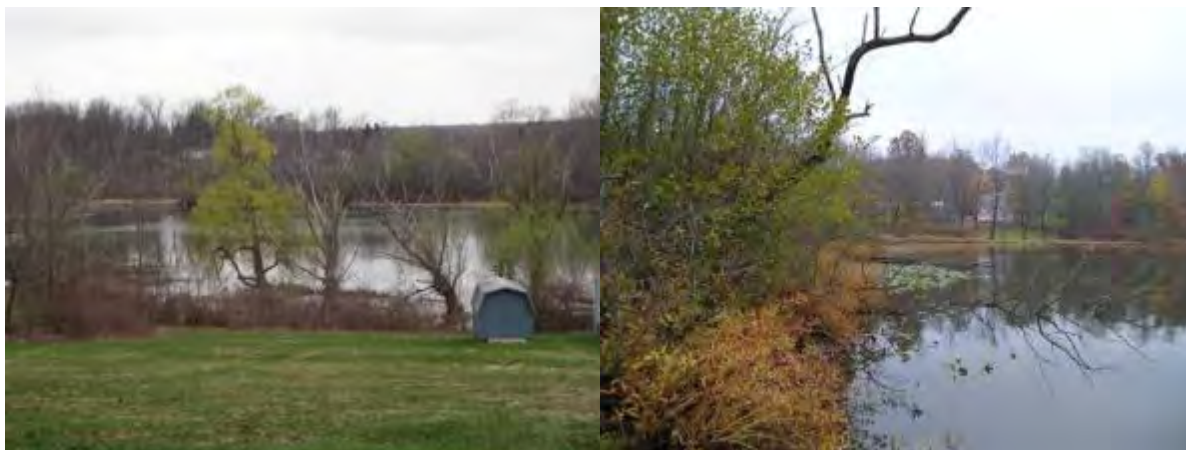
The furthest upstream section of the subwatershed is Pine Lake, just west of Punderson State Park. Pine Lake and another lake just north of S.R. 87 (shown on left below) both drain down to Kiwanis Lake (right). Kiwanis Lake was historically a cottage community and still contains small lots with several platted streets that were never constructed. The streams draining to Kiwanis Lake are primary headwater streams and have not yet been assessed. Kiwanis Lake is surrounded by open space owned by the Kenston Lake Homeowners Association. This open space contains significant shrub/scrub wetlands. Kiwanis Lake, an 80-foot deep kettle lake, serves as one of the primary sources of water for the nearby wetlands. A nearby spring could also contribute water to the streams, wetlands, and Kiwanis Lake. At this time the wetlands are assumed to be high quality Category 3 wetlands, but they are impacted by invasive buckthorn (*Rhamnus*) populations and control of these invasive plants is recommended.

- The area circled in yellow represents residential areas with very old HSTSs. These residences were initially conceived as summer cottages and have been converted to year-round use without updating the HSTS. Assistance to fund HSTS replacements in this area or allowing this area to become sewered will have to be investigated. Educational outreach to residents of this area, including the Kiwanis Lake Homeowner Association, is recommended.

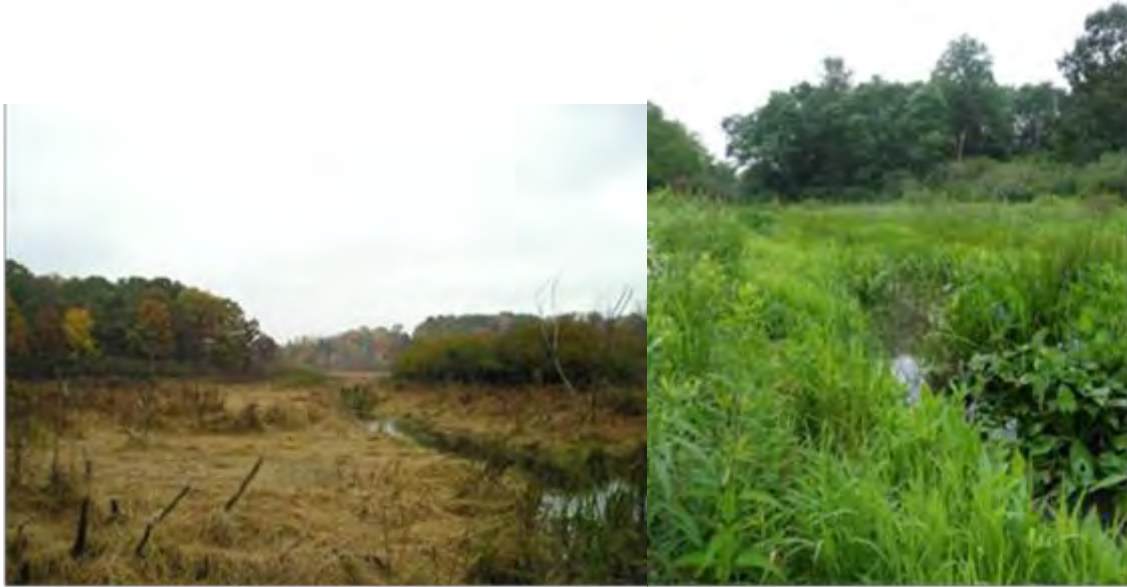
Downstream of Kiwanis Lake is another large wetland complex, approximately half of which is owned by the Newbury Township Trustees. The wetlands and associated streams have a tributary drainage area of 1.8 square miles. The wetland soils are composed entirely of Wallkill silt loam; a deep, very poorly-drained soil formed along streams and in bogs that is ponded much of the year and is poorly suited to any land use besides wetland habitat. The aquatic habitat is made up of shrub and emergent plant communities with a large forested buffer. Outside of the forested buffer, adjacent land uses include large lot residential, the Kiwanis Lake Subdivision, and open fields. Invasive species such as *Phalaris arundinacea*, *Phragmites australis*, and *Rhamnus* are noticeably present and their management and removal is recommended.

The wetland on the Township property has been historically impacted with small impoundments (both beaver and human-made) and dredging activities along the stream with materials cast into the wetland. Despite these impacts, the wetland is still considered to be a high-quality system and is assessed at Category 3.

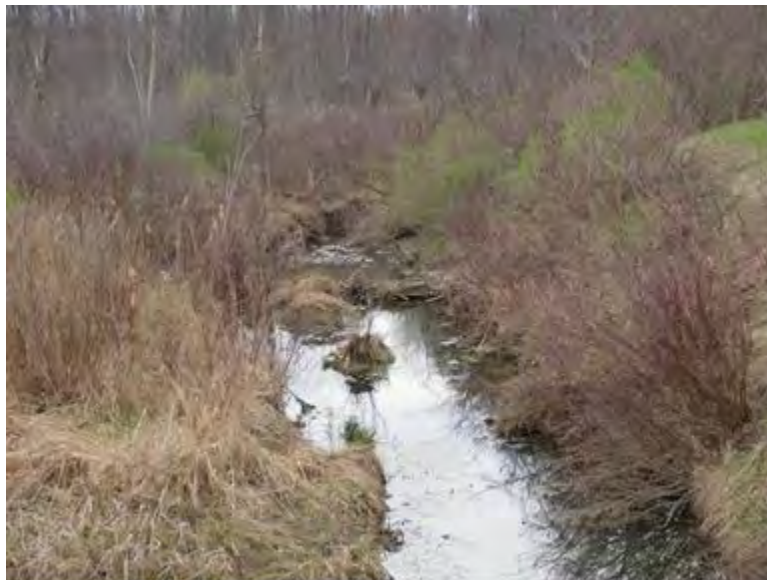
Immediately downstream of Fairmount Road, much of the riparian vegetation on the left side of the stream has been removed and erosion along the bank is evident. This area is recommended for supplemental riparian plantings.

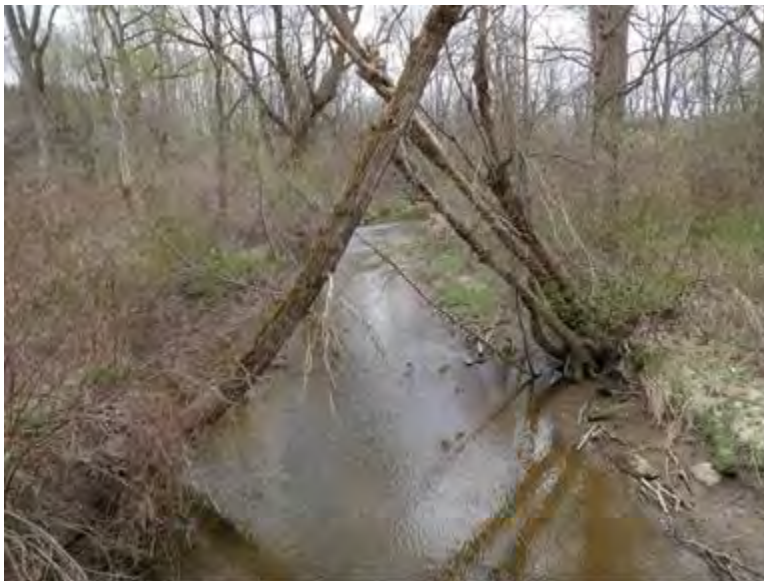
Continuing downstream of Fairmount Road, a tributary enters the main channel of Dewdale Creek from the east. This tributary is in a completely wooded corridor except in the location of the Swetland ponds (as named in ODNR's dam database). These ponds could be investigated for future removal or adaptation, as open water can create significant thermal impacts in a coldwater habitat stream. Otherwise this tributary is a good candidate for preservation as most of the wooded riparian corridor and associated wetland complexes are intact. The stream is in full attainment of CWH status near the mouth at Rockhaven Road in Munson Township. The photo below shows some of the wooded and wetland corridor evident throughout the lower reaches.

- Riparian corridor restoration downstream of Fairmount as noted above.
 - Further investigation of in-line flows in the Swetland ponds may also yield a potential restoration site.
