Chagrin River Watershed Action Plan

Chagrin River Watershed Partners, Inc.

Revised December 2009

Updated September 2011

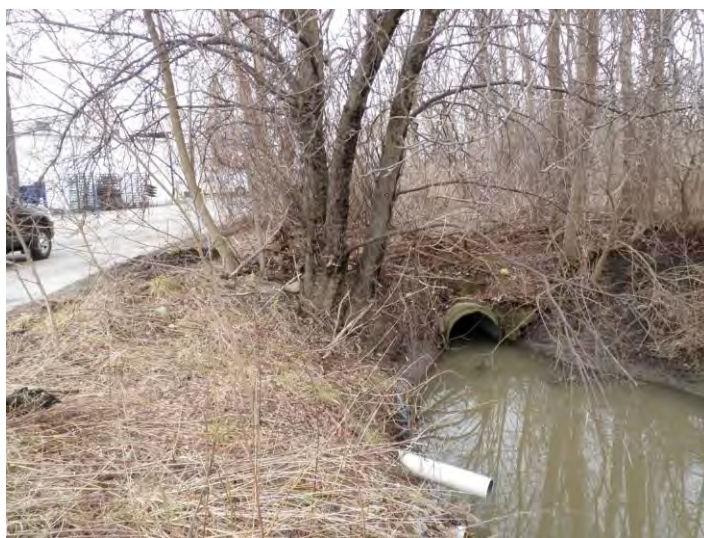
The headwaters of the Chagrin main stem in this segment are heavily channelized and modified and flow through medium to high intensity commercially developed areas. Portions of the channel are open and ditched between Arby's and Haueter's Lawn and Sport Center, but is then buried for about 245 feet until the stream emerges from a culvert adjacent to a large commercial plaza at 425 Water Street (see below). The stream in this area exhibits low flow, silted water and highly embedded substrate. Drainage pipes from the adjacent commercial plaza route stormwater directly into the stream.

Headwaters of the Chagrin River, showing culvert and drainage pipes behind large commercial plaza.

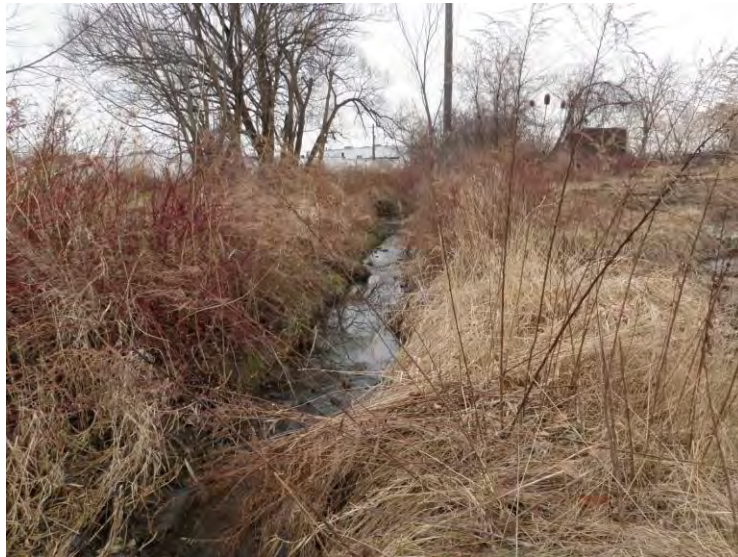
Downstream of the culvert, the stream remains highly channelized. The banks are vegetated with tall grasses and woody shrubs. This section of the stream follows an old CSX rail line and was likely ditched

Looking upstream (north) towards the commercial plaza and culvert.

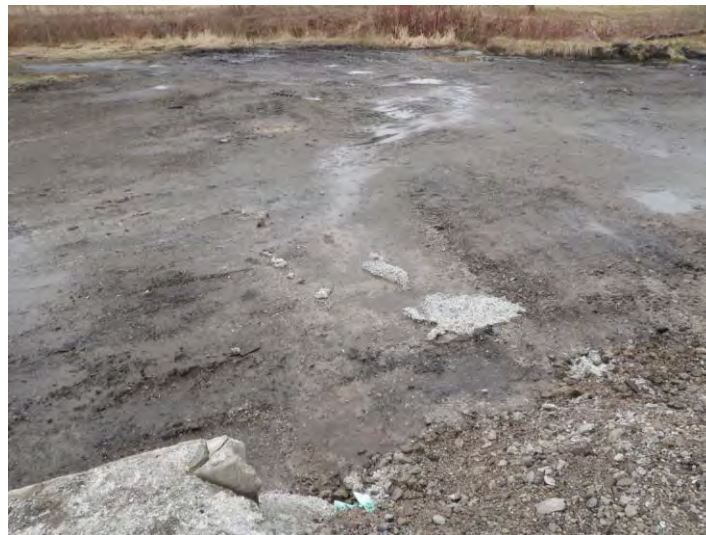
East of the stream are several parcels owned by the City of Chardon. These parcels used to house the City's salt storage and service garage, which caught on fire in March 2008. A new City service complex is slated to be built at 501 North Hambden Street. A large shed on the property is still used as salt storage by Chardon Schools. Surface runoff from this shed drains directly to the stream.

Salt from storage shed draining down towards the stream.

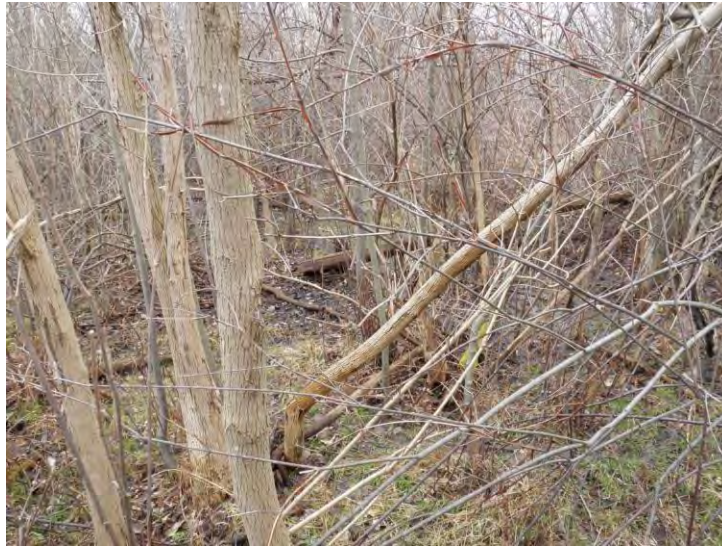
After entering the Hidden Glen property, the stream then flows south for about 1,488 feet along what was once CSX rail corridor, between forested commercial property and Chardon Lakes Golf Course. The Hidden Glen property is currently undeveloped and exists in an open meadow state. From aerial photos, the stream appears to exhibit some sinuosity through this segment, but private access issues prevented any direct stream observation. The City of Chardon owns a 3-acre parcel east of the Hidden Glen property that is being held for possible expansion of the Chardon cemetery. The parcel is undeveloped and appears to exhibit characteristics of a forested wetland. This wetland area may influence the nearby stream, contributing to low levels of dissolved oxygen.

Forested City-owned wetland area next to Chardon cemetery.

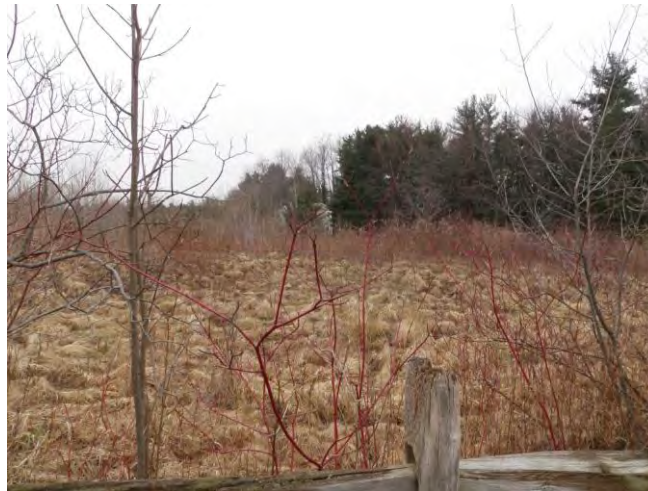
View of Hidden Glen property from Chardon cemetery, looking downstream. The house in the center distance marks the start of Burlington Green subdivision.

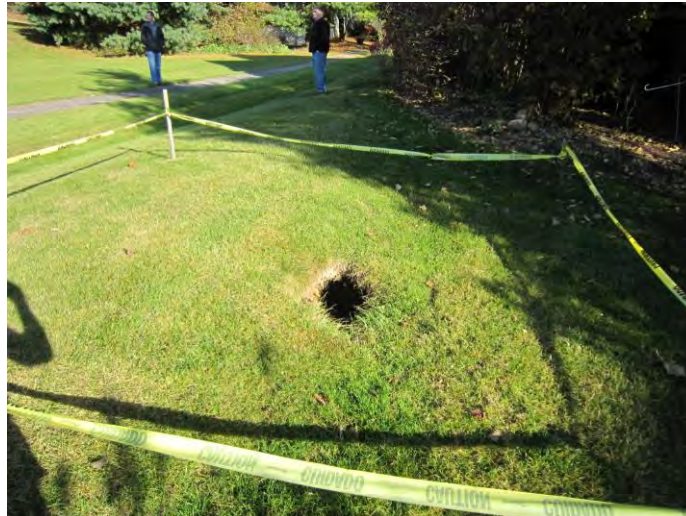
Sinkhole developing at Burlington Green subdivision from failed pipe.

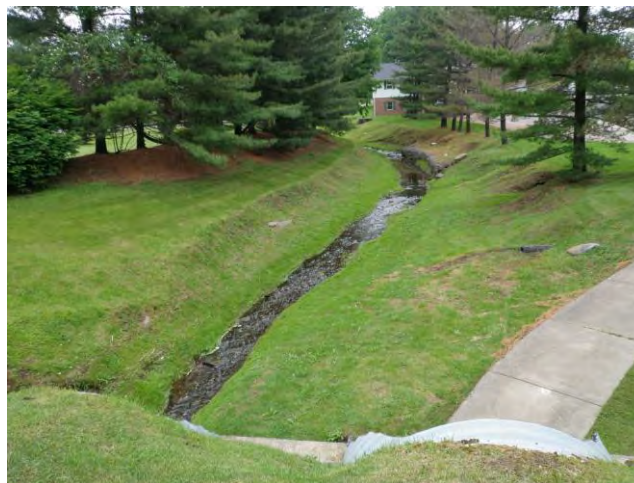
The stream exits the culvert under South Street and flows through the Burlington Oval subdivision, where it is deeply entrenched, channelized, and piped as it flows under Burlington Oval Drive. Riparian cover is minimal to nonexistent and most of the streambank is mowed to the edge.

Channelized and mowed stream at Burlington Oval subdivision, north of Burlington Oval Drive.

- Open space acquisition and preservation, targeting parcels marked as Priority Conservation Areas in the *Chagrin River Balanced Growth Plan*;
- Riparian restoration: replace turfgrass along streambanks with native shrubs, trees, and grasses
- Stream restoration: restore sinuosity and floodplain access to non attaining stream segments;
- Integrate more natural areas into Chardon Lakes Golf Course grounds, plant native vegetation along streams, restore channelized stream segments, assist Chardon Lakes with developing a nutrient management program;
- Implement stormwater retrofits in the high-intensity commercially developed areas of City of Chardon to reduce stormwater flows into the stream;
- Integrate good housekeeping standards into City of Chardon's municipal service facilities to match Phase II minimum control measures;

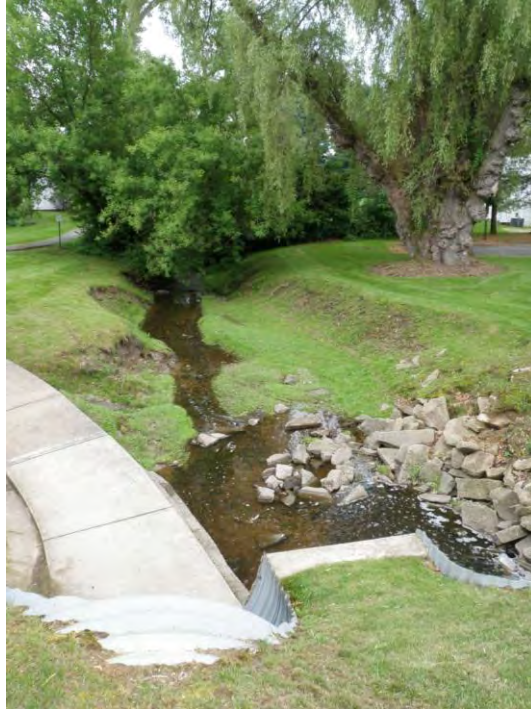
Severe bank erosion can be seen along this section of stream at the culvert downstream of Burlington Oval Drive. The stream flows through a parcel maintained as open space between the Burlington Oval and Woods of Burlington subdivisions. This parcel consists of a large forested wetland complex and preservation of this complex through purchase or easements should be investigated.

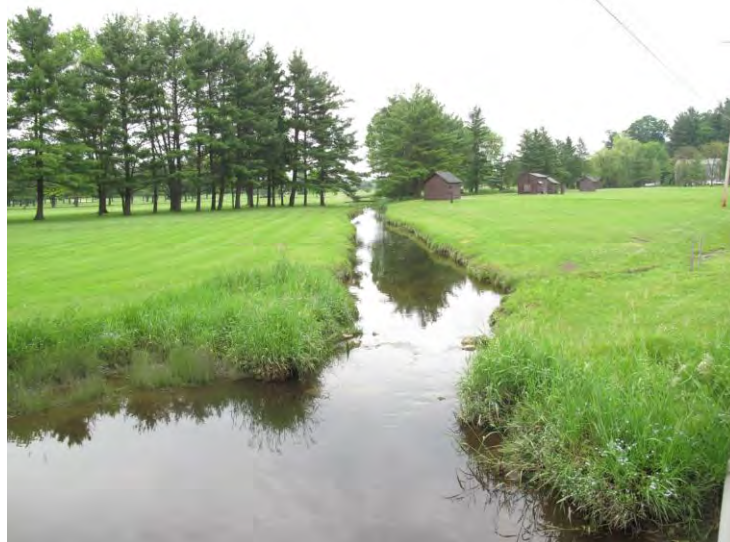
The stream flows southwest back under South Street and into the Chardon Lakes Golf Course, where it is again heavily channelized, entrenched, and mown to the edge for the next 1,600 feet where it meets Woodiebrook Road. An unnamed tributary flows from the northwest through Chardon Lakes to join with the main stem at this point and exhibits the same hydromodification and lack of riparian cover (above).

Figure X: Section of stream as it flows through Chardon Lakes Golf Course.

The area delineated by the orange circle appears to be a large forested wetland and so may contribute naturally low levels of DO to the stream system, which may hinder this segment from achieving full WWH habitat attainment status. However, the wetland system also retains stormwater and provides nutrient filtration and habitat for migratory and native species and should be preserved and maintained in a natural state. Stream restoration is a high priority in this subwatershed, most notably along the non-attaining segments that flow through the Chardon Lakes Golf Course and Hidden Glen property. Restoration is also a priority for the heavily channelized streams in the Burlington Green and Burlington Oval subdivisions, but may be difficult to accomplish based on constrained corridor size and multiple private ownerships. The Sanborn parcels should be looked at as possible conservation easement properties, and stormwater retrofits in the heavily developed commercial areas of the City of Chardon could serve to alleviate excessive stormwater flows to the stream. Although the City of Chardon is not under NPDES Phase II permitting standards, implementing Good Housekeeping standards at their municipal service facility would benefit water quality and reduce water quantity to sensitive headwater streams.
