Stream and Wetland Restoration Performance Assessment Project

Technical Report

Chagrin River Watershed Partners, Inc.
July 2018

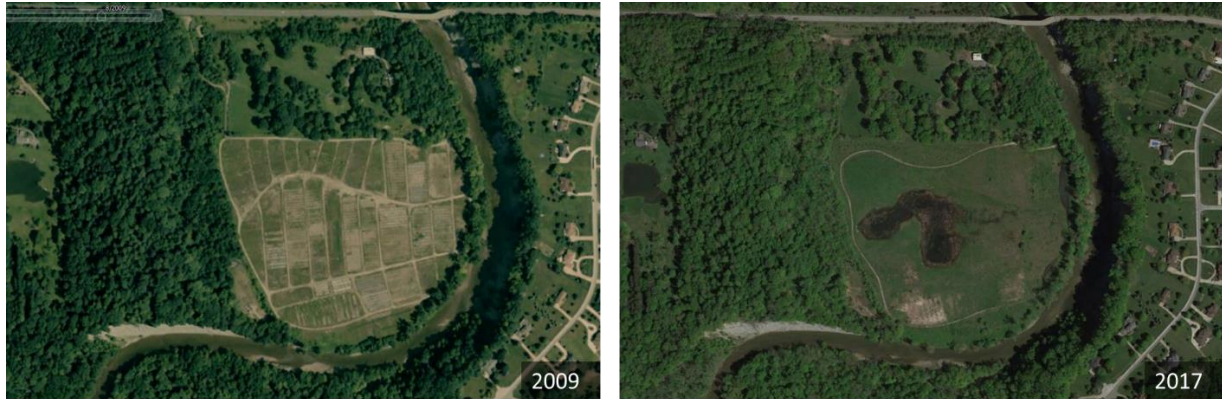
Figure 4. Aerial imagery of the Pleasant Valley Park floodplain restoration project, both pre-construction (2009) and post-construction (2017). Image source: Google Earth.

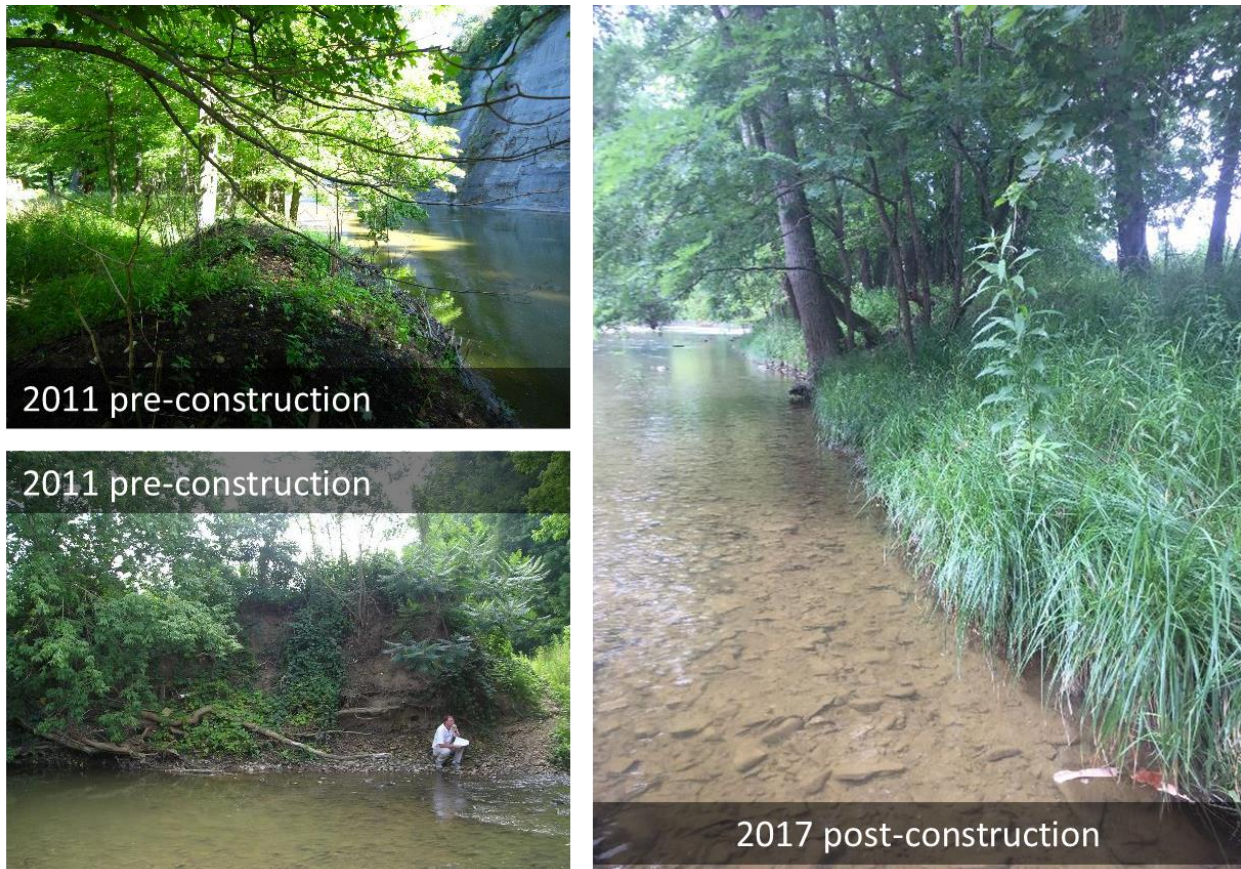
Figure 5. Pre- and post-construction conditions for the Pleasant Valley Park floodplain restoration project.

CRWP’s 2017 assessment results indicated a habitat assessment QHEI score of 80.5 (“excellent” narrative rating) adjacent to the restoration reach, which was slightly improved from Ohio EPA’s 2014 assessment. CRWP’s ORAM assessments indicated Category 2 (moderate quality) habitat within two restored wetlands, which was expected as these restored wetlands continue their establishment.

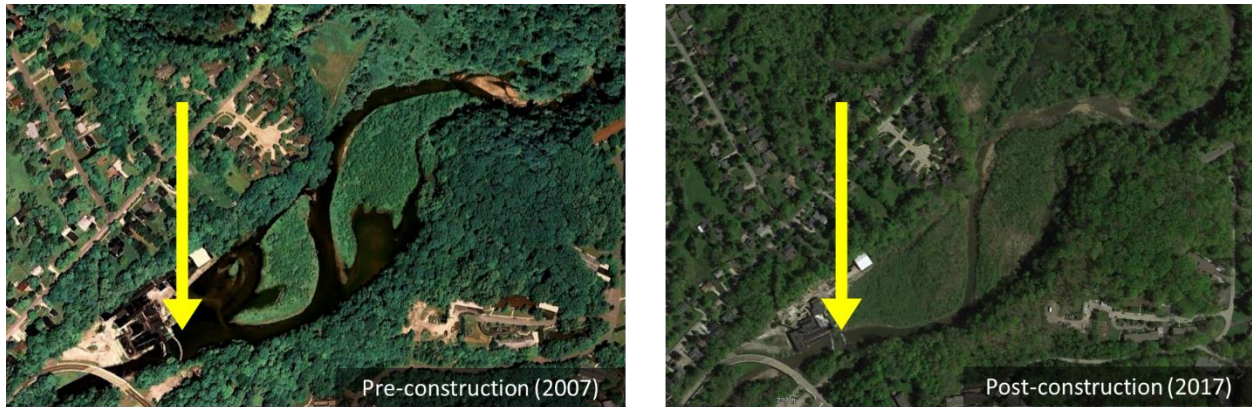
Figure 7. Pre-construction (2007) and post-construction (2017) aerial imagery of the Ives of Ohio lower dam modification and stream restoration project. A yellow arrow indicates the location of the modified dam. Image source: Google Earth.

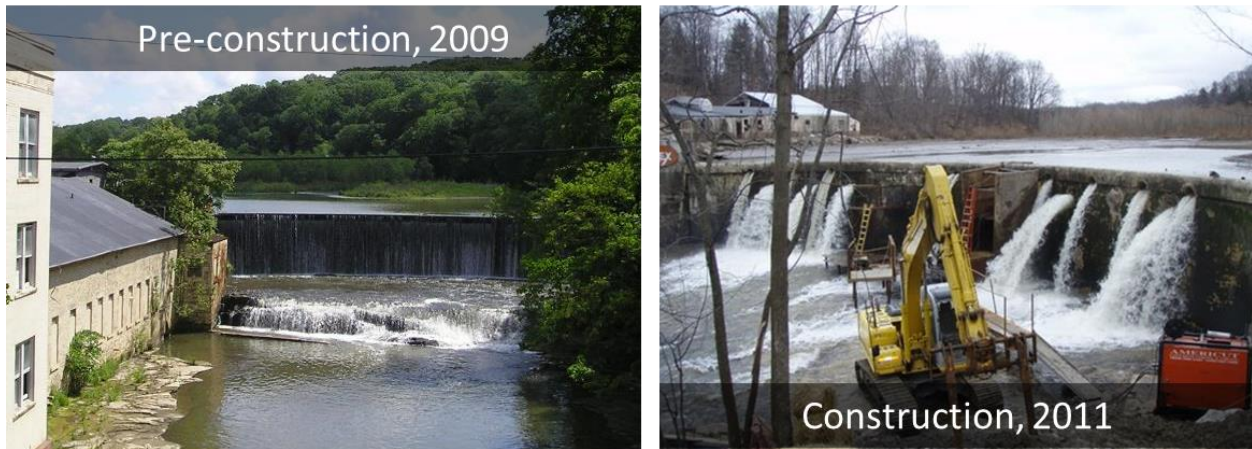
Figure 8. Pre-construction and construction conditions for the Ives of Ohio lower dam modification and stream restoration project. Photo source: Chagrin River Watershed Partners.

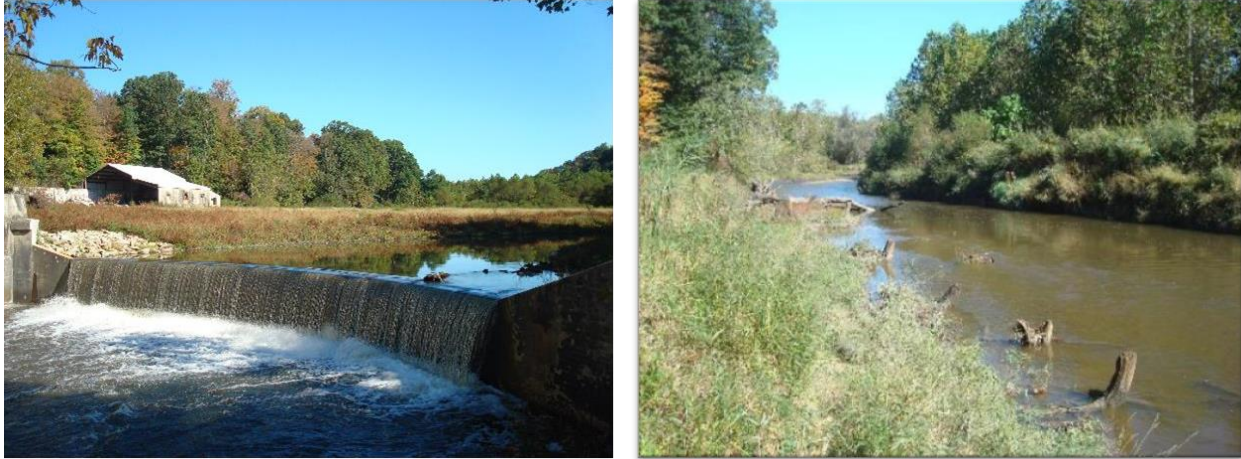
Figure 9. Post-construction conditions for the Ivex of Ohio lower dam modification and stream restoration project (Cuyahoga County). Photo source: Chagrin River Watershed Partners, 2013.

CRWP's 2017 assessment results indicated habitat assessment QHEI scores of 70.0 ("good" narrative rating) within the restoration reach and 81.0 ("excellent" narrative rating) downstream of the restoration reach. These results mirror 2014 post-construction habitat monitoring results, affirming that habitat had improved both within and downstream of the restoration reach since construction. Further, 2017 habitat assessment scores were slightly higher than post-construction stream habitat monitoring results from 2014, possibly indicating even further habitat improvement in the years since the post-construction monitoring period; however, it should be noted that the QHEI is a qualitative assessment and this improvement may not be significant enough to determine further habitat improvement since 2014. Riparian vegetative cover was estimated >95 percent (based on visual assessment). Coverage of invasive plant species within the restoration site was approximately 25 percent. This site was observed during high flow conditions after a heavy rain event in July 2017. It was noted that floodplain access was not optimal upstream of the modified dam; future quantitative assessments could be conducted to confirm this.

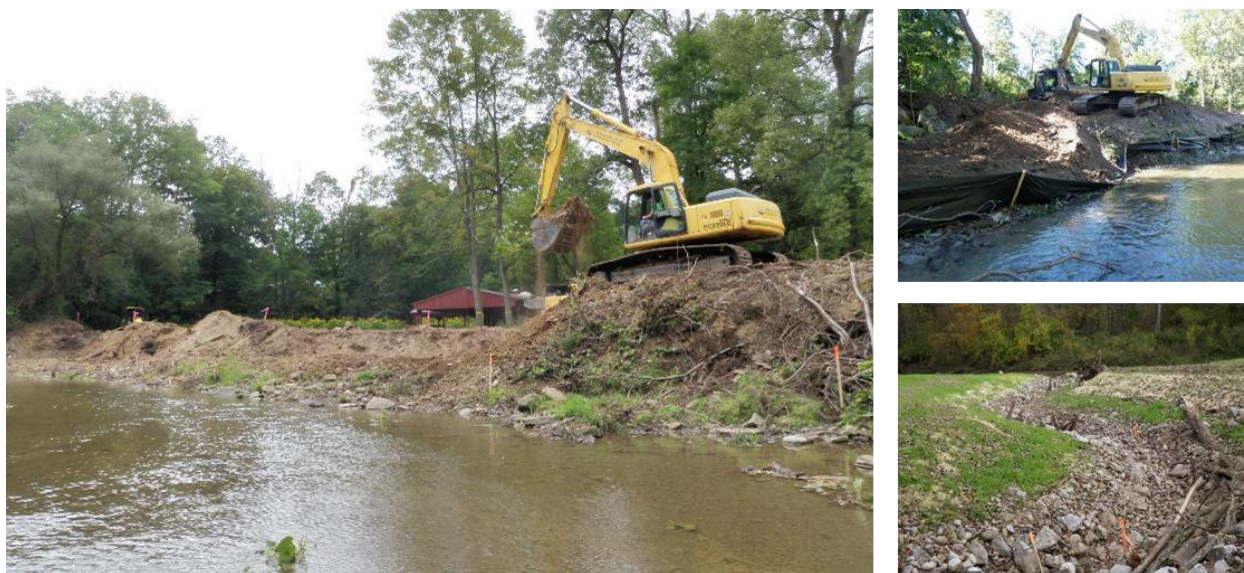
Figure 11. Construction conditions for the East Branch Chagrin River stream restoration project at Riverwood. Photo source: Chagrin River Watershed Partners, 2013.
