Pepper/Luce Creek Watershed Stream Assessment

Summary of Findings

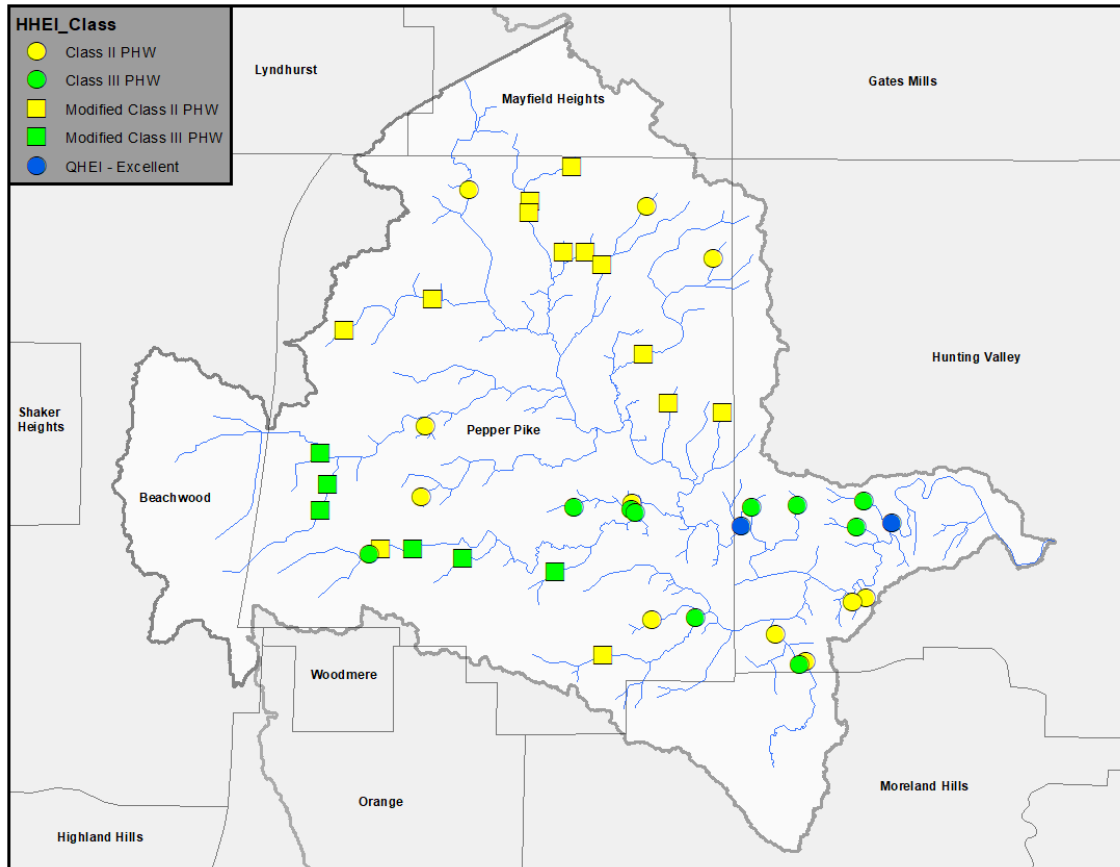
Figure 4. HHEI stream classifications within the Pepper/Luce Creek Subwatershed.

HHEI and BEHI scores were compared to the percent of impervious surface from the 2019 National Land Cover Database. All high-quality, Class III stream channels were located in areas of the watershed with 0% impervious surface at the sampling site. Where possible, efforts should be made to ensure that these areas remain healthy by maintaining native vegetation in the riparian zone (Figure 4).

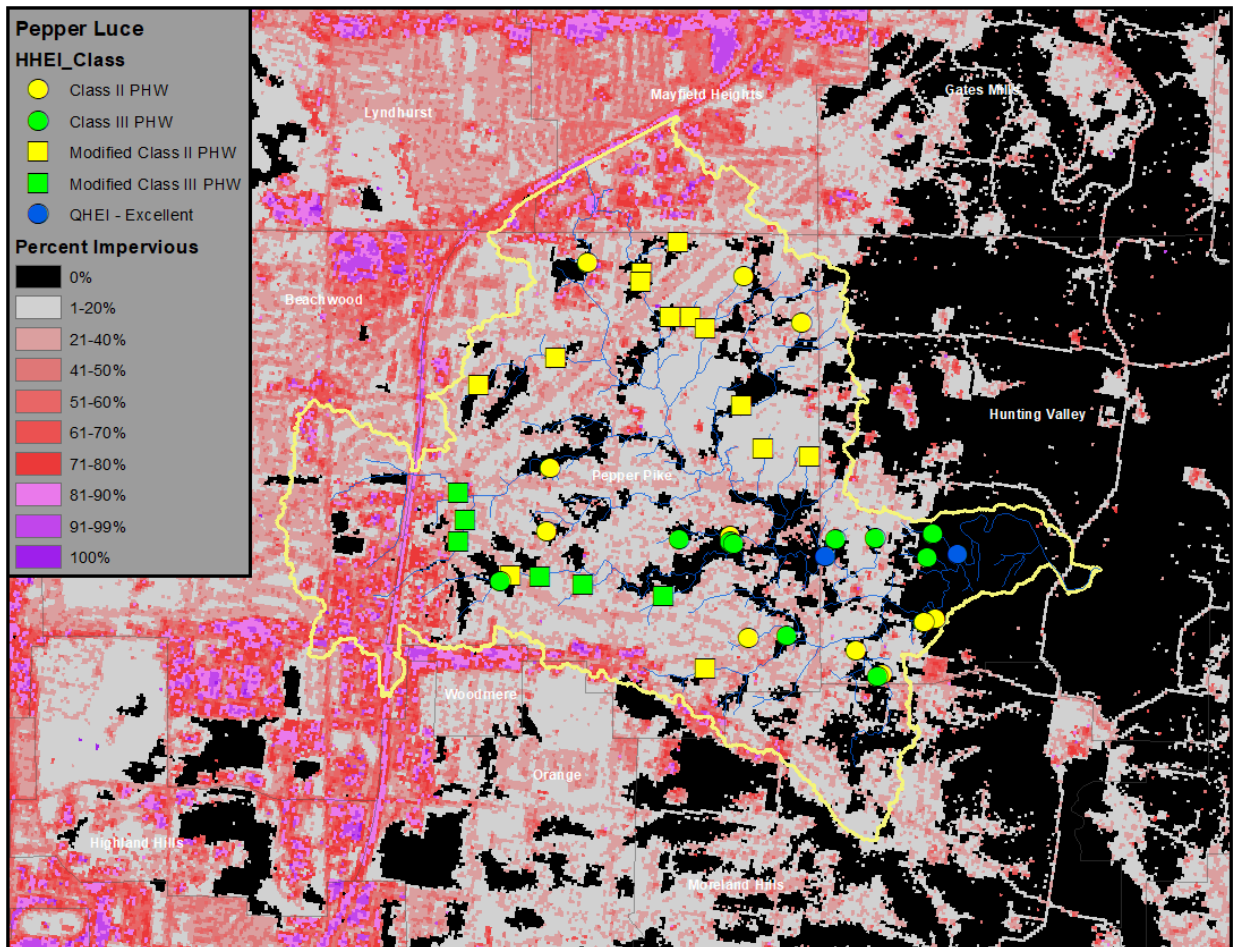
Figure 7. Percent impervious compared to HHEI scores.

Communities should consider implementing watershed wide stormwater management practices to lessen the erosion that is occurring within the Pepper/Luce Creek subwatershed.
