East Branch Chagrin River Restoration H2Ohio Project Request for Proposals (RFP) Issued March 15, 2022 Chagrin River Watershed Partners, Inc. (CRWP)

Daniels Park Stream Restoration Planning

Subject:	River Restoration Concepts
RE:	DANIELS PARK, WILLOUGHBY, OHIO
From:	Vince Sortman, Senior Fluvial Geomorphologist
То:	Keely Davidson-Bennett, Chagrin River Watershed Partners
Date:	August 6, 2018, revised October 25, 2018

Craig Swedenborg, P.E., U.S. Fish & Wildlife Service
Chris Meehan, P.E, Wenck Associates, Inc.
September 9, 2009
Final Draft - Hydraulic Analysis for Chagrin River Lamprey Barrier
Bill Holman, P.E., Stanley Consultants, Inc.

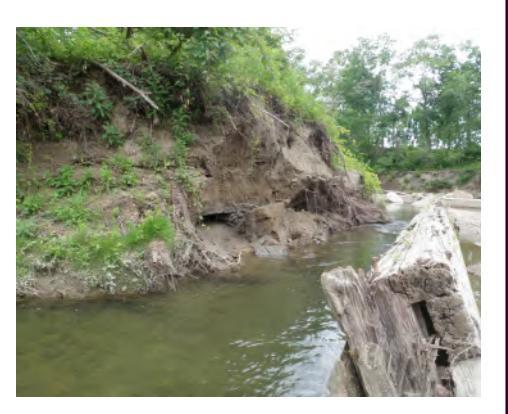
Eroding streambanks on East Branch near remnants of City of Willoughby's former water supply intake.

A remnant wooden dam and concrete intake structure and associated pipes and rubble from the City of Willoughby's former water supply intake are having a large impact on the hydraulics of the East Branch of the Chagrin River near its confluence with the Chagrin River. These structures have resulted in unnatural and variable deposition and erosion patterns. This reach is an extremely dynamic, unstable meander S-curve. The instability and hydromodification is negatively impacting the channel morphology and bank erosion and riparian zone components of the Qualitative Habitat Evaluation Index. The nearest assessment point on the East Branch was in nonattainment of its coldwater habitat aquatic life use when last assessed by Ohio EPA in 2004.

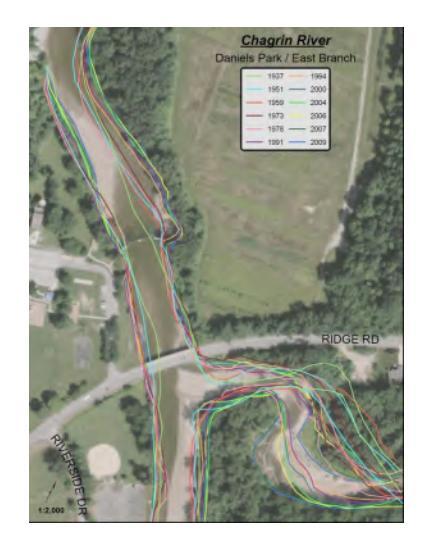
The East Branch at Daniels Park has been unstable for a long time.

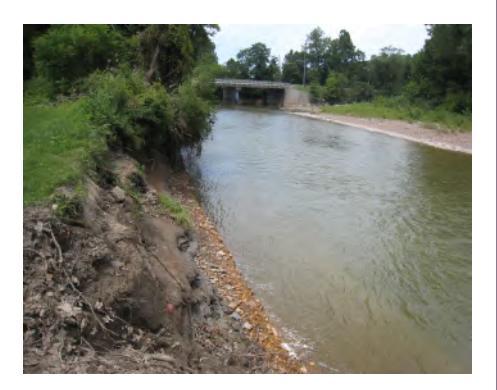
Eroding streambank on Chagrin River south of State Route 84 at Daniels Park.

Factors causing erosion on the western bank of the Chagrin River between State Route 84 and I-90 include: collapse of the downstream dam which lowered the base level, lack of adequate riparian buffer, and accumulation of sediment along the eastern bank. The erosion and migration of the western bank has resulted in deposition and aggradation of the eastern bank. The point bar on the eastern bank and associated transverse riffle are forcing flow into the western bank. Despite this ongoing erosion problem, the Chagrin River near this location has been able to maintain healthy fish and macroinvertebrate communities, and overall habitat quality is good. These erosion problems should be addressed to ensure that the Chagrin River in this area continues to support healthy aquatic communities.

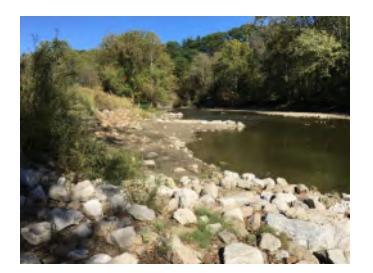
Bendway weirs would help stabilize the western bank of the Chagrin River south of SR 84.

Bendway weirs need to be keyed into the bank to prevent the river from cutting behind them.

The preferred restoration alternative (Alternative I) combines bendway weirs, a bankfull bench, and riparian restoration along the western bank with removal of the point bar on the eastern bank and realigning the transverse riffle. Bendway weirs are rock structures that direct flow into the center of the channel. A bankfull bench is a floodplain area that water overtops in common high flow events which allows for flood storage and velocity dissipation. The estimated implementation cost for Alternative I is \$485,000.

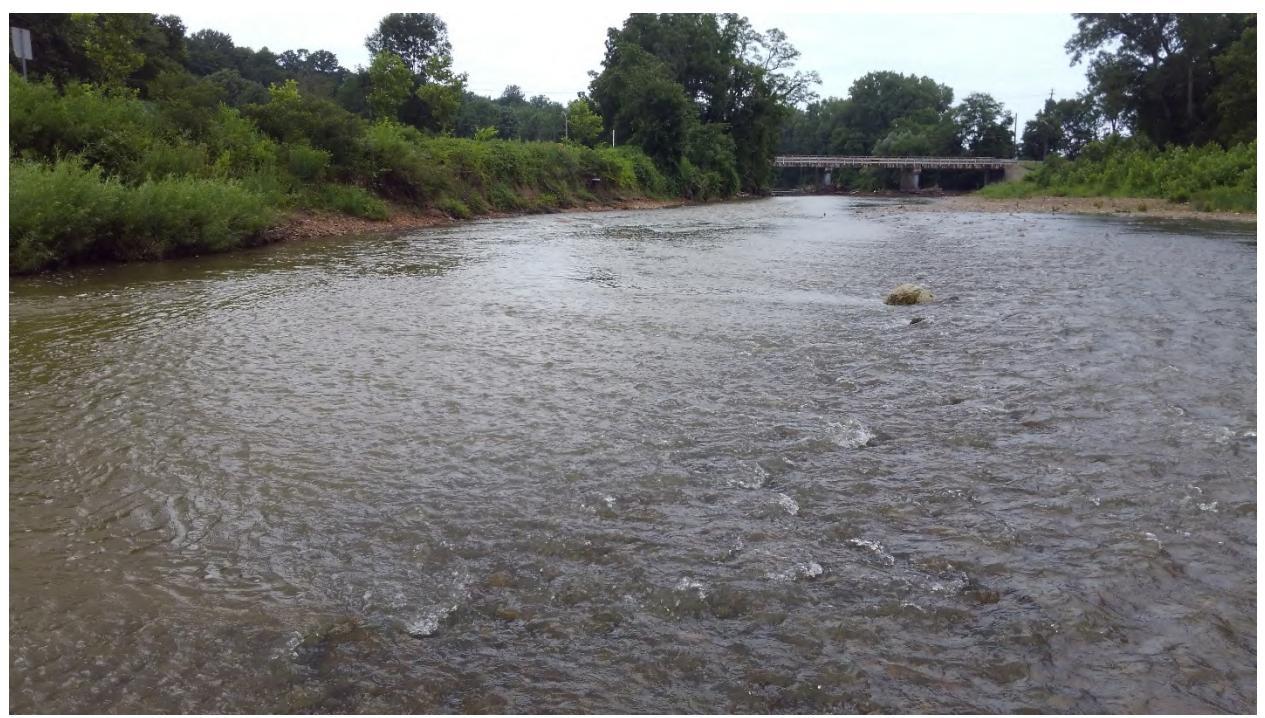
Chagrin River at Daniels Park looking downstream. Transverse riffle forcing flow into left bank.

The erosion and migration of the left bank provides the hydraulic opportunity for continued deposition and aggradation of sediments on the right bank. The growth of the bar along the right bank provides positive feedback to force flows toward the left bank. A distinct thalweg has formed along the left side of the river which has created a transverse riffle in this reach which directs flows into the left bank. The typical erosion process on channel banks is for the toe of the channel to erode away, because this is where the highest shear stresses occur, and then the bank material above slumps down into the channel and is eventually eroded away also. Several bank slumps were noted at the toe of the left bank during our site assessment.

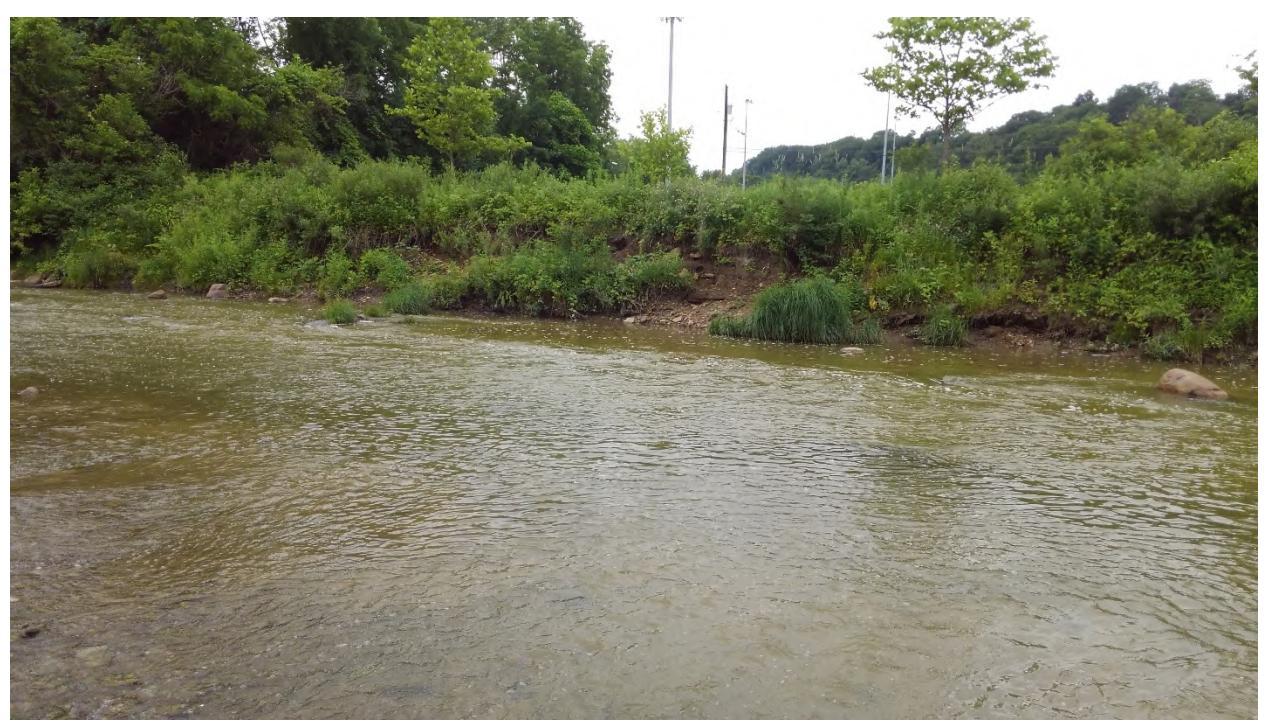
View of left bank on mainstem showing slumped bank material in channel after toe erosion.

The left bank (looking downstream) of the Chagrin River is actively eroding. The bank is about ten feet high and composed of mostly silty clay soil with some alternating layers of river bed material in the lower portion of the bank. It appears that the bank erosion was initiated by a combination of factors:

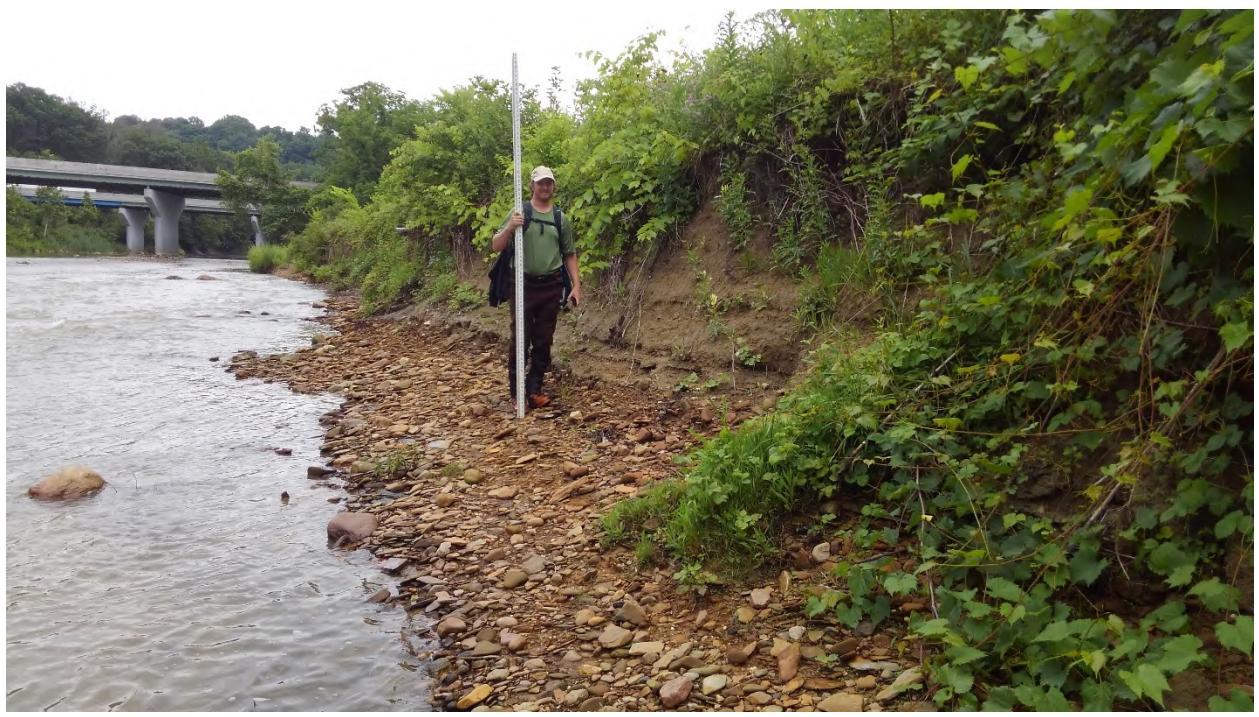
Looking upstream at eroding left bank of mainstem.

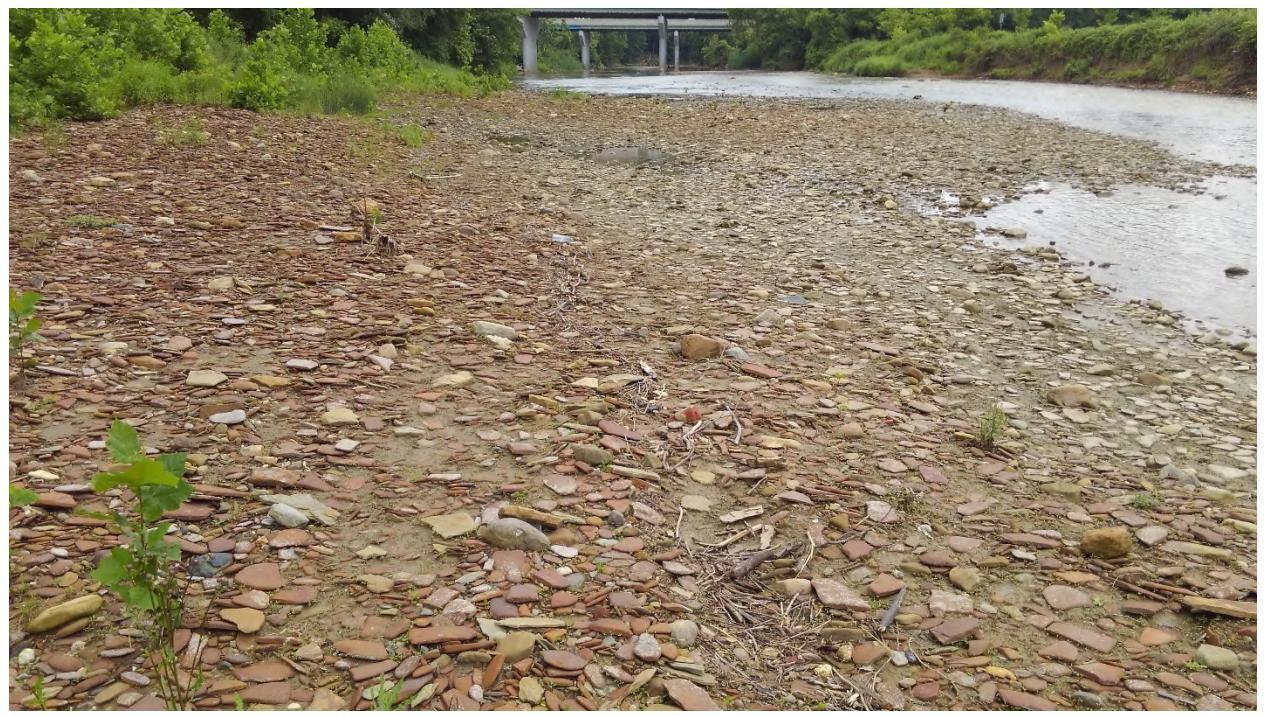
Looking upstream at large cobble/gravel bar forming along right bank of mainstem.

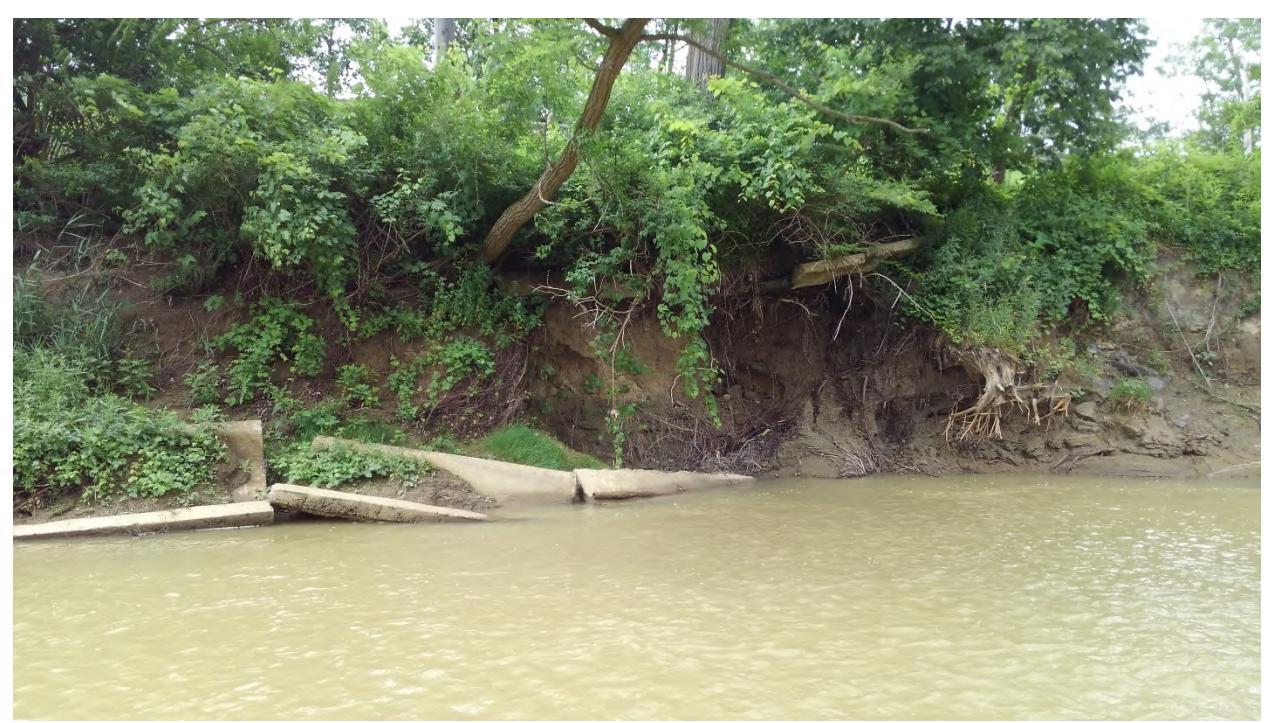
Actively eroding bank on the East Branch along Route 84. Concrete curb/gutter slumped into the channel from the top of bank.

The eroding banks on the East Branch are quite similar to the eroding bank on the mainstem. The banks are about 10' high and composed of mostly silty clay soil with some alternating layers of river bed material in the lower portion of the bank. The erosion process is also similar with the toe eroding and bank material slumping down into the channel.

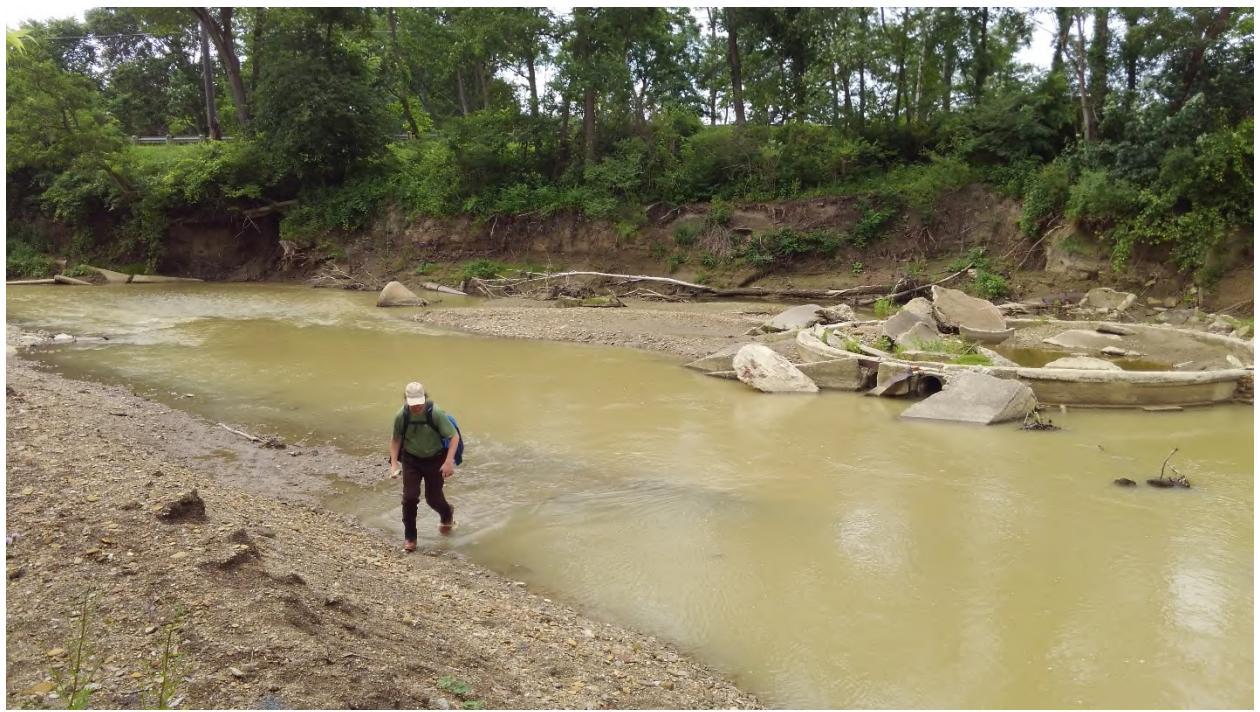
Remnant of concrete intake structure with eroding bank along Route 84,

The project reach of the East Branch is characterized by an extremely dynamic, unstable meander Scurve. The hydraulics in this S-curve have been highly altered by man-made structures. There is the remnant of a wooden dam that crosses the channel near the upstream end of the downstream meander which is connected to the remnant of a concrete intake structure on the edge of the downstream meander. There are also exposed pipes and concrete rubble in the channel. These structures alter the storm flow hydraulics such that the deposition and erosion patterns are not natural and appear to change from flow to flow.

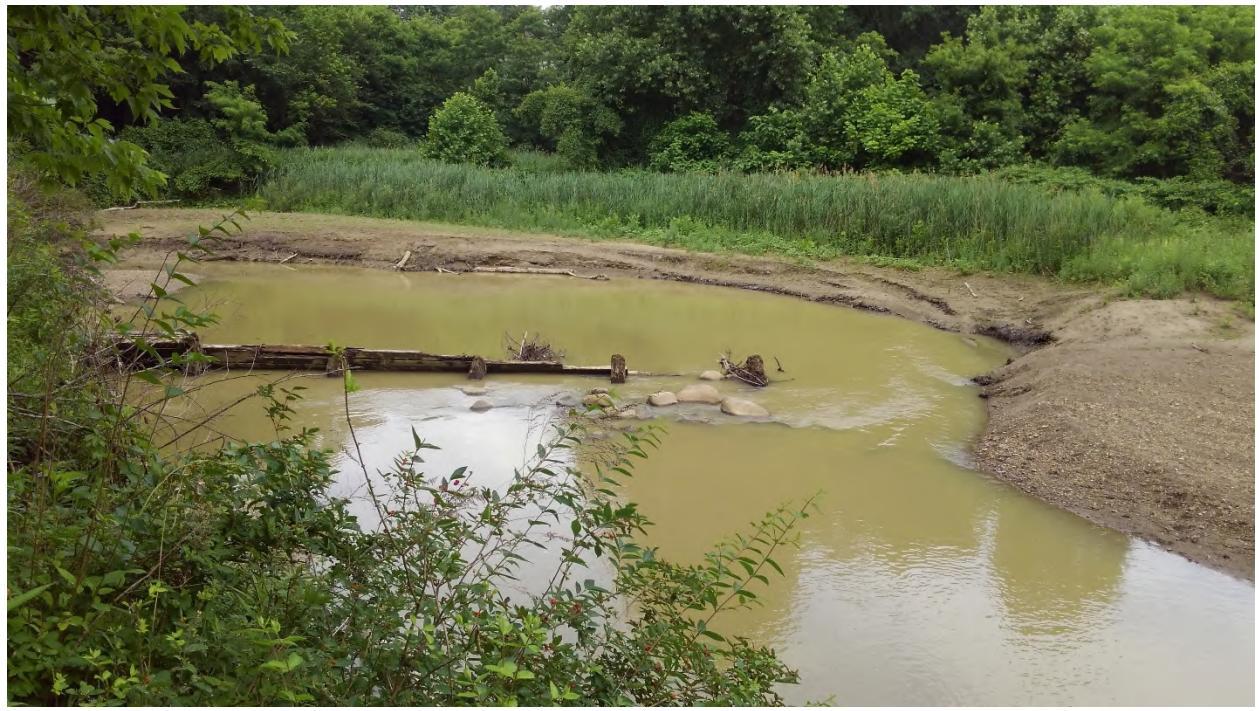
Remnant of wooden dam structure just upstream of old intake structure.

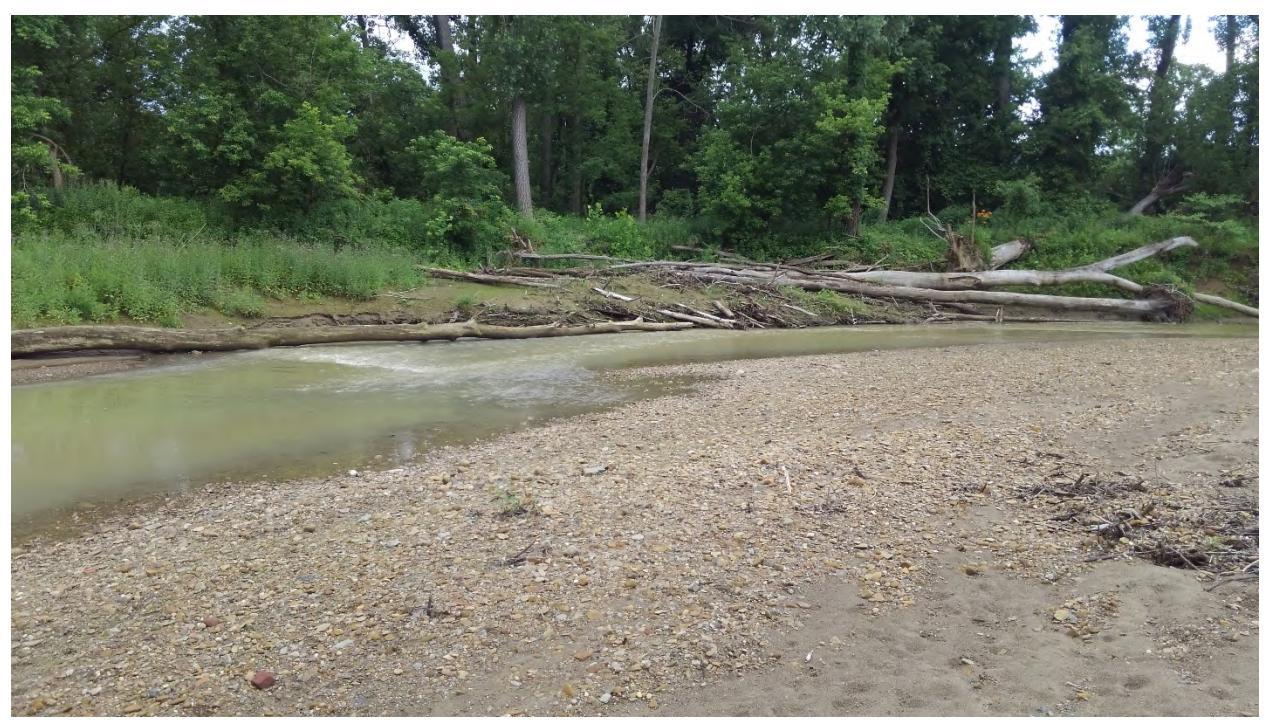
Looking downstream at low area in floodplain at upstream meander where new channel could be cut through to the mainstem.

Our preferred restoration alternative for the East Branch is to realign the channel to cutoff the downstream meander. This would eliminate the influence of the man-made structures on the flow hydraulics and provide a better approach of the East Branch into the mainstem. There is a low area in the floodplain between the East Branch and the mainstem that appears to be the best location for the new channel alignment. The material excavated for the new channel would be used to create a plug between the new channel and the old channel; however, most of the old channel would remain open as a backwater/oxbow wetland. The new channel alignment would have one meander. This meander could be stabilized with toe wood using trees removed from the excavated area. Using toe wood to stabilize the meander will greatly reduce sediment loading and improve aquatic habitat. Creating the backwater/oxbow wetland will provide habitat and plant communities that are lacking in this area.

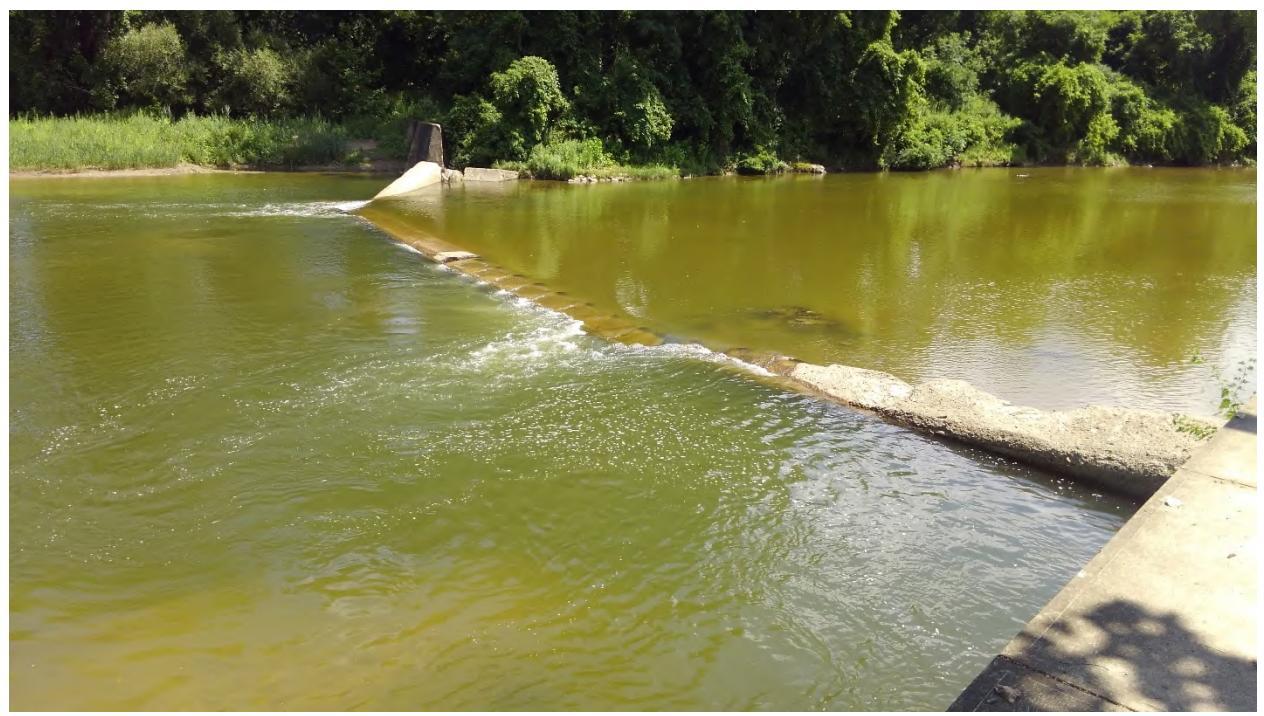
View of collapsed dam from west bank. Notice two low areas with elevated velocities. Also notice deep scour pool just downstream of dam.

Because the dam collapsed into a deep scour hole, a large section of the top of dam is close to water level during low flow conditions and therefore does not appear to be a fish barrier. However, most of the base flow is concentrated at two low areas of the collapsed dam. This situation does elevate flow velocities through the two low areas which could hinder smaller native fish. There is a section of concrete that is slightly higher than the two low areas but is low enough for base flow to flow over in a thin stream. If this section of concrete could be lowered several inches it would increase the flow area and reduce the velocities at the two low areas increasing the potential for small native fish to pass. Also, most of the scour hole downstream of the dam is still intact and provides good pool habitat.

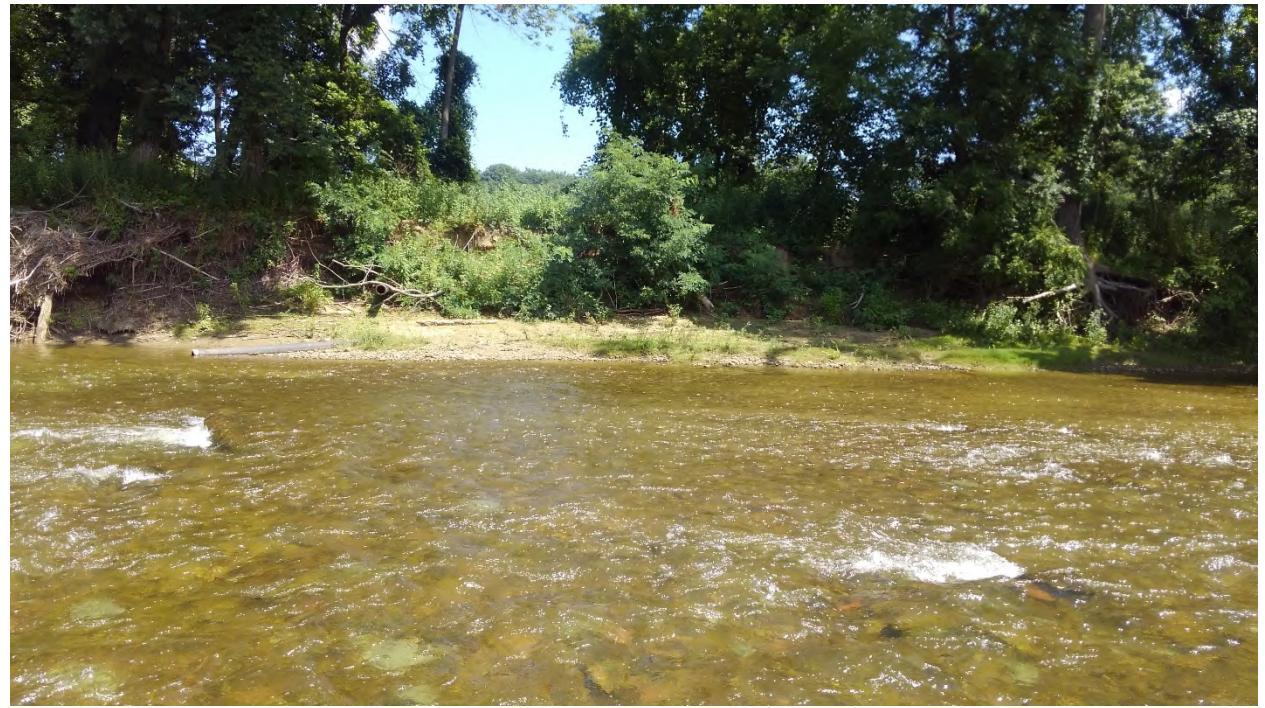
Wide riffle downstream of collapsed dam. Notice deposition along right bank.

The river channel in this area is not unstable. No mid-channel bars have formed. There is a wide riffle just downstream of the scour hole but even during low flow conditions there was about 12 inches of depth in the thalweg. Also the reach just below the dam appears to be depositing sediments along both banks. There appears to be some active erosion on the right bank but it's relatively small and looks like some strategically placed large woody debris would help create deposition there.

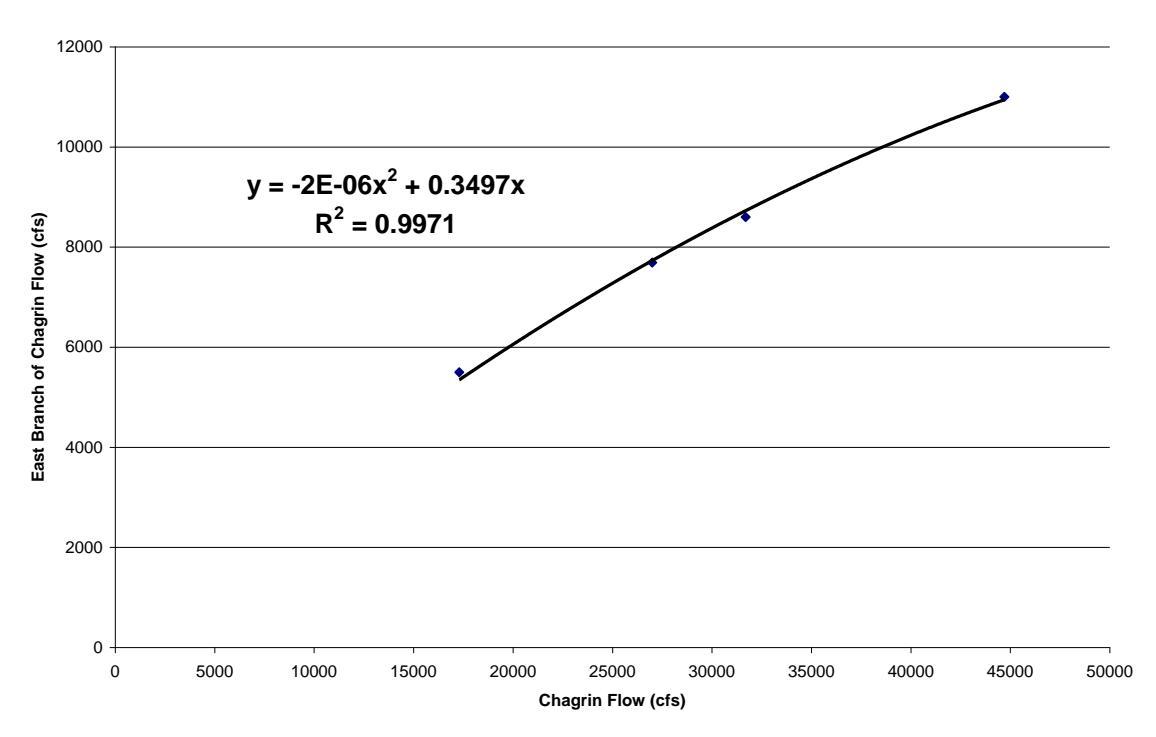
Figure 1: Correlation of Flows between Daniels Park Dam Site and Kirtland Country Club Site.

Chagrin and East Branch Chagrin Flow Correlation - Data from the City of Willoughby FIS

The results of the correlation demonstrate a good fit (R2 = 0.9971), which enables flows developed at the Daniels Park Dam to be correlated to the Kirtland Country Club Site. The results of the correlation are provided in Tables 3 and 4.

There were no flow records available for the Kirtland Country Club site. Flows for this site were developed by correlating flows from City of Willoughby FIS between the East Branch of the Chagrin to the Main Stem of the Chagrin. The correlation of the 10, 50, 100, and 500-year storm events are shown in Figure 1.

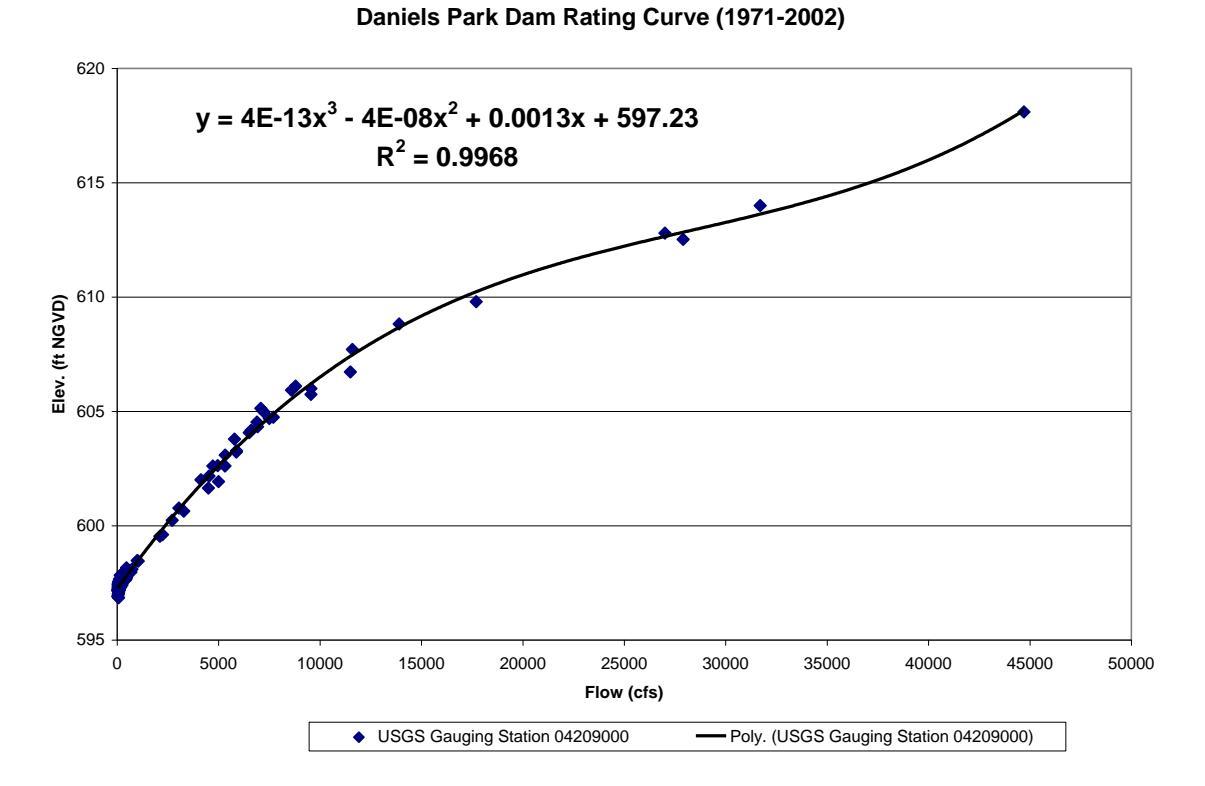
Figure #2 – Rating Curve for Daniels Park Dam based on USGS Gauging information (1971-2002)

A rating curve was also developed for this site based on stage data collected by the USGS to supplement information provided by the Flood Insurance Study for the City of Willoughby. Stage data from the USGS monitoring station was only used from 1971 to 2002, since there was concern elevation data after that time would not be representative of having a fixed crest weir at that location. The rating curve for the location is shown in Figure #2.

Based on this information a HEC-RAS model was developed to determine elevations upstream and downstream of the dam along with separation. The results of this analysis are provided in Tables 5 & 6. A negative number in the separation column indicates the weir is submerged and sea lamprey would be able to migrate past the weir.
