# Marcourt Farms Chagrin River Restoration Project

The Village of Hunting Valley

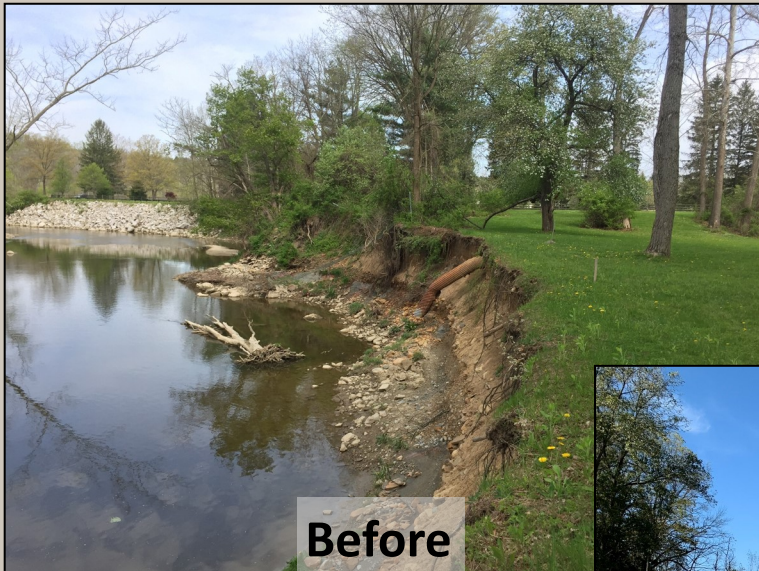
**Before**

In 2016, the Village of Hunting Valley was awarded an Ohio EPA Section 319(h) grant to sponsor a river restoration project on two privately owned parcels along the main stem of the Chagrin River. The project site, located on a bend, was experiencing severe erosion, with streambanks as high as fifteen feet, downed trees, two broken stormwater outfalls, and the absence of a functioning riparian area. These conditions contributed to increased sediment entering the river and impacted the river's ability to properly function and provide habitat. As a result, the Village partnered with Chagrin River Watershed Partners to complete a river restoration project using a large woody debris approach.

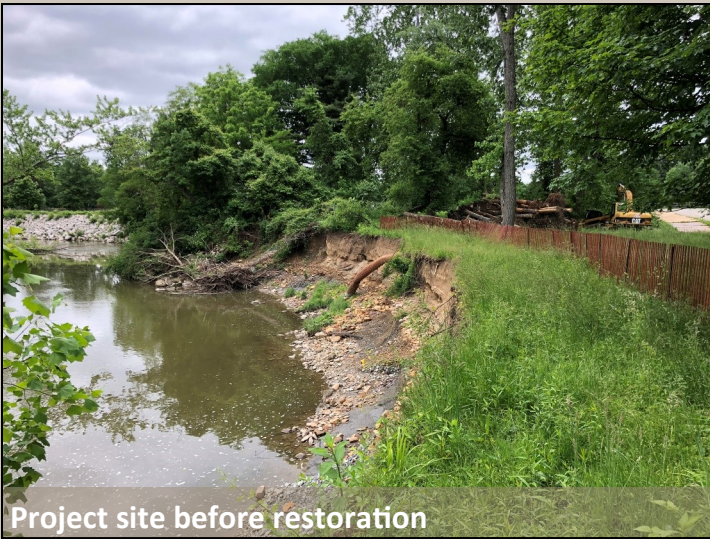
Project site before restoration

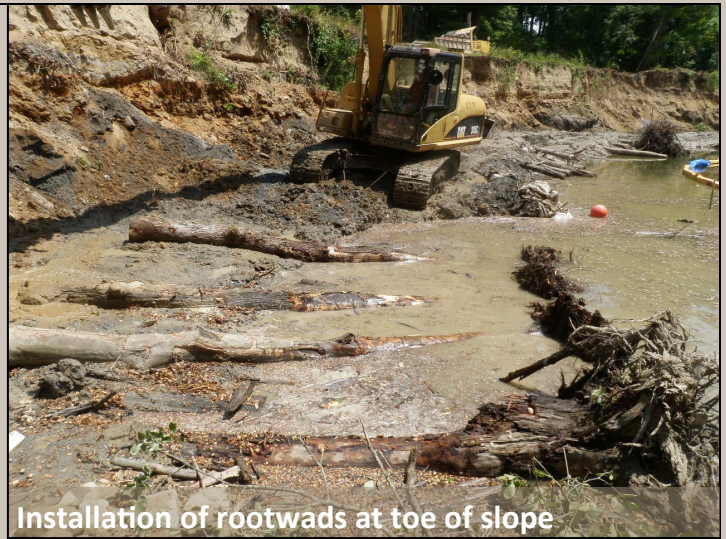
Installation of rootwads at toe of slope

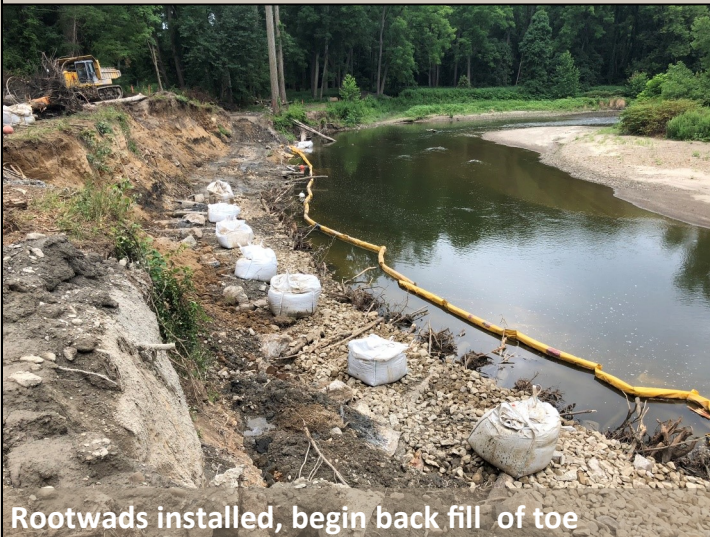
Rootwads installed, begin back fill of toe

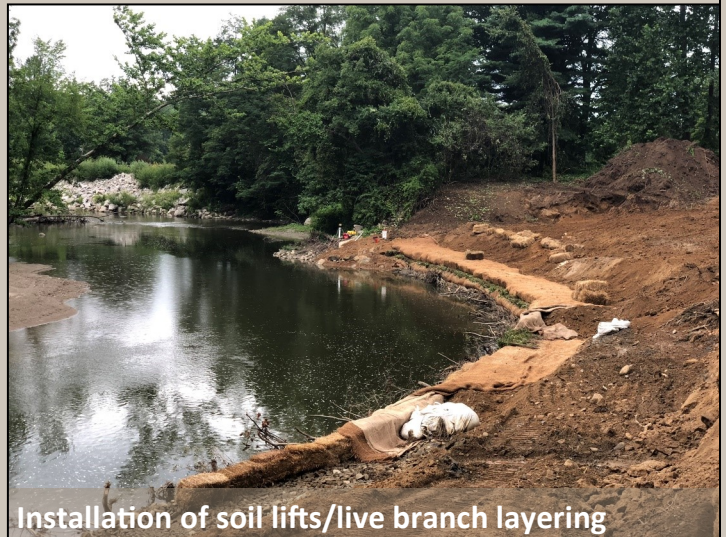
Installation of soil lifts/live branch layering

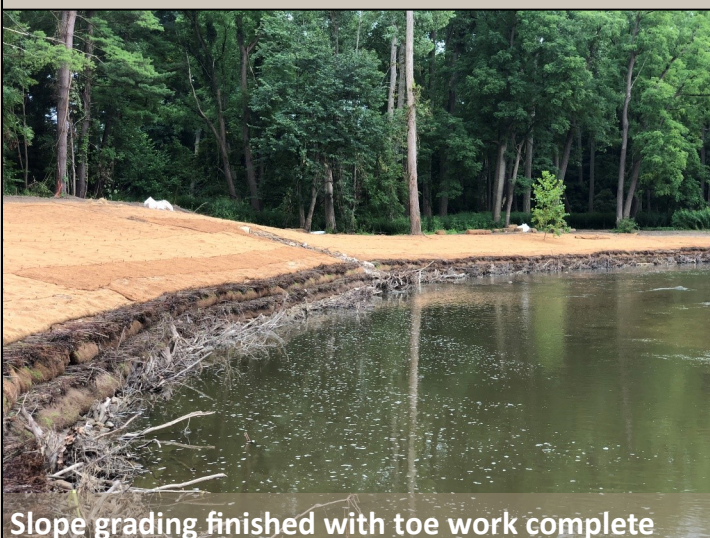
Slope grading finished with toe work complete

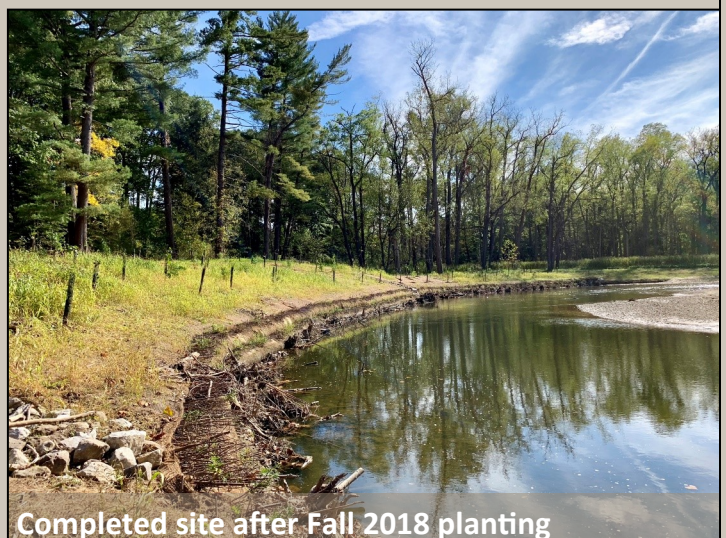
Completed site after Fall 2018 planting
