## BASS LAKE PRESERVE

### SPRING BROOK RESTORATION

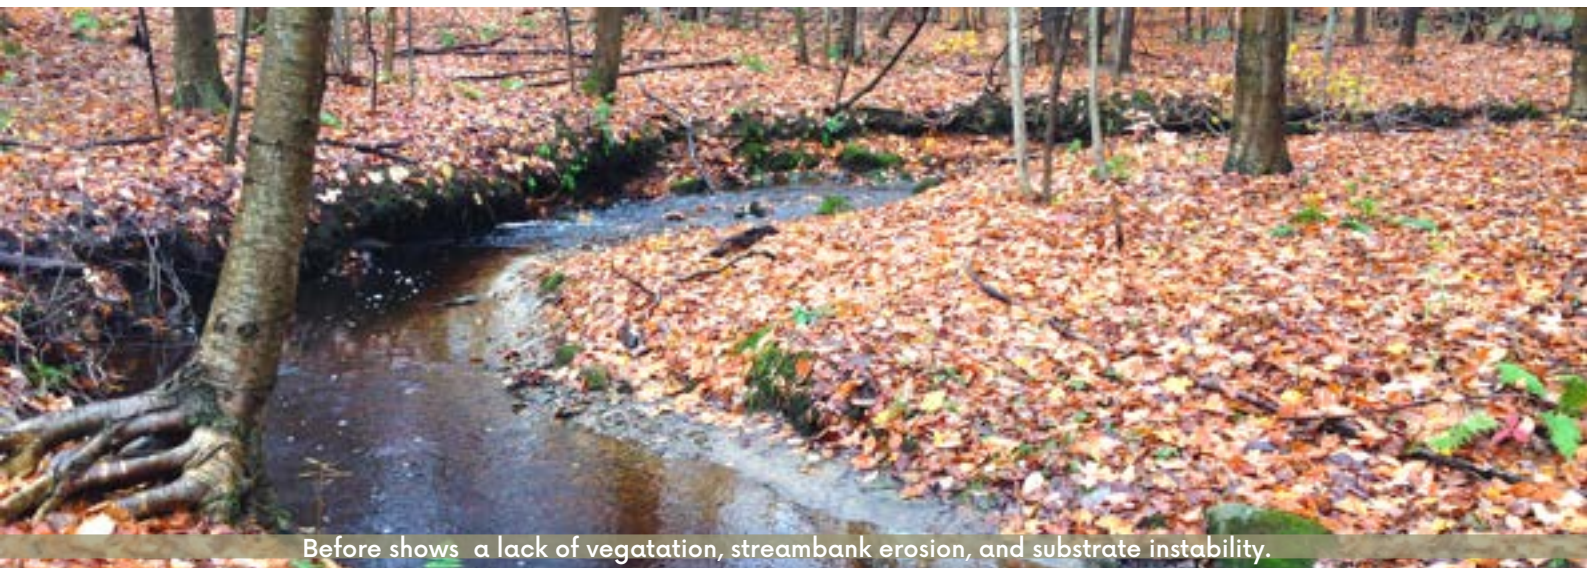
Before shows a lack of vegetation, streambank erosion, and substrate instability.

Prior to restoration, Spring Brook showed signs of degradation, including scouring and channel incision due to a sudden change in the stream's slope. The stream's substrate was previously made up of a healthy combination of cobble, gravel, and sand with well-developed riffles, runs, and pools, which provided excellent habitat for sensitive wildlife. However, the substrate had been scoured down to predominately hardpan clay material, which is very poor habitat. The stream was also becoming shallower and wide, and it was being threatened by increased streambank erosion, associated sediment, and significantly increased head cutting.

This project restored approximately 800 linear feet of stream by reconnecting the stream to its floodplain and reducing the stream's ability to scour the beneficial sediment which makes up the stream's riffles and pools. The project also reconstructed and added more riffle complexes, which added habitat and stability for sensitive coldwater wildlife. The project also included the removal and control of invasive species and about 2 acres of riparian enhancement.

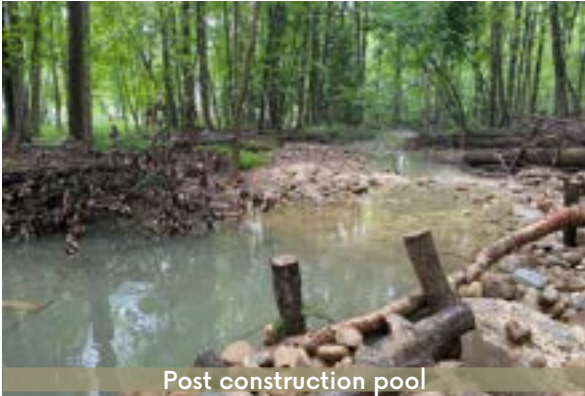
Post construction pool

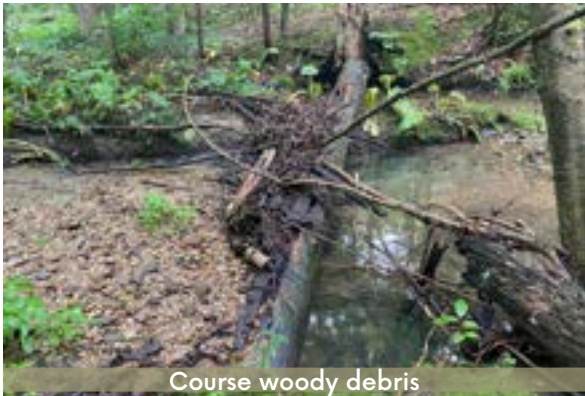
Course woody debris

**Woody Debris:** Spring Brook was enhanced with boulders, woody debris, branch, and log revetments. Coarse woody debris in streams is one of the most influential habitats that can be added to streams. Macroinvertebrates and fish use these materials for food, protection, breeding, and shelter.
