## VILLAGE OF BRATENAHL

### NINE MILE CREEK RESTORATION

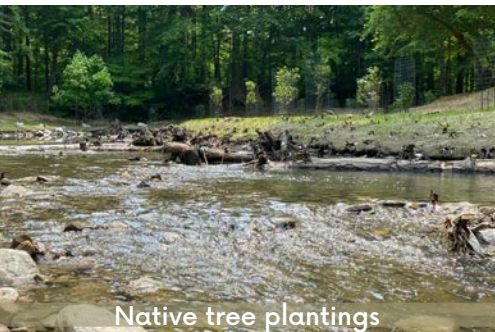
Native tree plantings

This project restored approximately 2200 linear feet of stream bank and 3.2 acres of riparian enhancement while employing as many nature-based approaches as possible. Several riffle structures were installed and the stream banks were graded to create a shallow and smooth transition from streambed to floodplain. The strategic placement of tree trunks and other woody materials helps to prevent bank erosion and approximately 1,200 tons of gravel, cobbles, and boulders now guard stream banks against flood scour. The longtime failing outfall was replaced with a concrete drop structure and ecological restoration made use of native trees, shrubs, and ground plants.

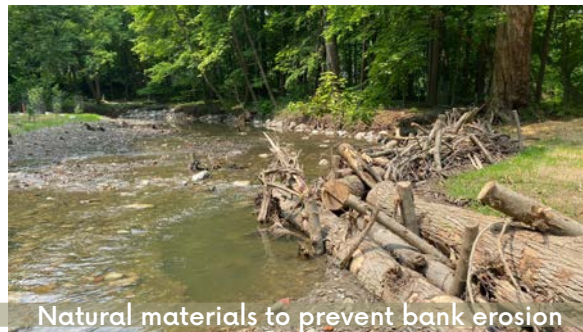
Natural materials to prevent bank erosion

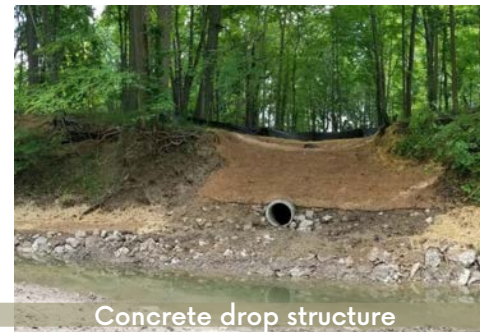
Concrete drop structure
